# Arbeitsbericht NAB 16-20

## FEBEX-DP Post-mortem analysis: Sensors

M. Rey, F-J. Sanz, J-L. García-Siñeriz

AITEMIN

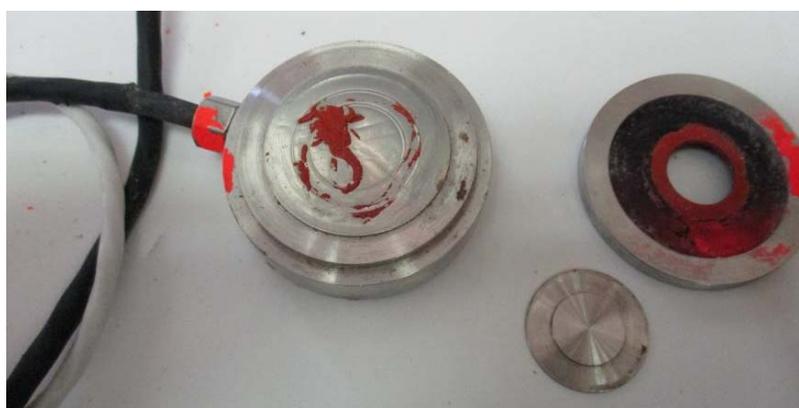
The first total pressure cell (PSO-01) was apparently in quite good conditions (see Figure 10). The sensor's body, the cable gland and the cable were in a good state; the protection rubber was separated from the membrane, but the sensor was not mechanically damaged. The conductors were clean without any traces of rust.

**Figure 10. Detail of state of total pressure cell PSO-01**

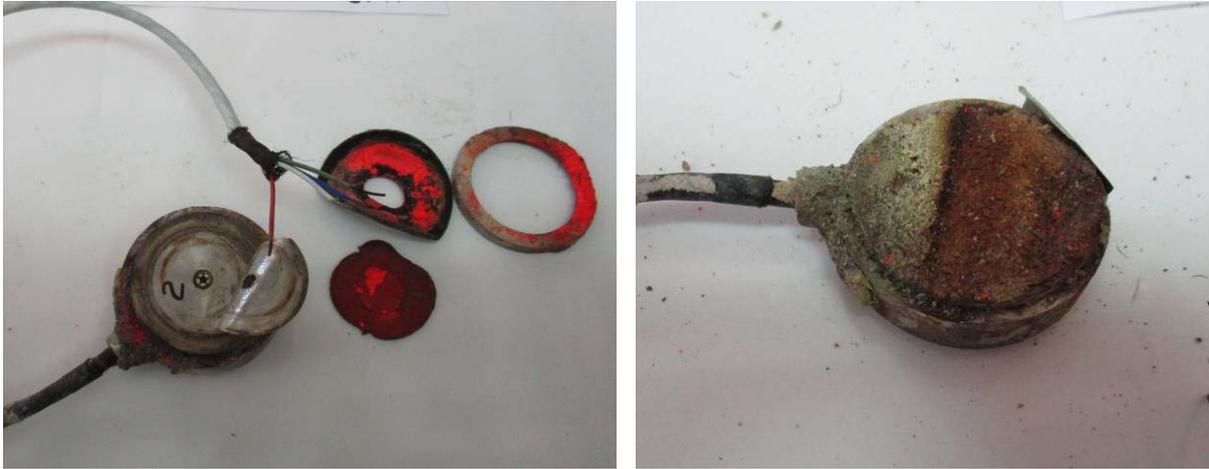
The second total pressure cell (PSO-02) was found very much damaged; the protection membrane was completely separated from the joint, the measuring area was pierced and no oil remained. The body of the sensor was quite corroded and water had entered the electronics, the conducting wires appeared rusty; see Figure 11.

**Figure 11. Detail of state of total pressure cell PSO-02**

There is no clear explanation of why the second pressure cell was much more damaged than the first one.

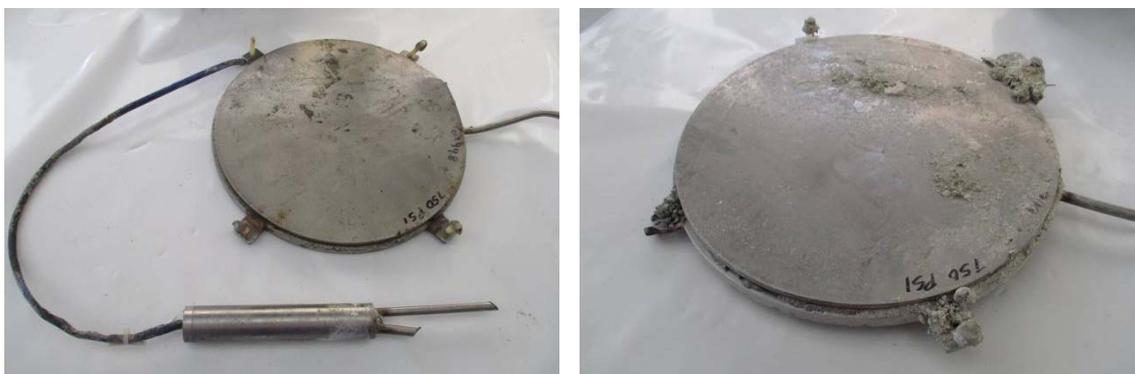
The two total pressure cells were slightly damaged during their extraction, showing some hits of the robot that had dismantled the plug, although their general state of conservation was good; they did not reveal any signs of external corrosion (see Figure 14). The cable was slightly damaged in the vicinity of the sensors, but there was no internal rusting of the wires, indicating they had remained watertight or that the presence of water had not been significant in the section; see Figure 15.

**Figure 14. Detail of sensors PSP-01 (left) and PSP-02 (right)**

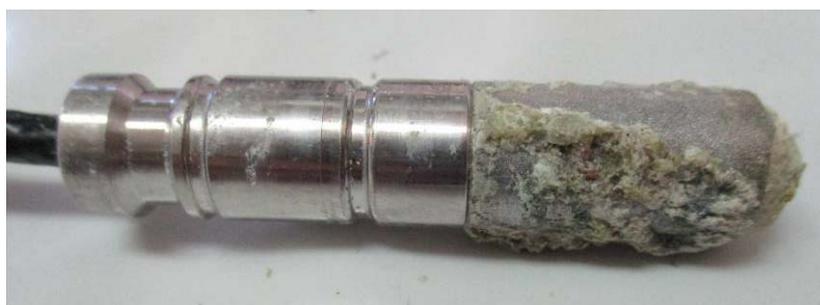
In the case of WCSQ-02, there were some bentonite traces at the filter surface (see Figure 19). The internal part of the three thermohygrometers (filter and sensing element) showed some rusty parts/traces of rust and evidence of contact with water, see Figure 20.

**Figure 19. Detail of external aspect of WCSQ-01**

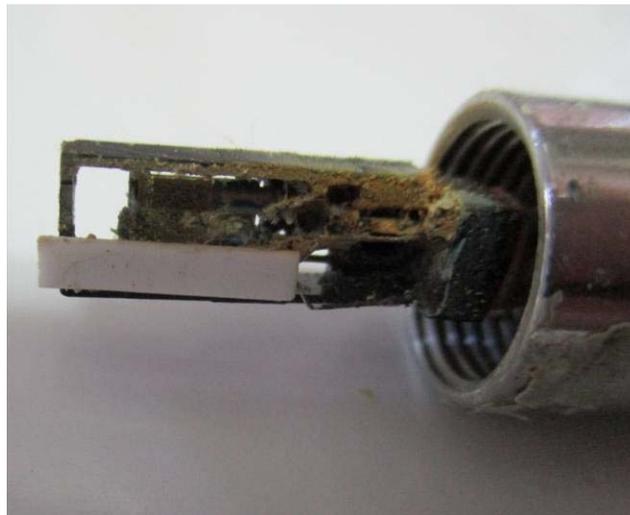
**Figure 20. Detail of internal aspect of WCSQ-02**

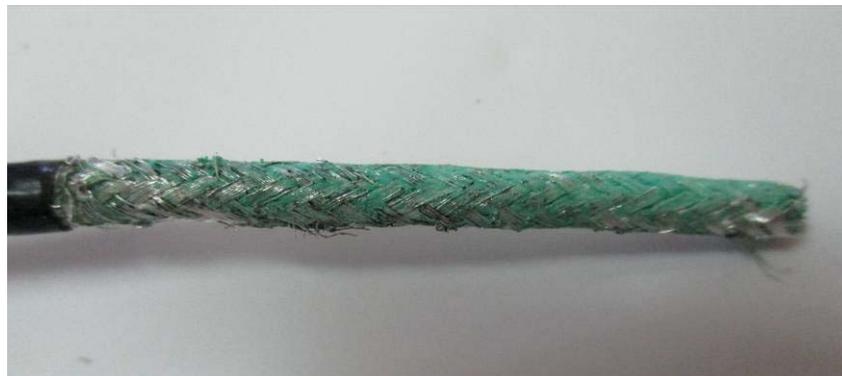
The plastic jacket of the cables of these sensors appeared quite deteriorated. The external shield of the cable had a bad smell and a *malleable* texture. The internal shield and wires were very rusty, evidence of their contact with water, see Figure 21.

**Figure 21. Detail of internal shield, WCSQ-03**

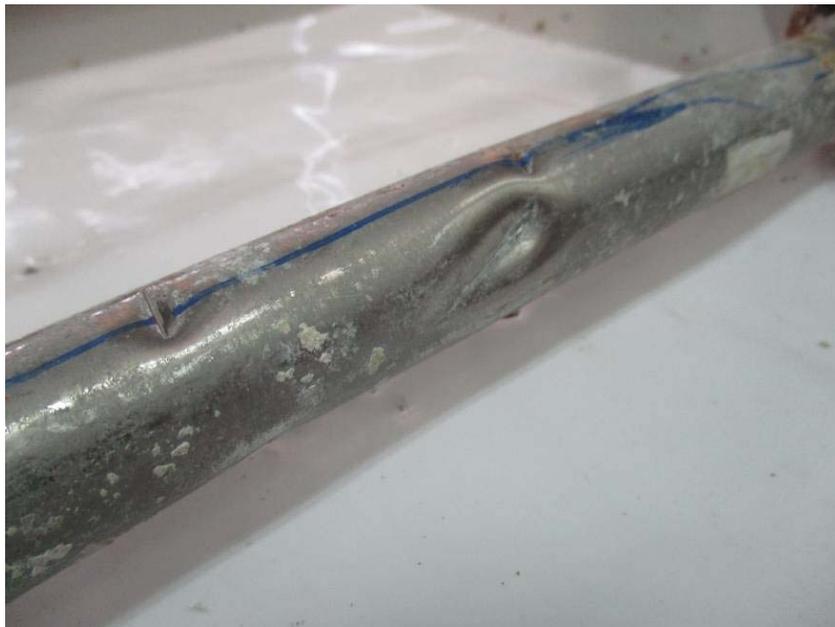
The two extensometers (SH-SG-01 and 02) were found blocked<sup>2</sup>, showed some external scratches from the dismantling operation and were slightly deformed as a consequence of the bentonite's swelling. The technical data of these sensors is given in section 9.3.4.

**Figure 26. Detail sensor SH-SG-02, slight deformation  
(Dents were caused by dismantling works)**

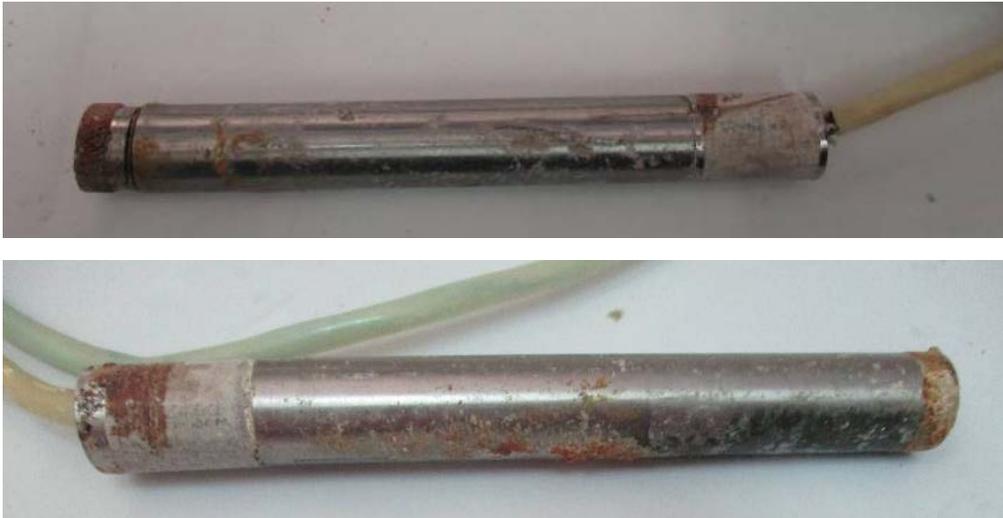
Of all sensors, those in the vicinity of the liner (Q-SH-03, Q-SH-04, Q-SH-05 and Q-SH-10) were in the worst conditions after dismantling, and those in the upper part (Q-SH-10, Q-SH-11 and Q-SH-12) were the most deformed; see Figure 33.

**Figure 33. Detail of deformation sensors Q-SH-04 and Q-SH-10**

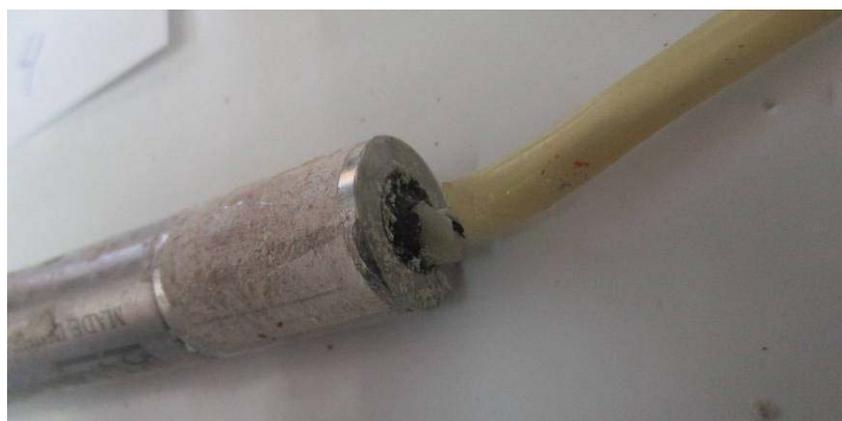
In all cases, the cable of the pore pressure sensors was quite difficult to manipulate, it had lost its initial flexibility and appeared very rigid; in some sensors the jacket was broken just at the output of the sensor body, causing water to enter the inner part of the cable; see Figure 34.

**Figure 34. Detail of broken cable shield sensor Q-SH-04**

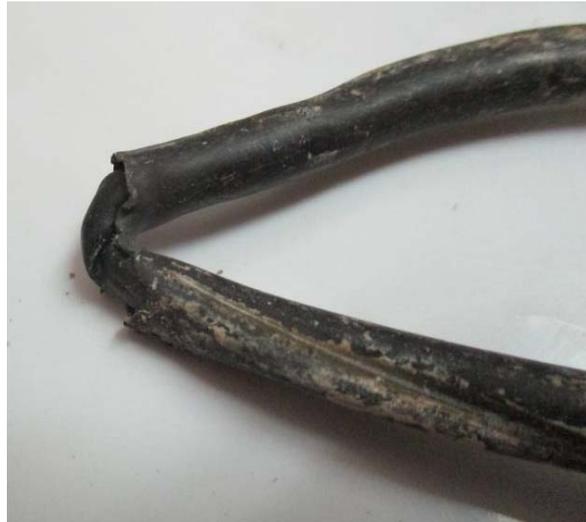
All capacitive thermohygrometers (WC-SH-01 to 13) went out of order during the operation but showed a good state of conservation, except for the cables and the plastic jackets that protected them, which were quite damaged in all sensors and squashed in some of them (WC-SH-07, WC-SH-08, WC-SH-09 and WC-SH-10); see Figure 35. The technical data of the thermohygrometers are included in section 9.3.7. (ROTRONIC ones).

**Figure 35. Detail of squashed plastic jacket in thermohygrometers**

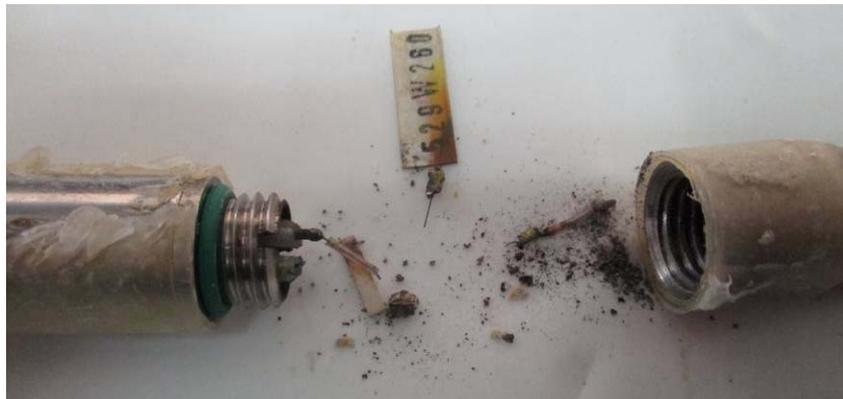
Evidence of the presence of water/humidity inside the sensors was seen, affecting both the filter and sensing element inside the measuring chamber. This was especially the case of thermohygrometers in the central and lower part of the section (WC-SH-01 to WC-SH-06 and WC-SH-11), where the sensing elements (capacitive film and temperature sensor) appeared corroded and/or destroyed, see Figure 36 and Figure 37.

**Figure 36. Detail state of sensing element, capacitive thermohygrometers**

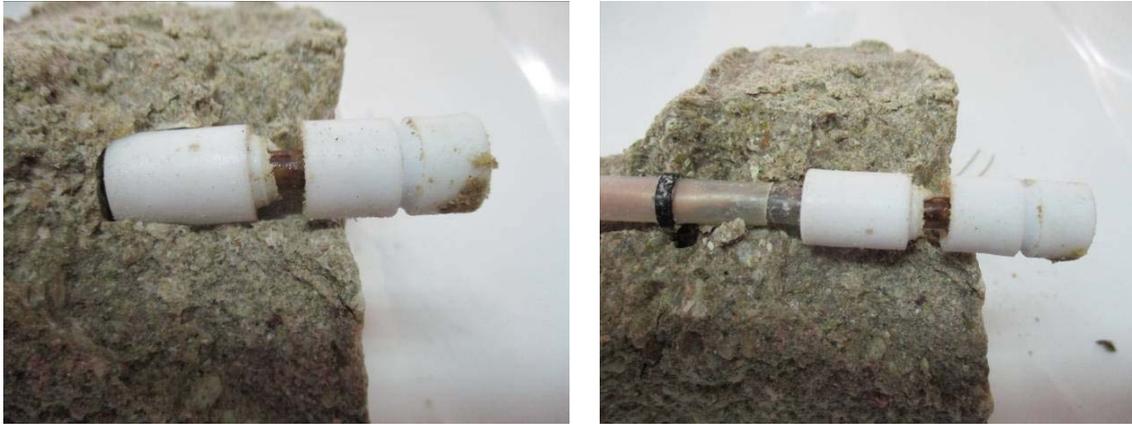
Regarding the psychrometers (WP-SH-01 to 08), the swelling of bentonite caused a deformation of the Teflon® body in most of them. In some sensors the ceramic filter was broken (WP-SH-02, 04, 05, 06, 07 and 08) and in WP-SH-03 the cable was separated from the body. The technical characteristics of these sensors are included in section 9.3.8.

**Figure 38. Detail of state of Teflon® protection, sensor WP-SH-02**

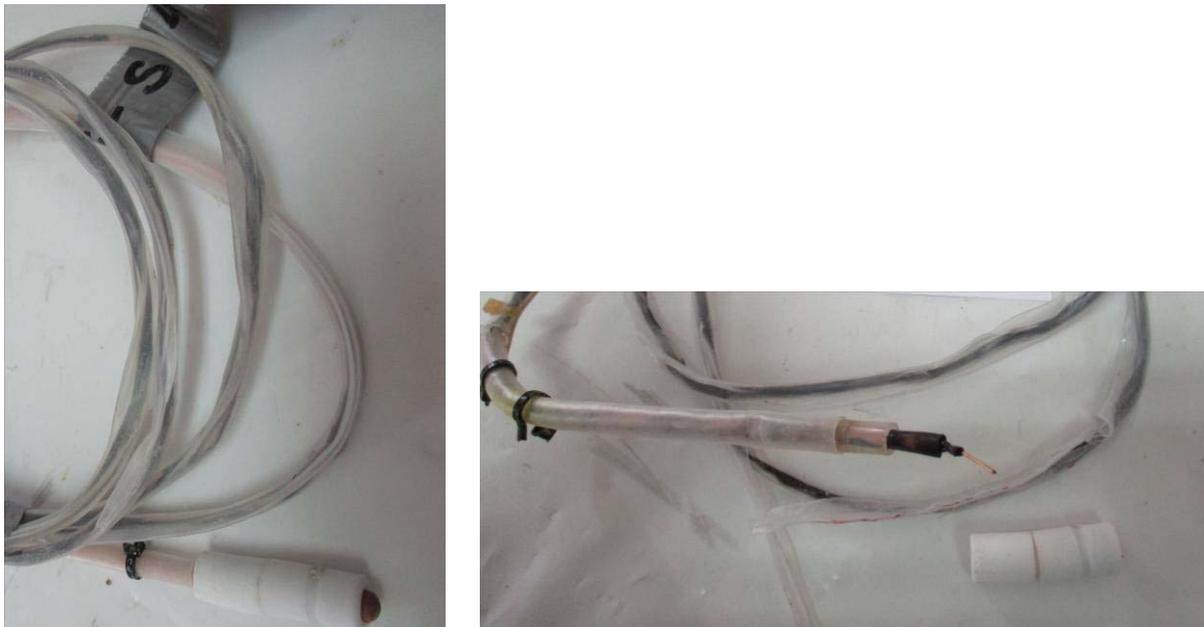
The cables and their protection tubes appeared quite damaged, squashed and broken. The cable was degraded and a change of colour was also noticed; see Figure 39 and Figure 40.

**Figure 39. Detail state of cable and protection tube, psychrometers section 41**

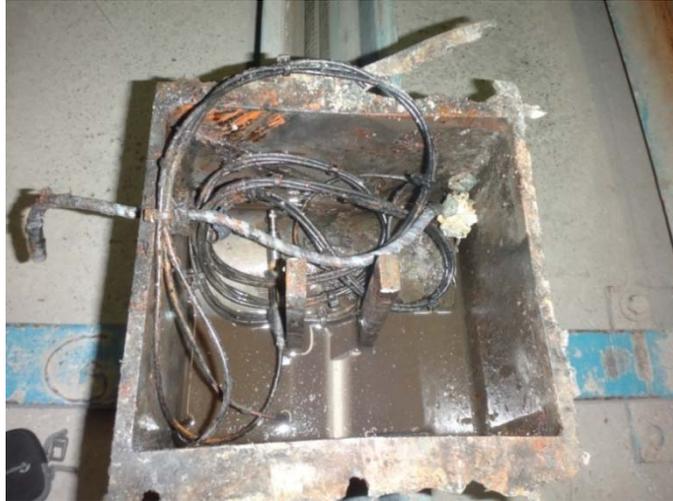
The metal box of the crackmeter was found filled with water and with all metal parts in an advanced state of corrosion. The sensing elements inside showed evidence of prolonged submersion in water; the cables were disintegrated in some points, with the inner wires completely rusty/corroded (see Figure 51 and Figure 52). The cable glands that used to isolate the cable input from the sensing element were no longer fixed to it.

**Figure 51. S-S-47-1 / 3SEF2-01-F1 box filled with water after dismantling**

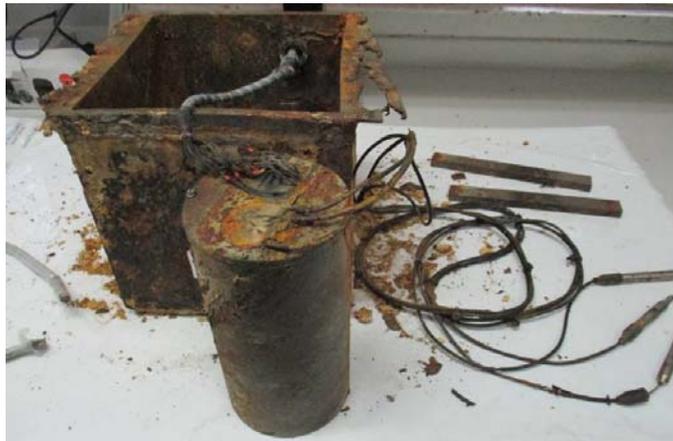
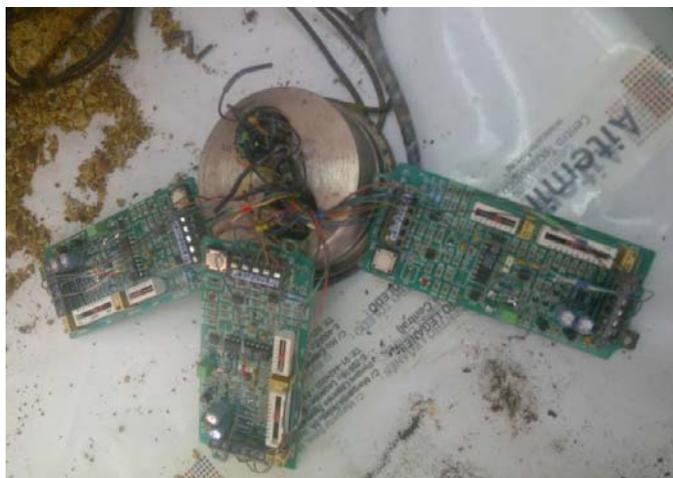
**Figure 52. Detail of the state of the crackmeter components (S-S-47-1 / 3SEF2-01-F1)**

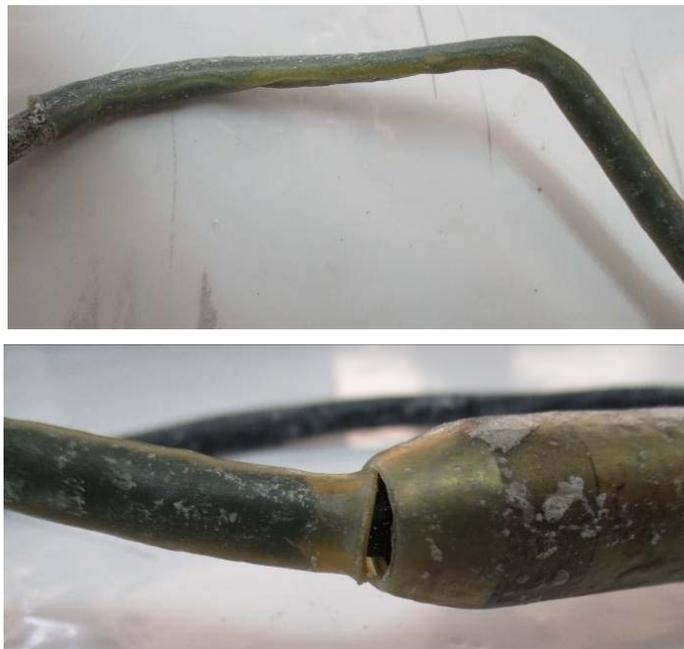
**Figure 57. Detail of the state of cable sensor WC-SF2-04**

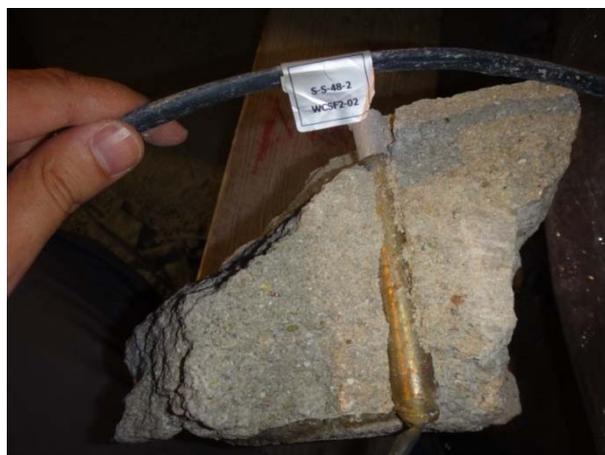
The cable and the cable plastic jacket were quite degraded and sometimes broken, as in sensor WC-SF2-02 (Figure 58).

**Figure 58. Detail of the state of sensor WC-SF2-02 in situ after dismantling**

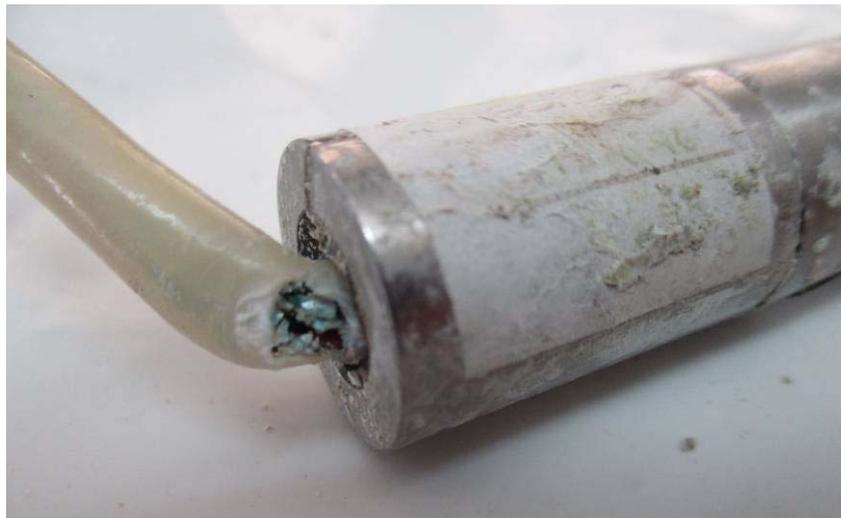
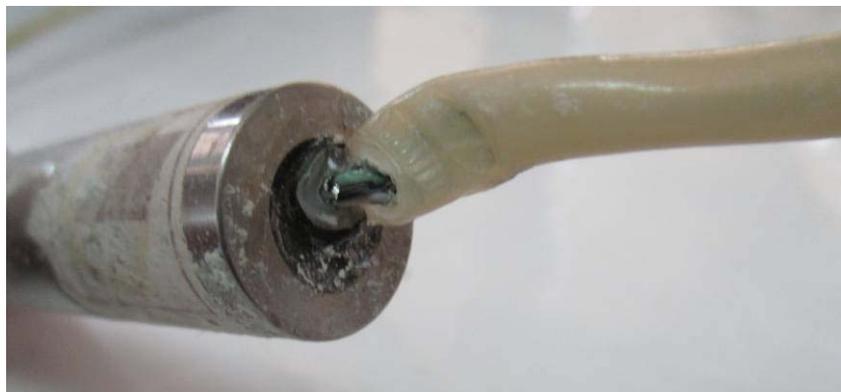
The cables at the output of the sensor were bent in a 90° angle breaking the cable at this point in some cases (see Figure 59 Q-SF2-01, 04, 05, 07 and 08; see Figure 60). The inner wires/conductors were rusty (showed signs of rustiness), especially in those sensors with broken cables.

**Figure 59. Detail of the cable conditions at the sensor's output, Q-SF2-04**

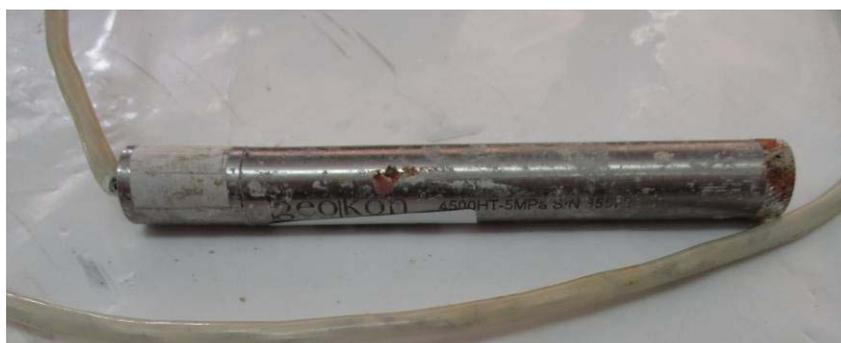
**Figure 60. Detail of the cable position at the sensor's output, Q-SF2-07**

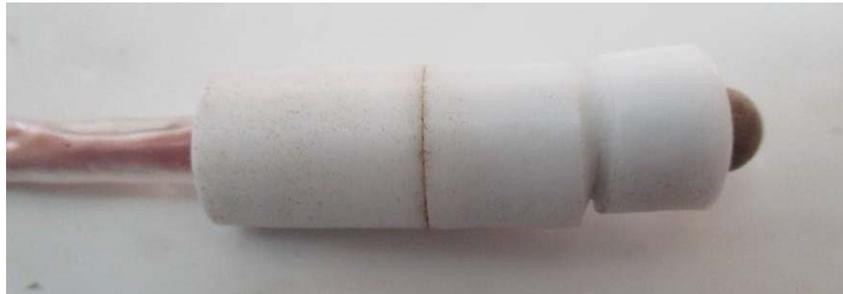
The filter was damaged and had even disappeared in some cases (WP-SF2-01, 03, 05 and 06). The cable and the protection tube were in a bad state, very damaged, with evident signs of degradation (black colour in some points). The sensors with the most significant signs of damage were those installed in the lower part and left part of the section.

**Figure 61. Detail of the deformation of sensor WP-SF2-04**

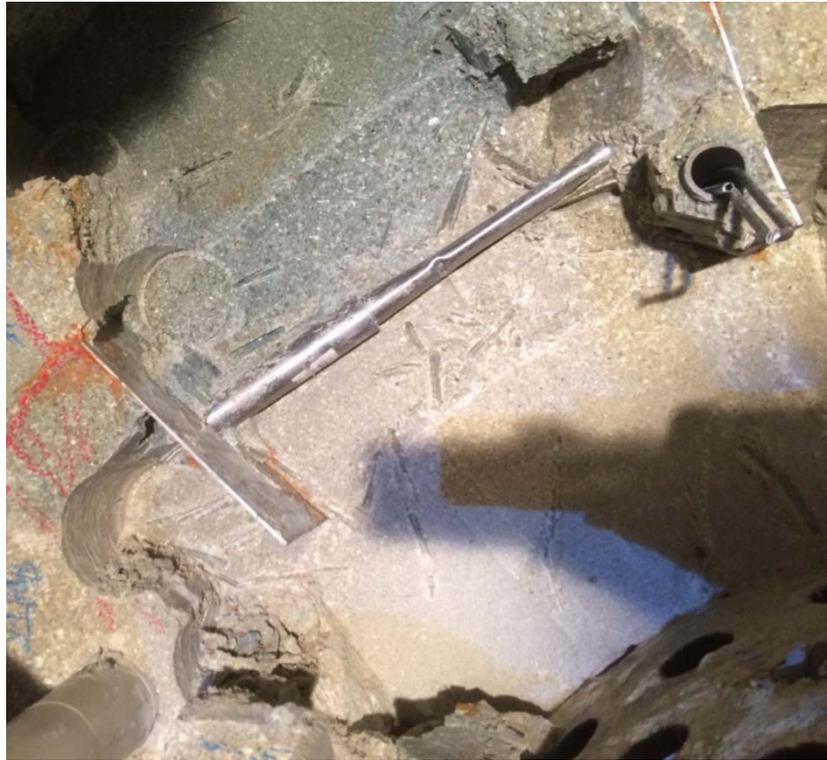
The cable was brown at the sensor output, probably as a consequence of corrosion. Some traces of humidity/water were found in the inner part of the cable of SBF2-01.

**Figure 64. View of sensor SBF2-02 during dismantling**

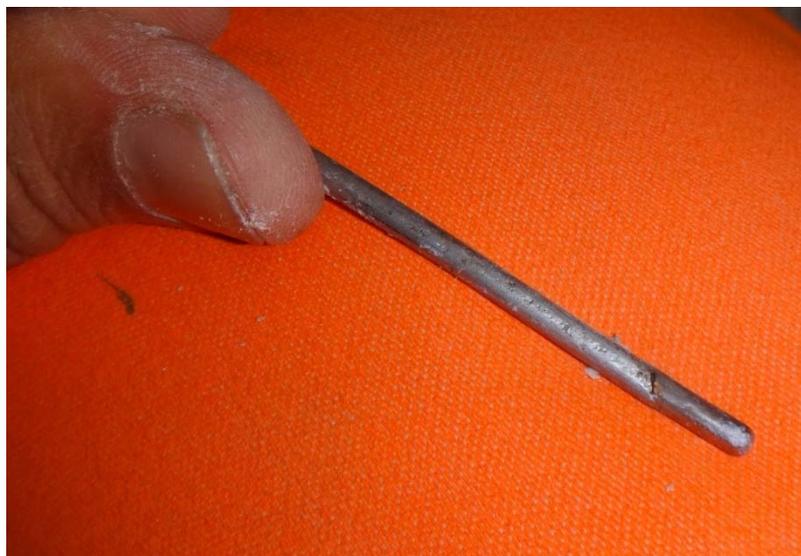
**Figure 67. View of a corroded dent at the end of one thermocouple**

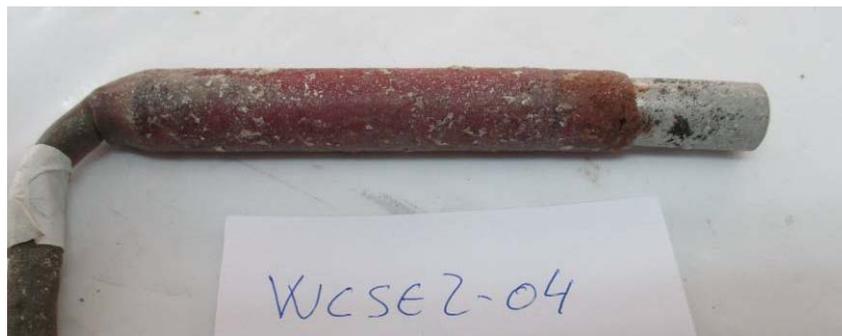
The thermohygrometers (WC-SE2-01 to 10, see technical data in section 9.3.7.) were in quite good condition, with only a few traces of rust under the plastic jacket protecting the sensor in WC-SE2-01, 02, 07 and 08. In the case of WC-SE2-03 and 04, the sensor body was very rusty; see Figure 72. The effect was smaller for WC-SE2-05 and 06.

**Figure 72. Detail of thermo-retractile with rust from sensor WC-SE2-04**

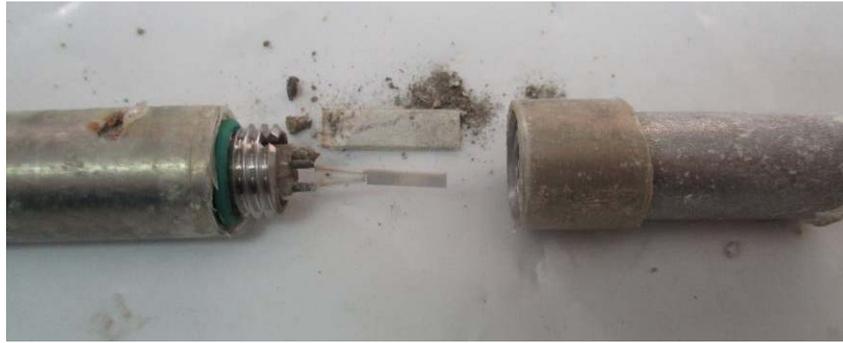
The sensing element and inner side of the filter were damaged in almost all sensors; it was disintegrated in the case of sensors WC-SE2-03, 05 and 10 and to a smaller extent in sensors 04 and 06; see Figure 73. Sensor WC-SE2-07 was recovered with no filter, and bentonite was found in the measuring element. The rest of sensors were dirty and rusty, but without important damage.

**Figure 73. Detail of the state of sensing element sensor WC-SE2-05**

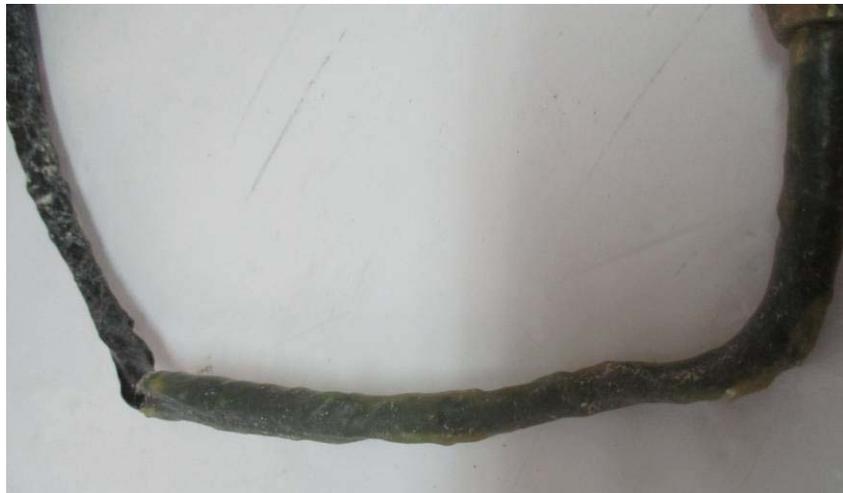
The cables of those sensors located in the central ring showed important/significant damage, as well as those installed in contact with the rock. The cable and its thermo-retractile protection were quite degraded, as seen in previous dismantled sections, see Figure 74.

**Figure 74. Detail of the squashed cable sensor WC-SE2-10**

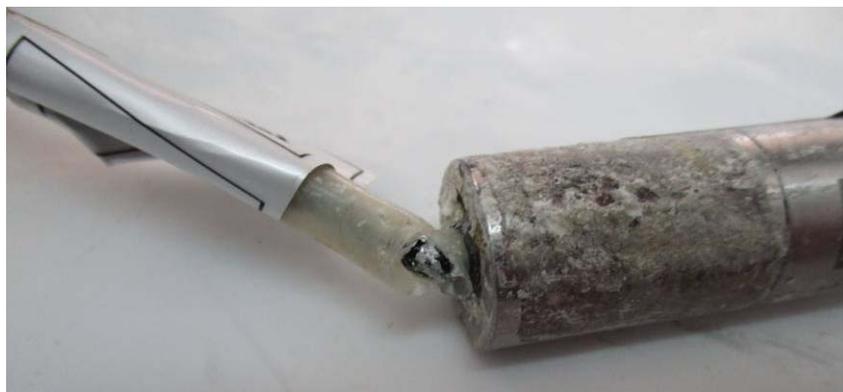
**Figure 75. Detail of broken cable, sensor QSE2-04**

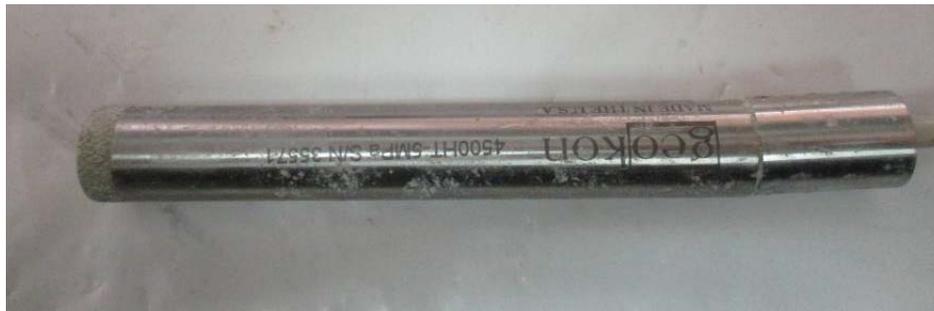
Sensor QSE2-08 was slightly deformed as a consequence of bentonite swelling, Figure 76.

**Figure 76. Detail of sensor QSE2-08 deformation**

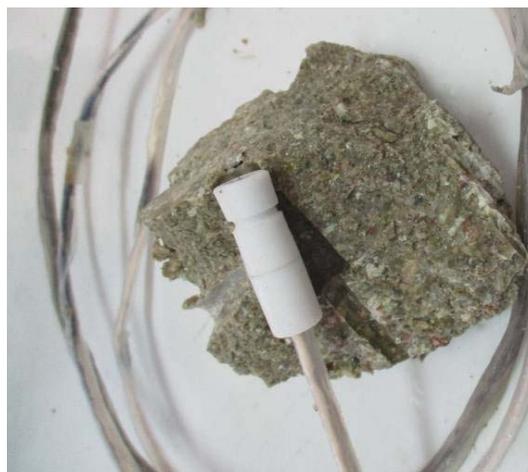
**Figure 77. Detail of psychrometers' protection slightly deformed by bentonite's swelling (left S-S-51-19 / WPSE2-01; right S-S-51-23 / WPSE2-05)**

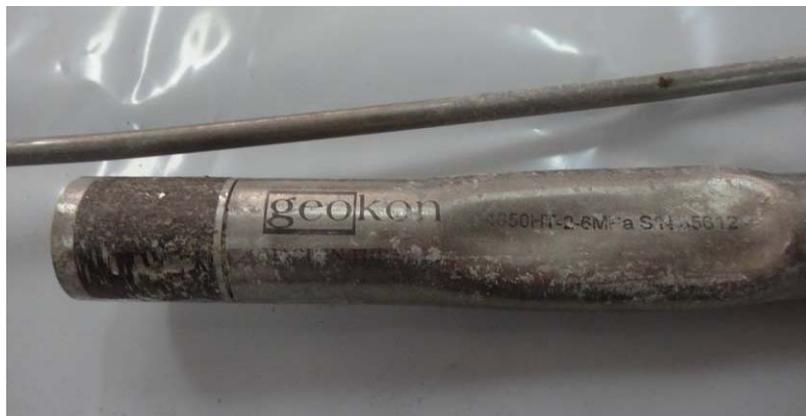
**Figure 79. Detail of deformation of sensor PSE2-02**

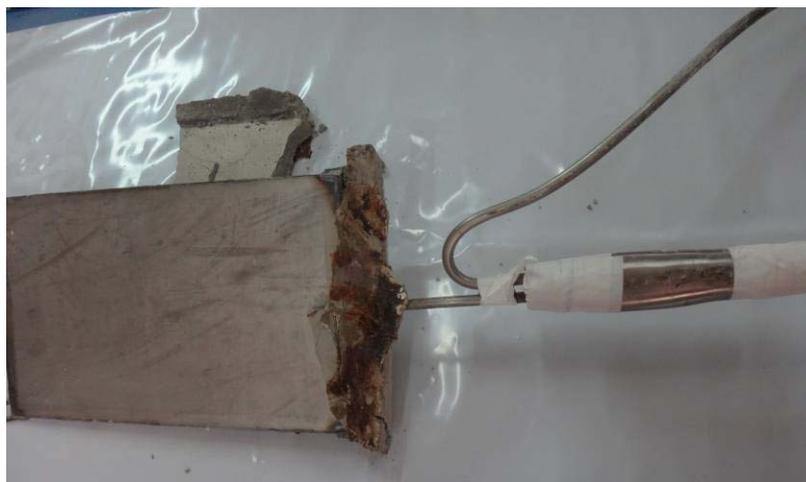
**Figure 80. Detail of sensor PSE2-05 with the joints sealed due to the mercury leak**

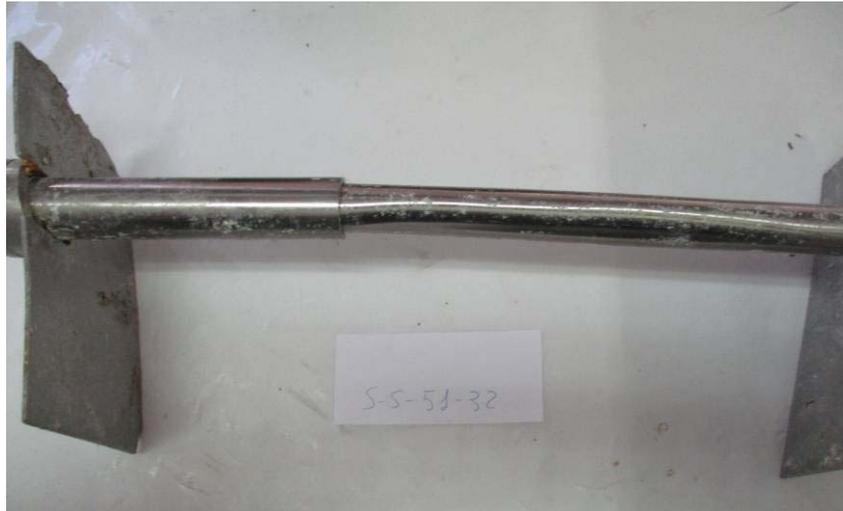
**Figure 81. Detail of deformation of sensor SB-E2-02**

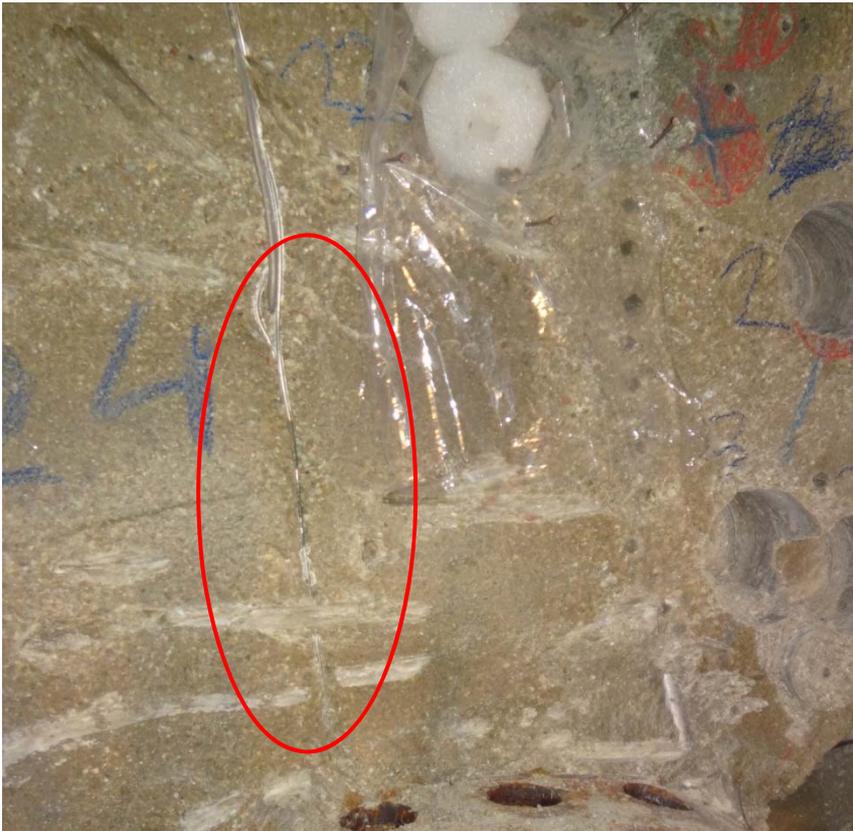
Figure 85. Detail of thermocouples T-SD2-12 and 11 running towards the liner where some rust (black colour) can be seen in T-SD2-11

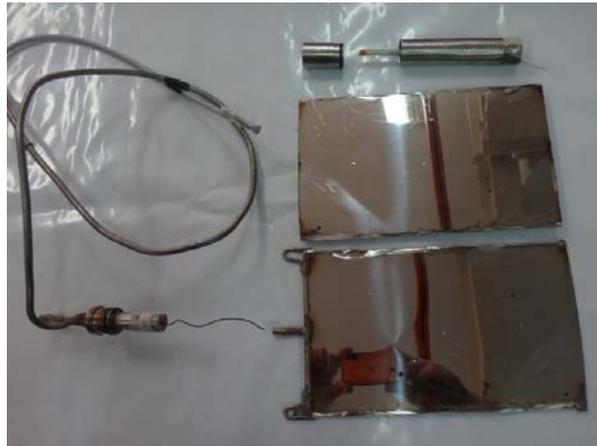
**Figure 87. Total pressure cell close-up of a disassembled damaged sensor**

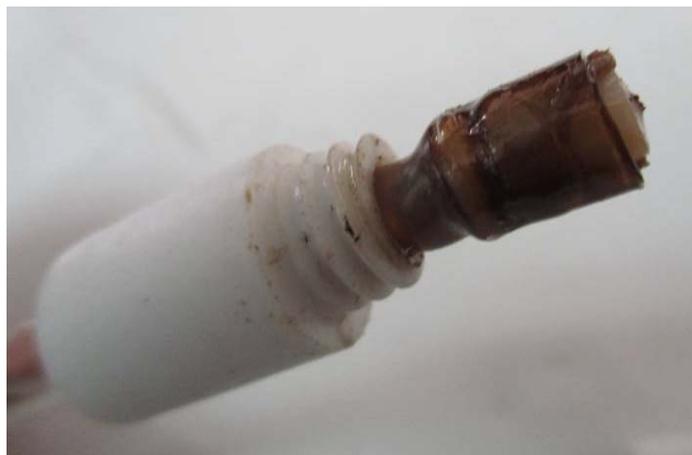
Figure 92. Viscous substance in psychrometer

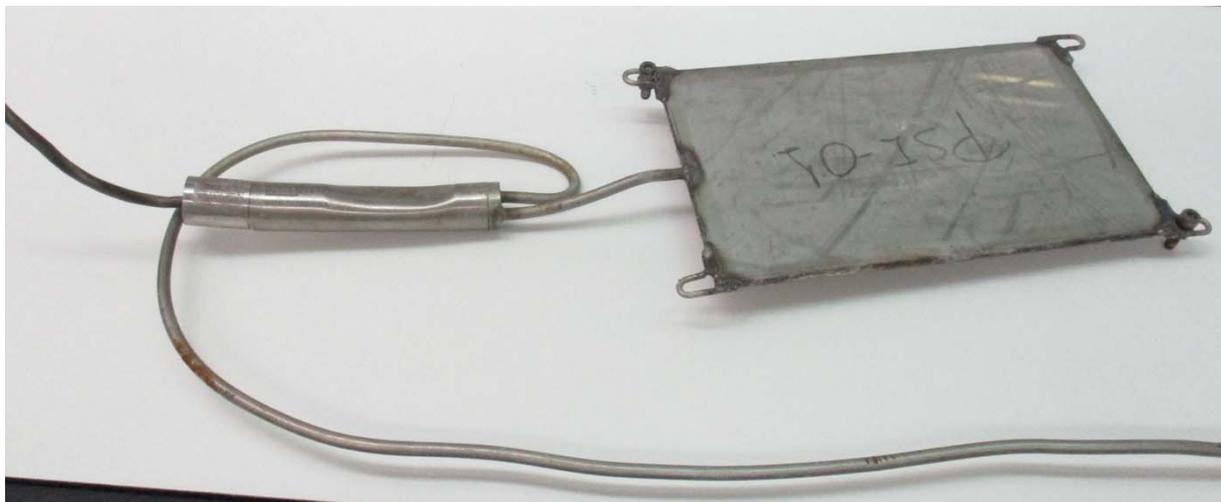
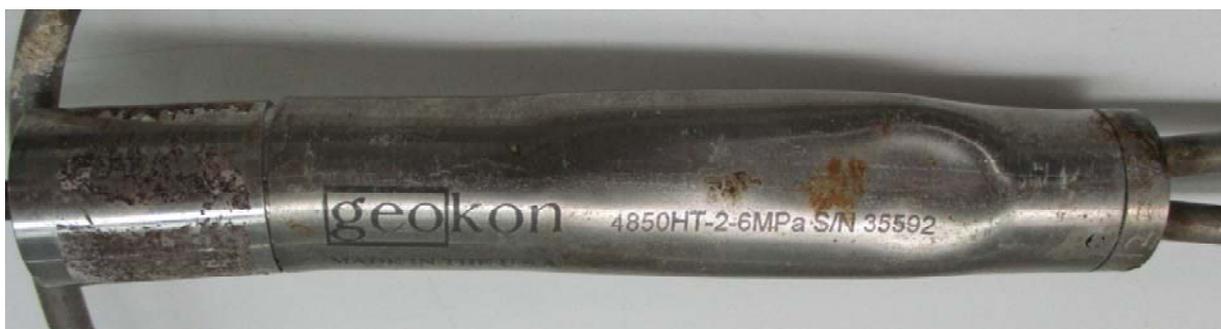
Figure 95. Detail of damage in P-SI-01 after extraction
