Arbeitsbericht NAB 16-54

Corrosion Study of FEBEX-DP Components

Virginia Madina

TECNALIA

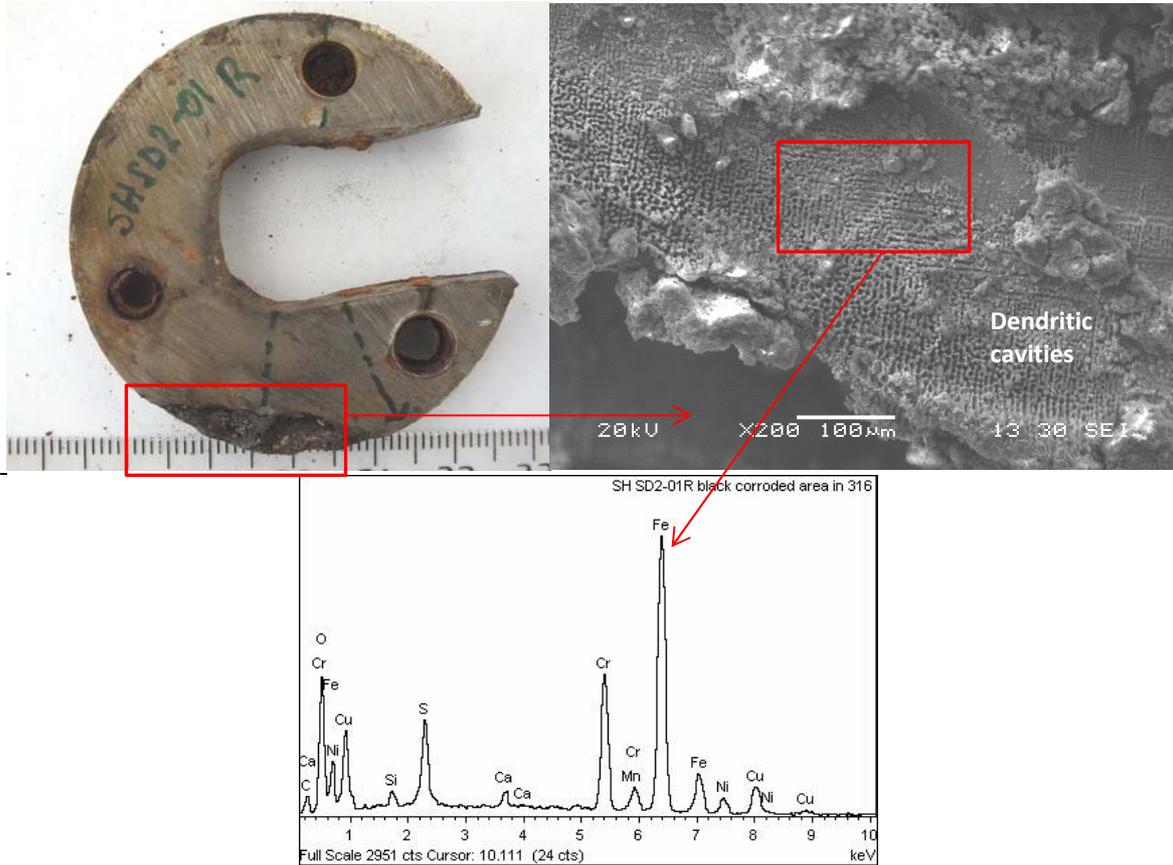
The EDS analyses carried out on the black corroded area of the joints close to the rock from sensors ref. SHSD2-01 and SHSD2-02, Figures 3.16 and 3.21, respectively, show a significant presence of sulphur. There is not detected sulphur in such significant way in other zones of the sensors. It should be noted also in the electron micrograph shown in Figure 3.16, the dendritic skeletons observed in the weld joint. This corrosion morphology is sometimes associated with microbiologically influenced corrosion (MIC).

Figure 3.16: Macrograph showing corroded zone of joint from sensor ref. SHSD2-01 close to the rock, and electron micrograph and EDS spectrum corresponding to this zone

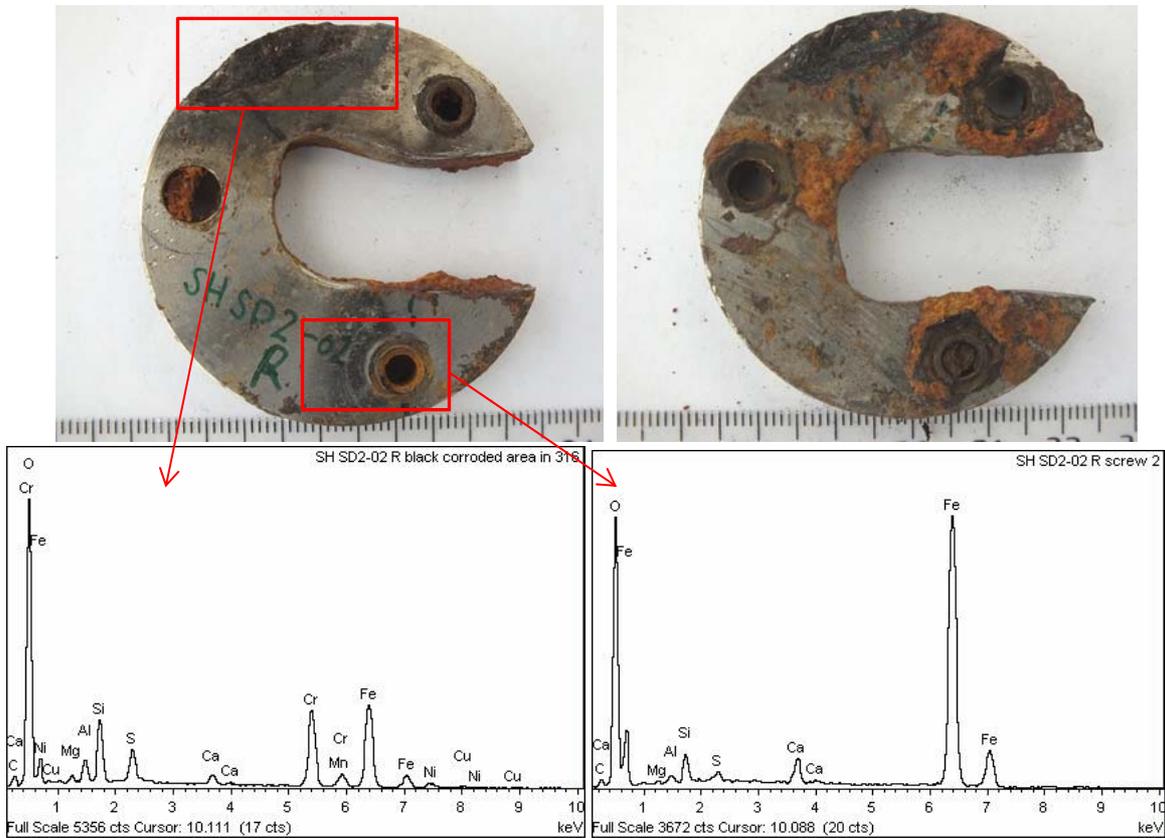
Figure 3.21: Macrographs showing corroded zone of stainless steel joint section (one side and the other) from sensor ref. SHSD2-02 close to the rock, and the corresponding EDS spectra

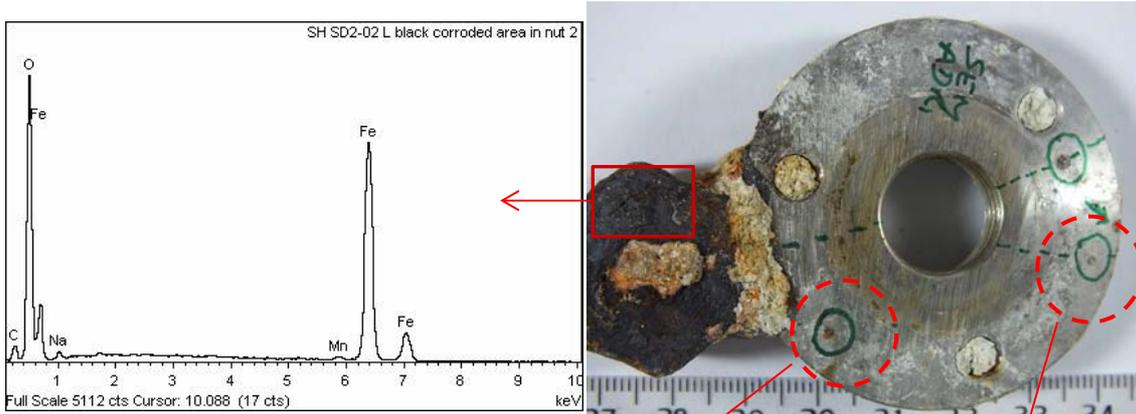
Chloride is only detected in the EDS analyses carried out on the shallow “pits” observed on stainless steel joints close to the liner in sensors ref. SHSD2-02 and SHSD2-03, shown in Figures 3.22, 3.23 and 3.27.

Figure 3.22: Macrograph showing corroded zone of joint from sensor ref. SHSD2-02 close to the liner, and EDS spectrum corresponding to carbon steel corroded nut

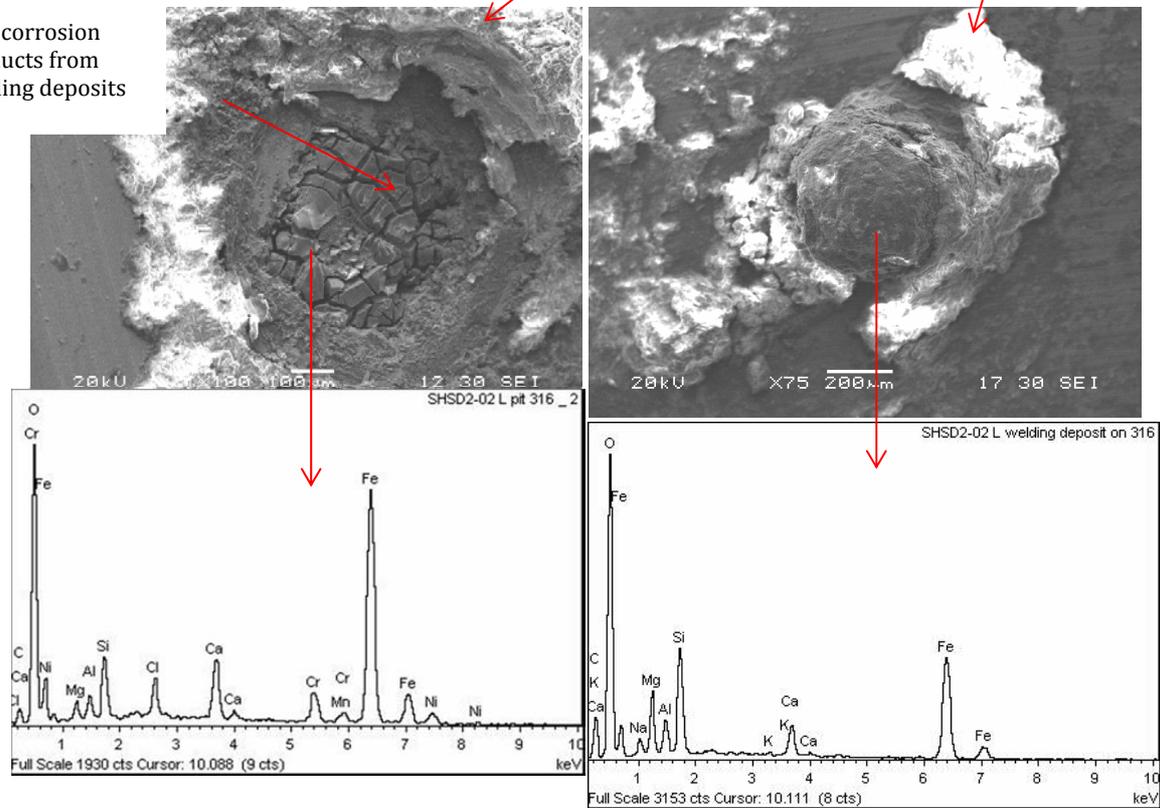
Figure 3.23: Electron micrographs of iron weld deposits on stainless steel joint from sensor ref. SHSD2-02 close to the liner

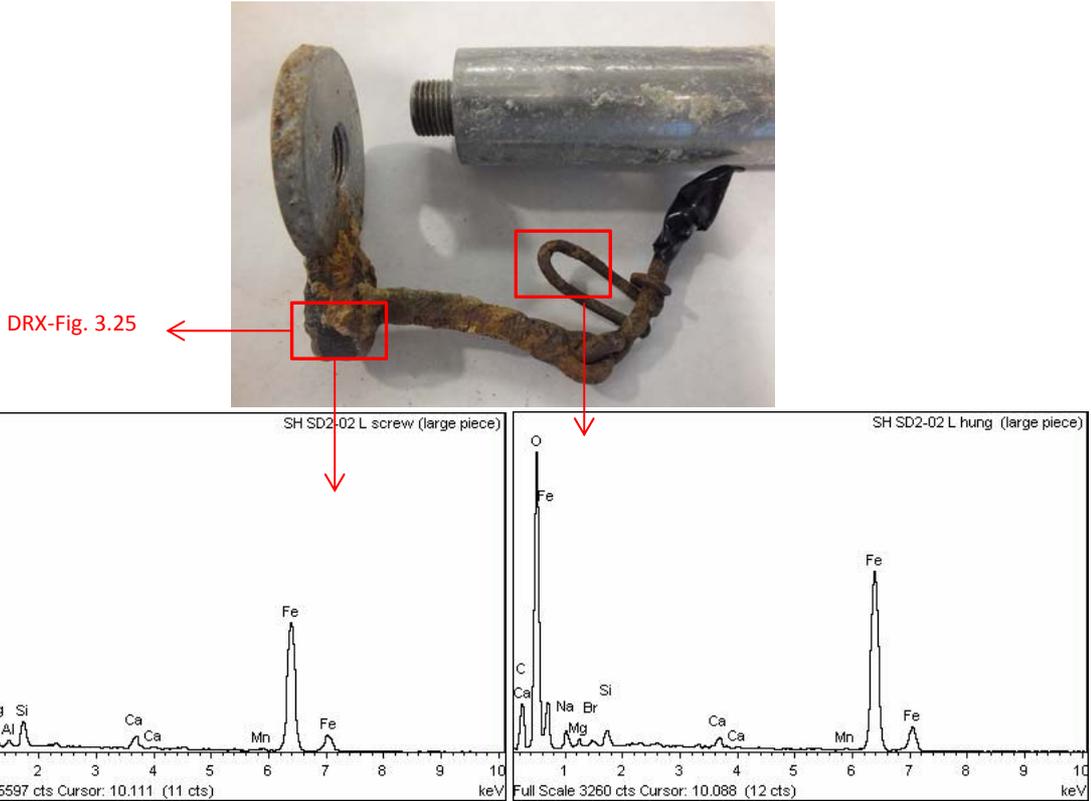
Figure 3.24: EDS spectra of corroded surface of carbon steel components in sensor ref. SH-SD2-02 close to the liner

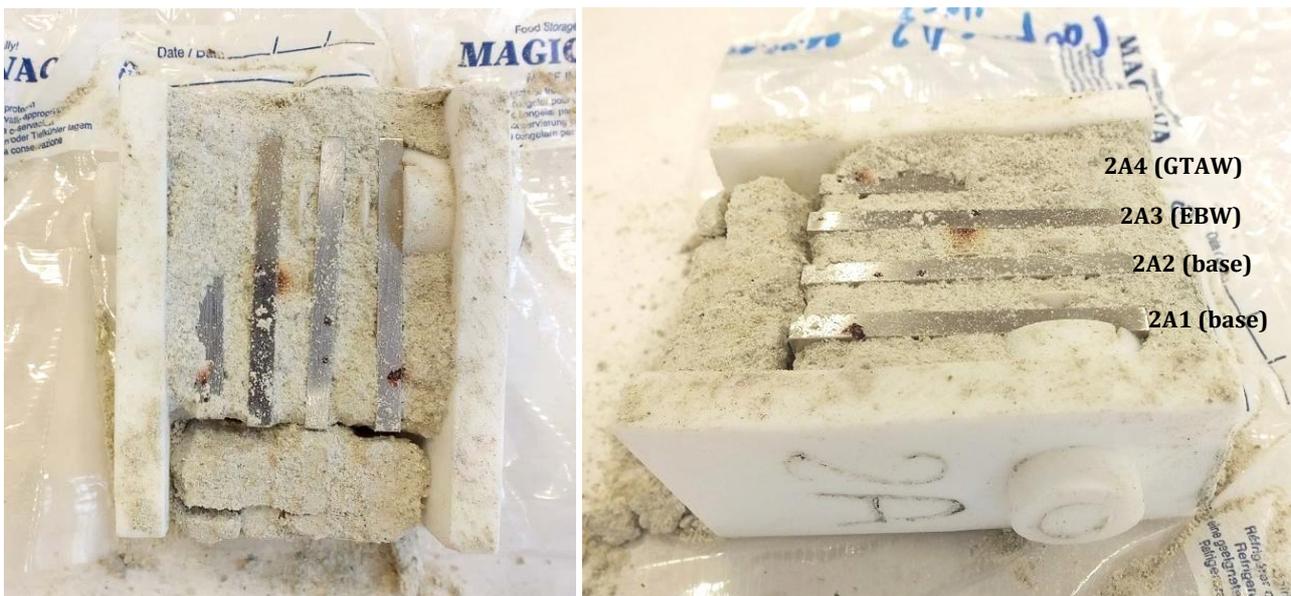
Corrosion products associated to cracking are reddish-brown, and they are poorly adhered. Corrosion products associated to pits are more compact and adherent, being the corrosion products brownish-black. No significant differences in corrosion behaviour are observed between welded and base material samples.

Figure 5.3: Macrographs showing general appearance on reception of rack ref. 2A (stainless steel)

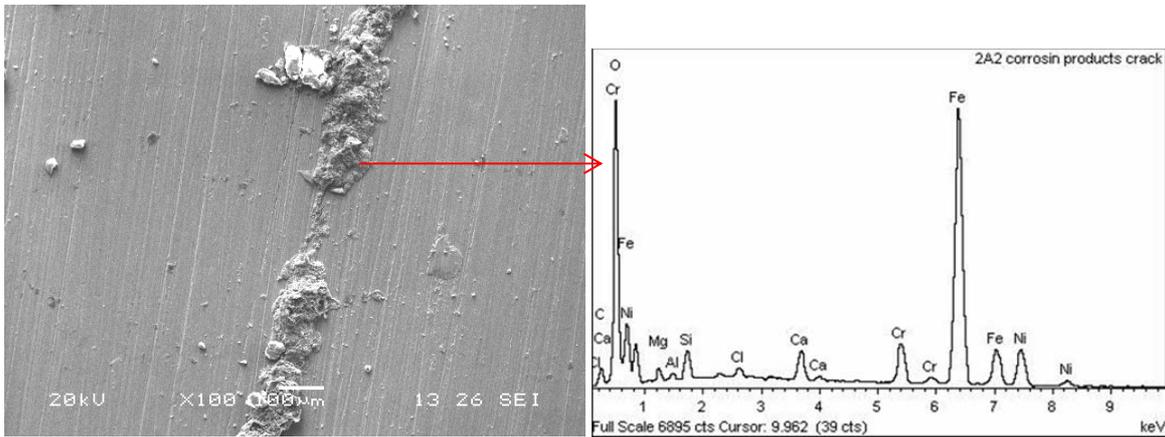
Analyses of the reddish corrosion products associated to cracking, show them to be enriched with the elements iron and oxygen, Figures 5.8 and 5.9. As well as iron, the analyses identify chrome and nickel, as elements making up the stainless steel, and silicon, calcium, magnesium and aluminum, as elements making up the bentonite surrounding the samples. EDS analysis carried out on the brownish-black pits show them to be more enriched with chromium, Figure 5.10. The EDS analyses carried out in all the corroded areas of the coupons detect a significant chloride peak, sometimes predominant, as in Figure 5.11. Table 5.2 lists the semi-quantitative elemental chemical composition obtained in the EDS analyses carried out.

Figure 5.8: Electron micrograph of the surface of coupon ref. 2A2 showing detail of cracking and the corresponding EDS spectrum

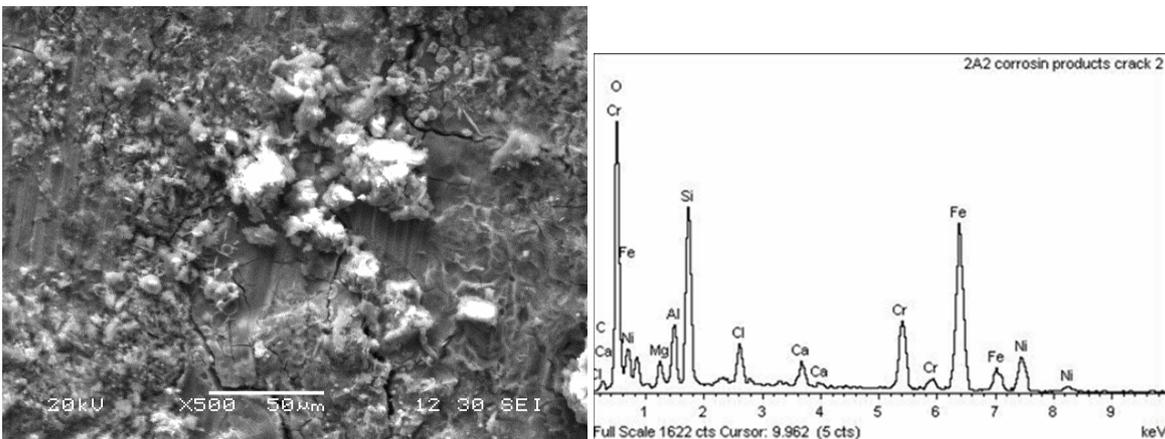
Figure 5.9: Electron micrograph of the surface of coupon ref. 2A2 showing detail of cracking and the corresponding EDS spectrum

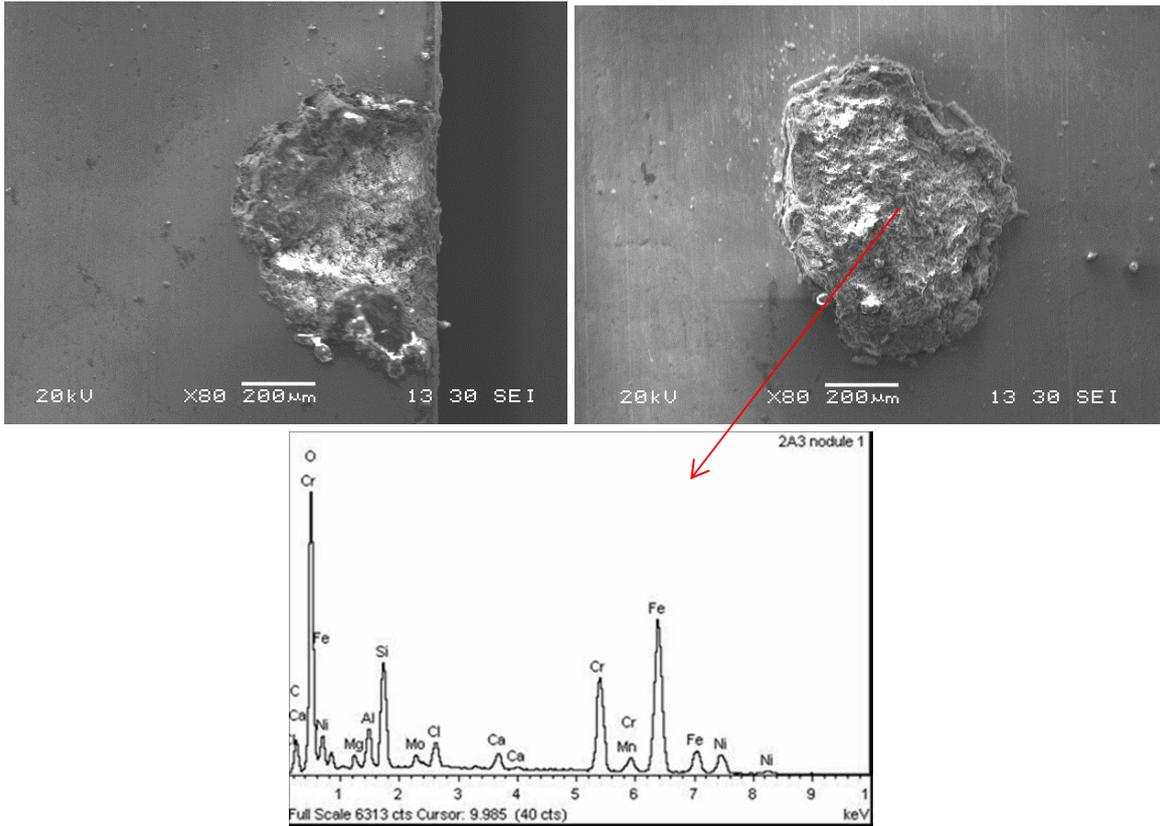
Figure 5.10: Electron micrographs of two pits on coupon ref. 2A3 and the corresponding EDS spectrum

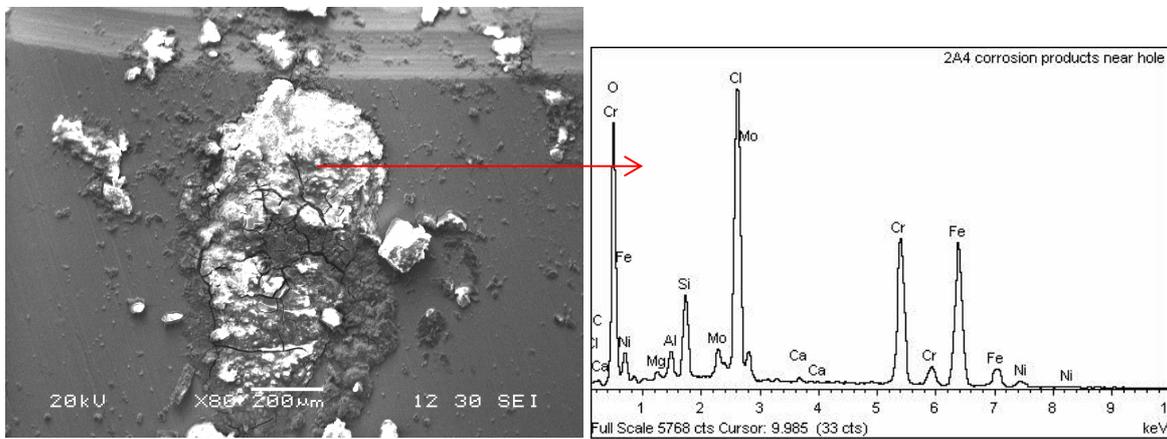
Figure 5.11: Electron micrograph of "shallow" corroded area on coupon ref. 2A4 (see Fig.5.7) and the corresponding EDS spectrum

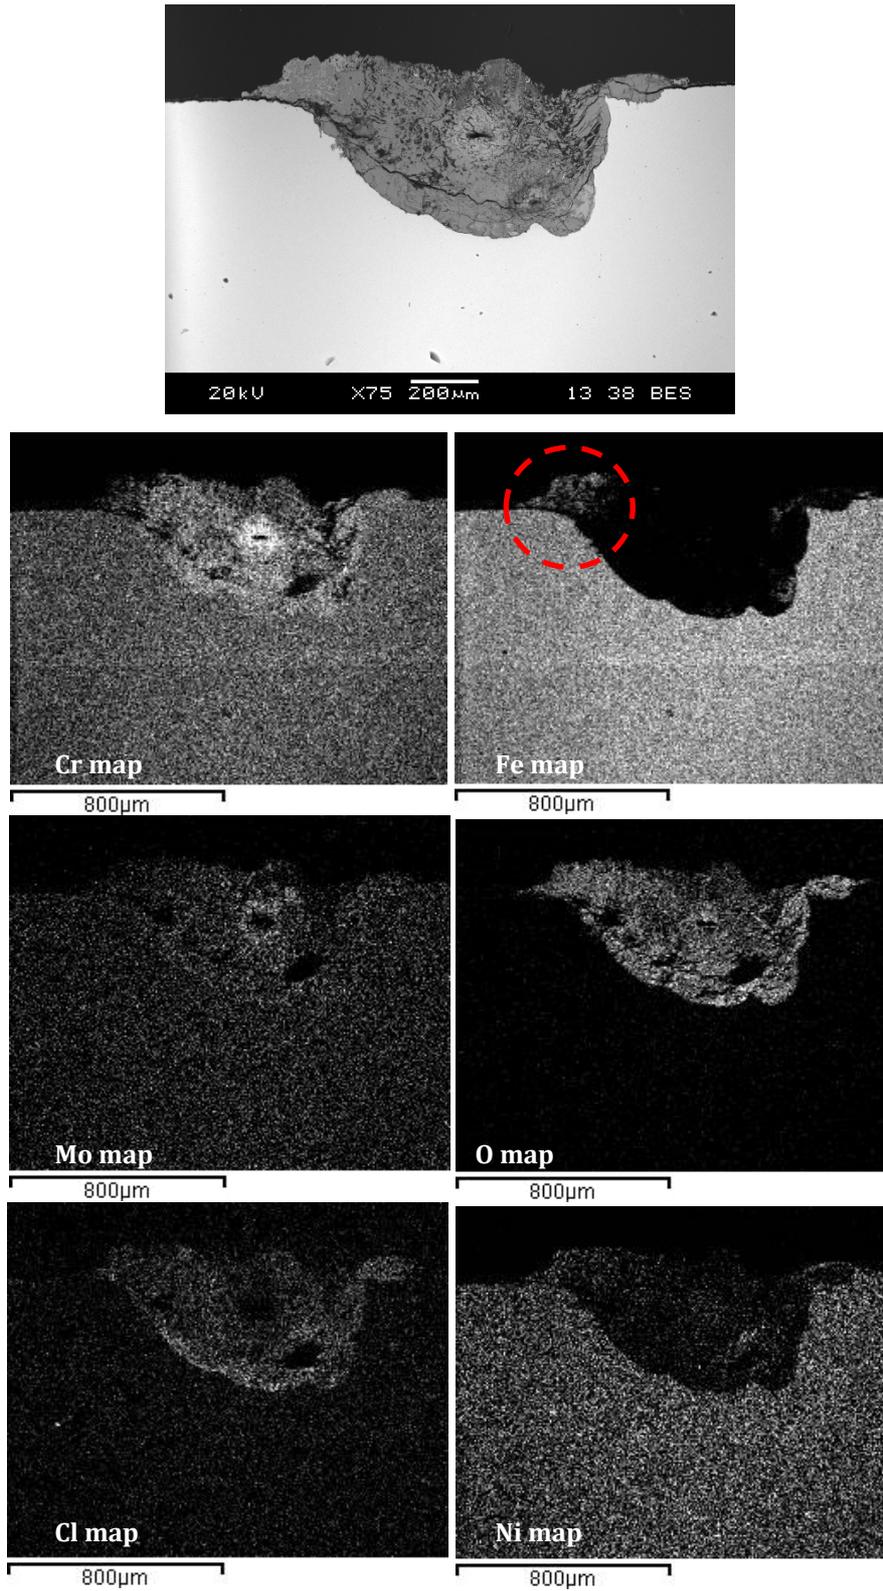
- Oxygen and chromium are the main constituents of the corrosion products generated inside the pit
- Chlorides are also detected in the corrosion products. Chloride concentration is slightly higher at the bottom of the pit
- Iron oxide (apparently associated to magnetite) is only detected at the top of the pit.

Figure 5.13: Back-scattered electron micrograph of pit section from coupon ref. 2A2, and associated element maps

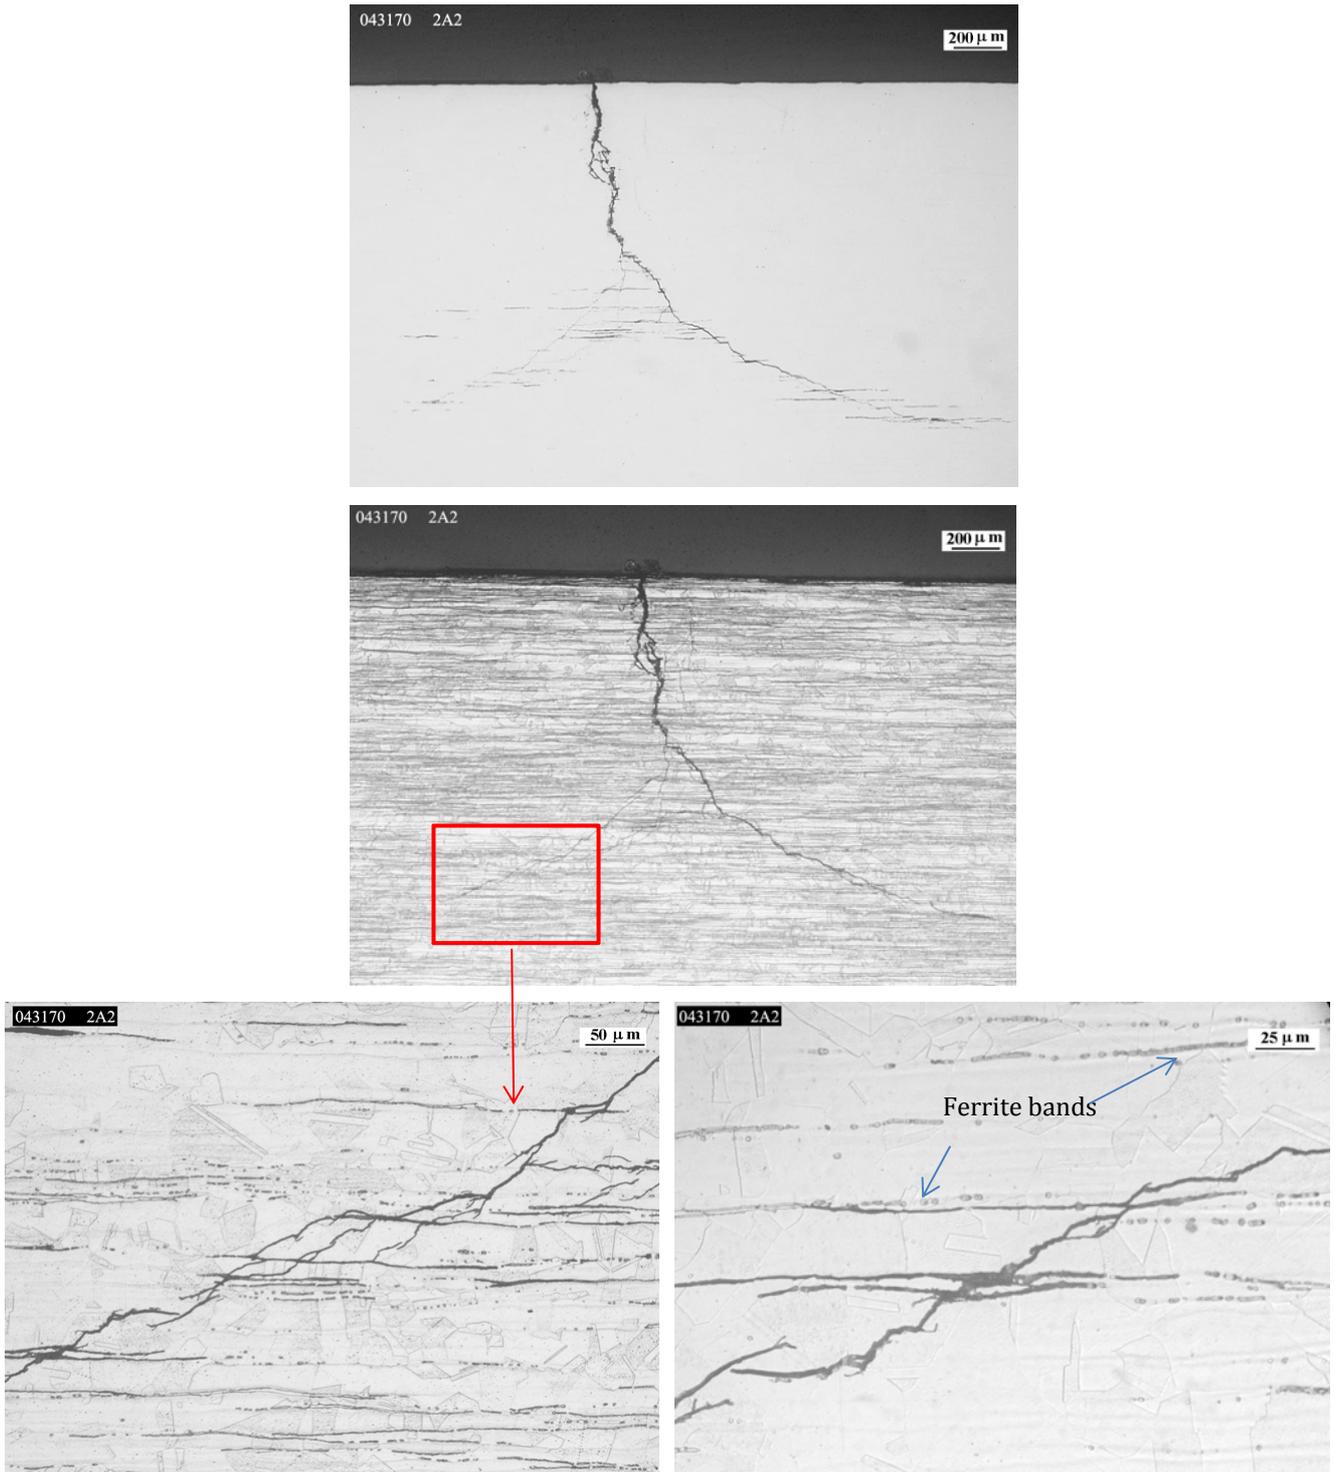
Figure 5.14: Optical micrographs of section of 316L stainless steel coupon ref. 2A2 showing transgranular cracking. Top unetched, middle and bottom with metallographic etching

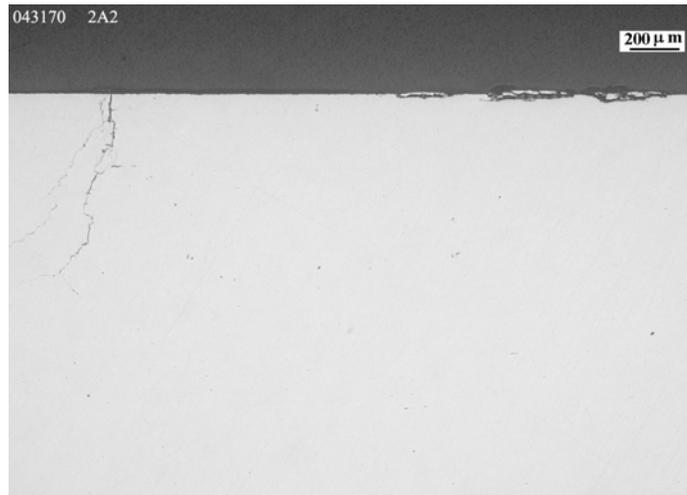
Figure 5.15: Optical micrograph showing cracking and shallow corrosion area for coupon ref. 2A2, unetched

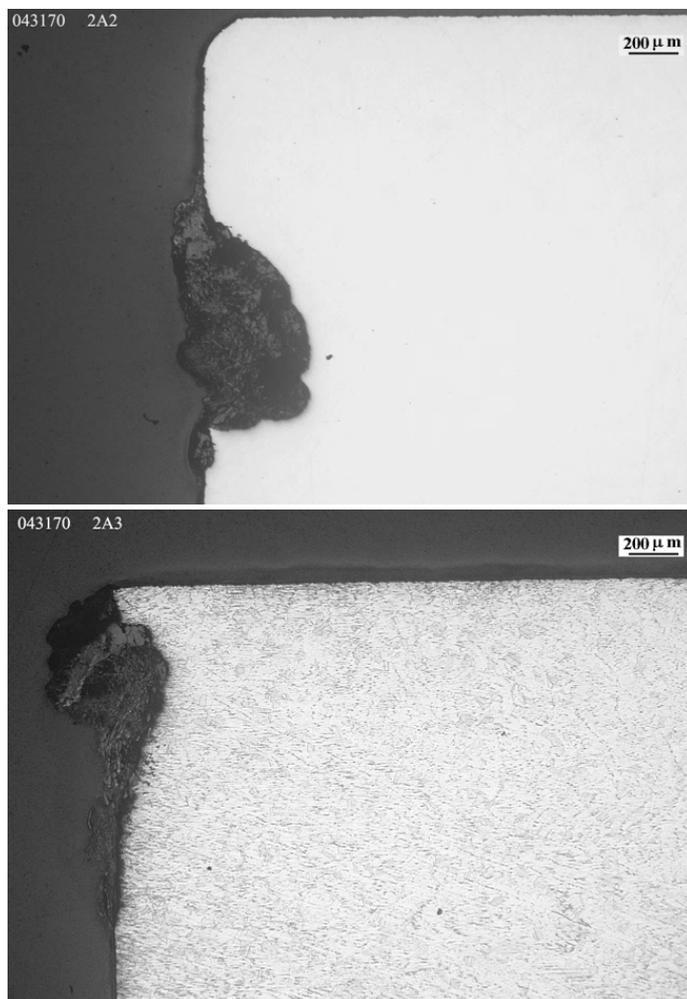
Figure 5.16: Optical micrographs of two sections of pits from coupons ref. 2A2 (top-unetched), and 2A3 (bottom - with metallographic etching)

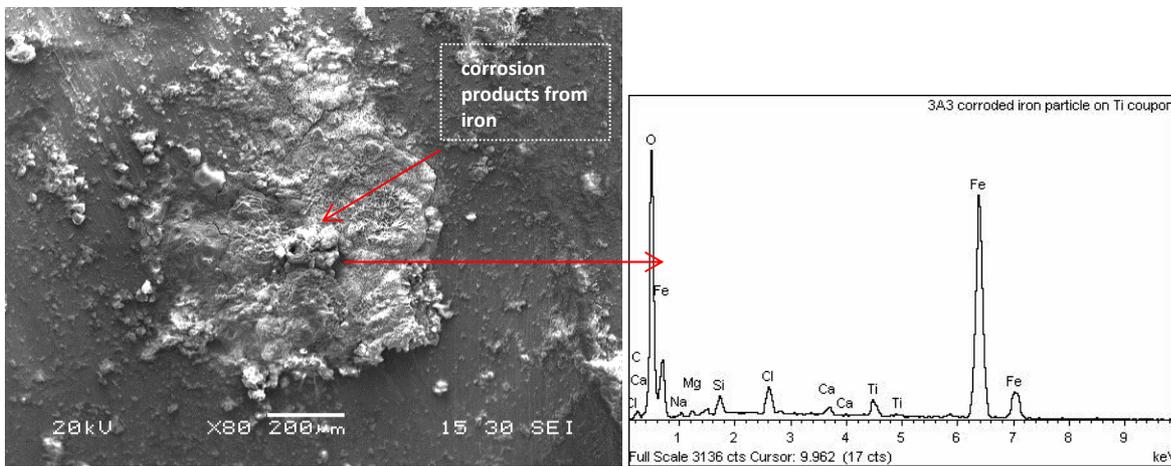
The SEM micrograph in Figure 5.25 shows a corroded “iron particle” on the surface of coupon ref. 3A3. EDS analyses indicate that these particles are composed principally of iron (Fe) and oxygen (O), as iron oxides.

Figure 5.25: Electron micrograph showing detail of iron particle on the surface of coupon ref. 3A3 and the corresponding EDS spectrum

Iron corroded particles seem to be associated to some kind of contamination of the coupons before testing or during the test.

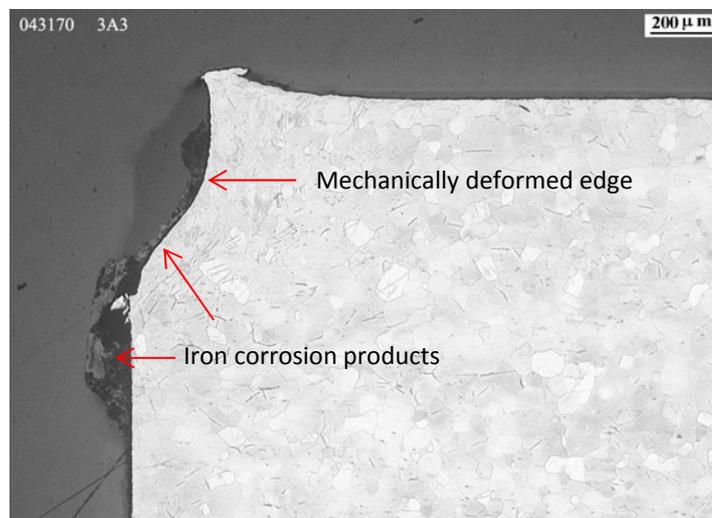
Figure 5.26: Optical micrograph of section of coupon ref. 3A3 (TiGr7), showing a mechanical deformed edge and iron corrosion products on its surface, with metallographic etching

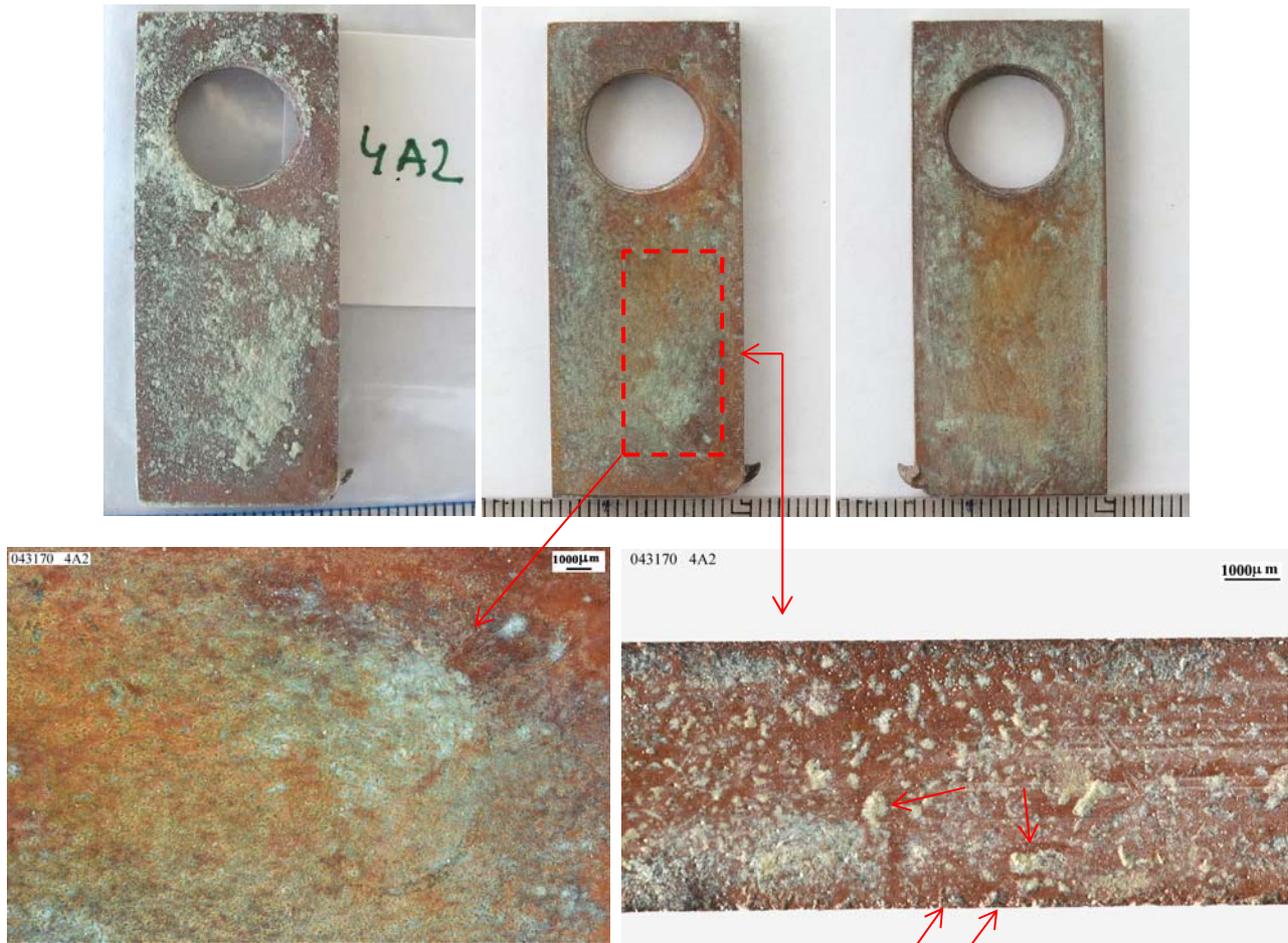
The surface of the Cu-ETP coupons show a brownish-red color, with greenish areas mixed with bentonite, Figures 5.29 and 5.30. Uniform general corrosion appears to be the predominant mechanism observed, with a quite adherent oxide layer. Only when the adhered bentonite in coupon ref. 4A2 is removed with a plastic brush, there are observed small areas of localized corrosion in one edge of the coupon, Figure 5.30.

Figure 5.30: Photographs showing coupon ref. 4A2 (one side and the other), and details of the corroded surface

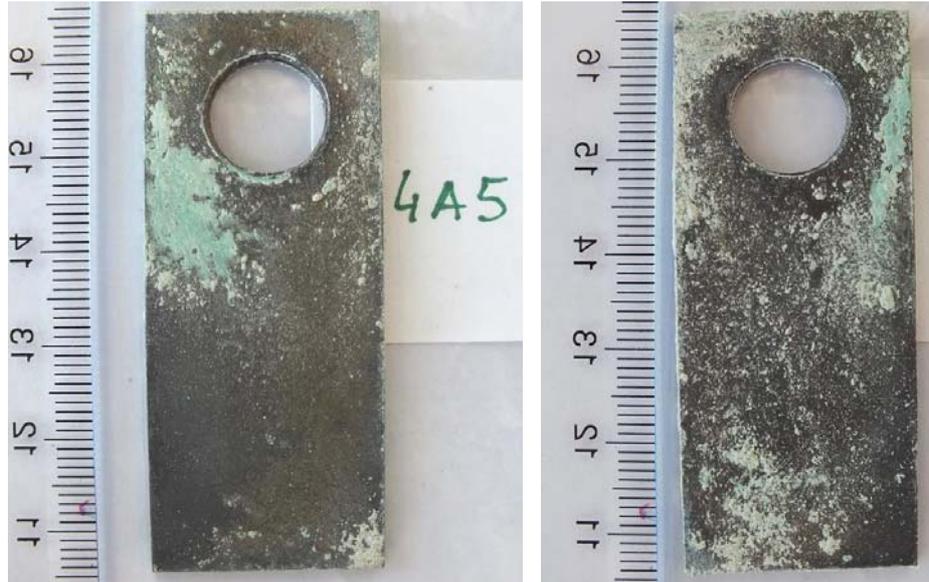
With respect to the Cu30Ni, the test coupon examined shows a blackish-grey color, with greenish areas mixed with bentonite, Figure 5.33. Uniform general corrosion appears to be the predominant mechanism observed, with a quite adherent oxide layer generation. Of all copper coupons, this is the one that shows a smaller extension of the generalized corrosion.

Figure 5.33: Photographs showing corrosion coupon ref. 4A5, one side and the other

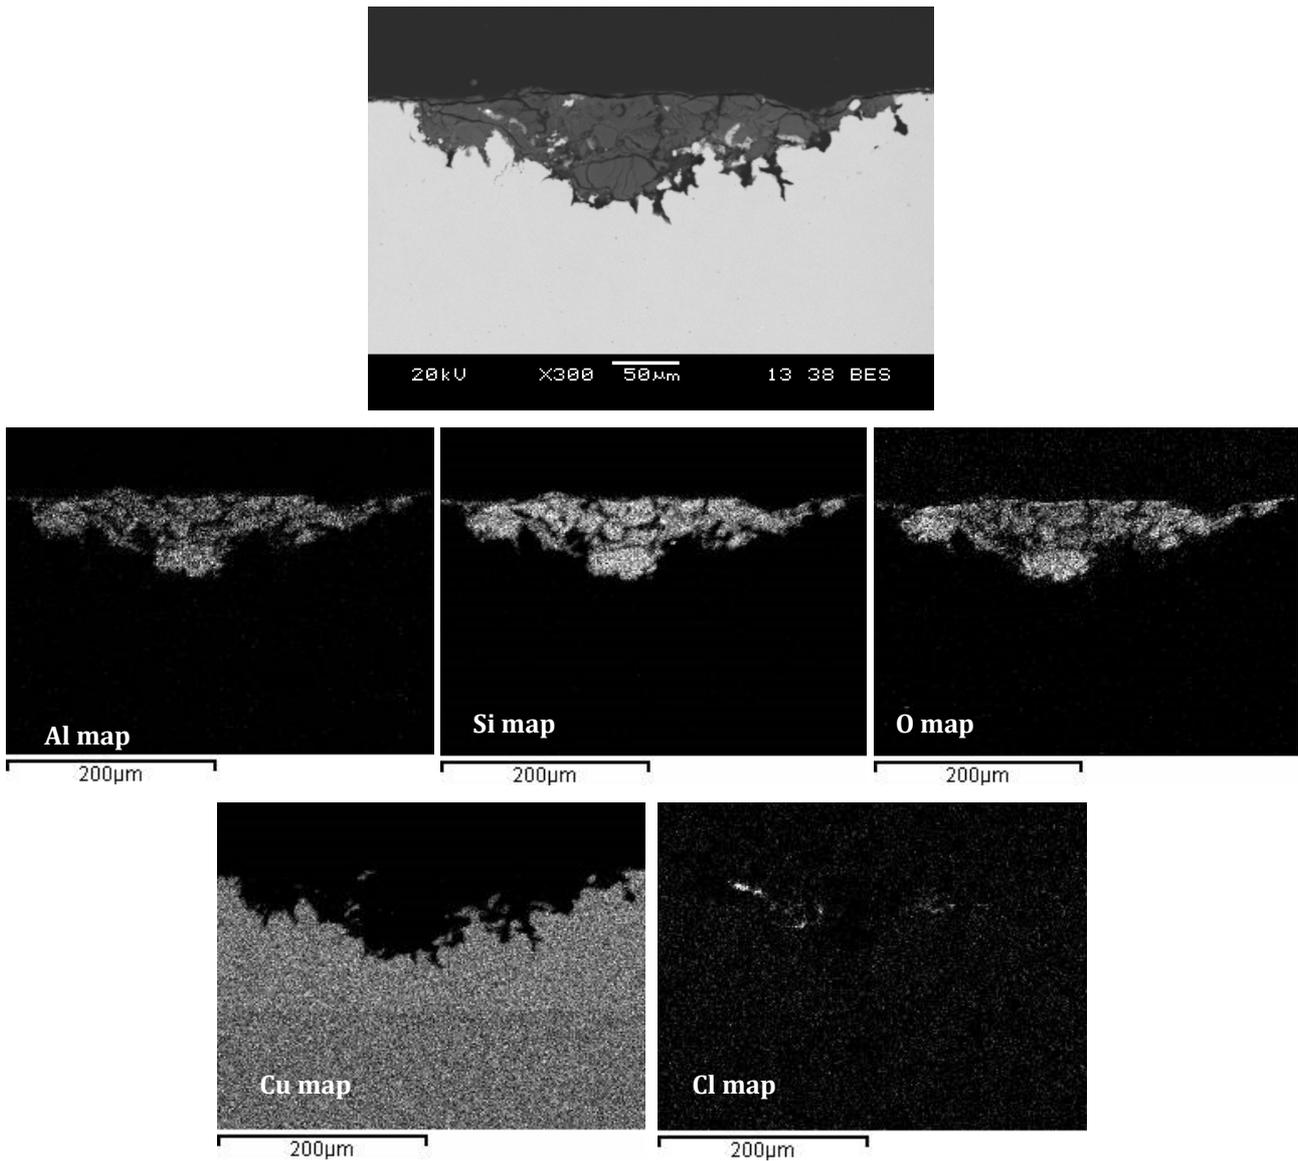
Figure 5.41: Back-scattered electron micrograph of pit section from coupon ref. 4A1 and associated element maps

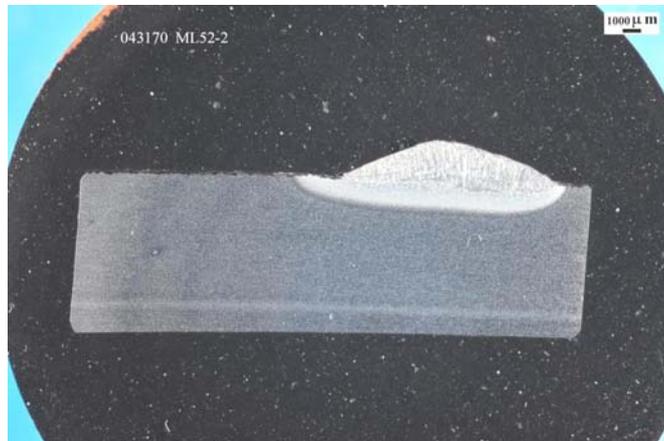
Figure 6.26: Metallographic probe of transversal section of iron welding deposit on external surface of sample ML-52-2, with metallographic etching
