# Arbeitsbericht NAB 16-11

## **FEBEX DP: Dismantling of heater 2 at the FEBEX "in situ" test Description of operations**

March 2016

**National Cooperative  
for the Disposal of  
Radioactive Waste**

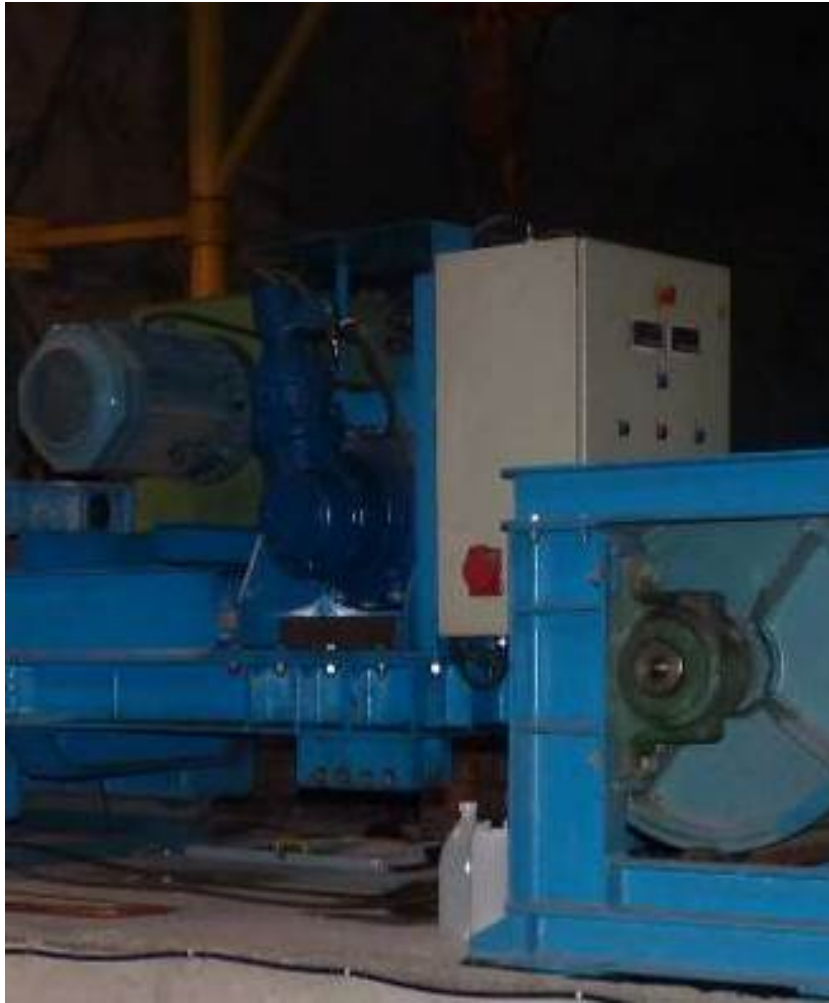
Fig. 4: Hydraulic winch of the extraction car.

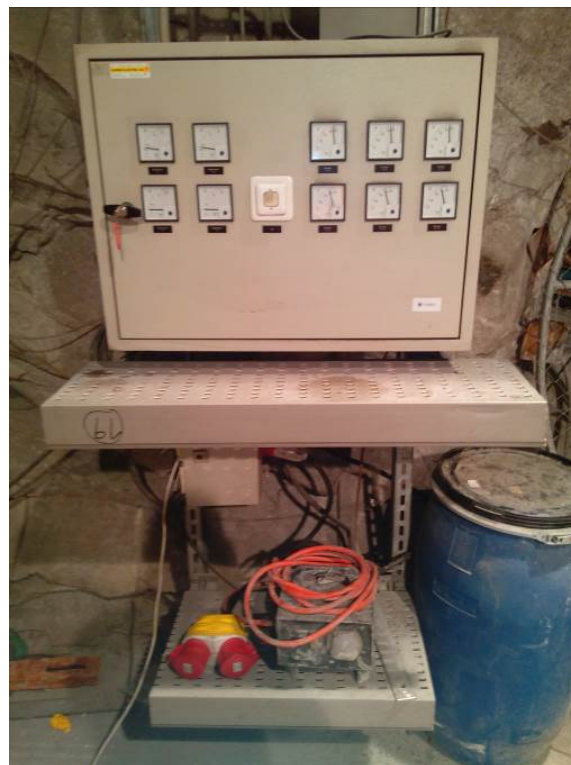
Fig. 6: Double headed three-phase connector below power cabinet.

A double headed 3-phase connector (5 poles, 32 amperes) was prepared and left below the power cabinet (Fig. 6). The external electrical winch, the hydraulic winch of the extraction car and the mobile electrical crane use this type of connection. Therefore only two of them can be used at the same time. Each of these elements has its own connector but for the extraction car to reach the front of the experiment a cable long enough had to be provided.

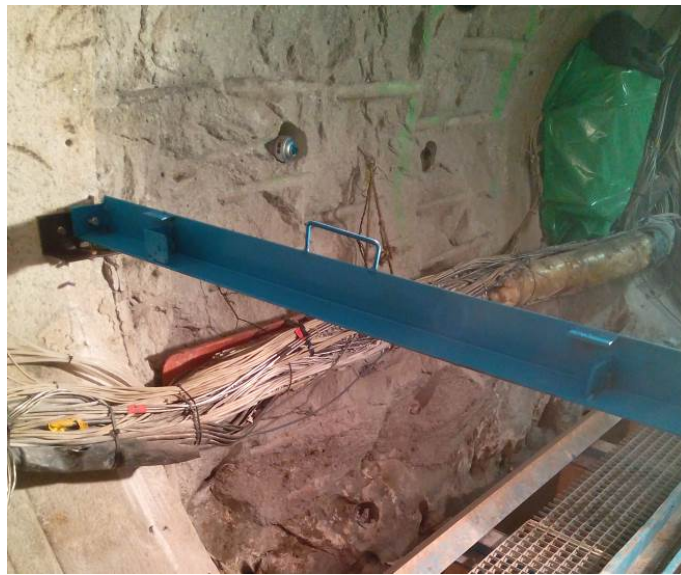
Fig. 7: Laser frame installed on lateral fixing on the gallery's walls.

The extensometers and their attachment system were removed from the plug face, as well as several other remains (bolts, etc). The axes and centre of the plug were revealed by means of a levelled laser system and the aid of previous marks on the walls. For this purpose, a portable structure for the positioning of the lasers (laser frame) was developed. This structure consists of a metallic beam that must be installed between two pieces at the right and left of the gallery, where a system of screws is prepared to level the structure so to match the inclination of the gallery itself (Fig. 7). After the positioning of the axes and centre, the location of the first drillings and the overcorings (C-C-32-1 to 6) was sprayed at the plug face (Fig. 8).

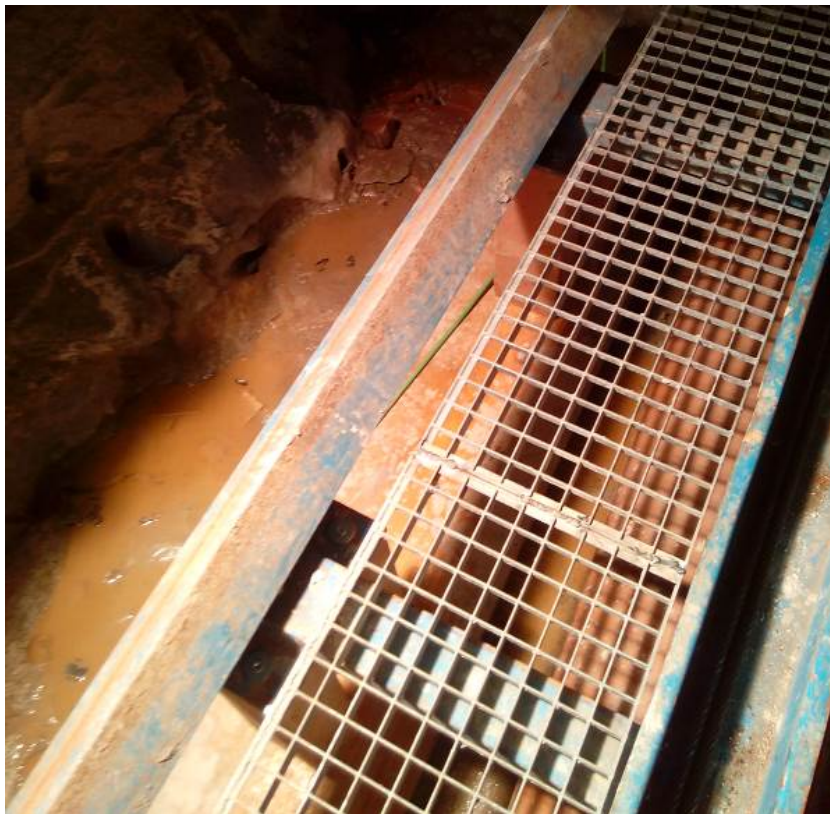
Rail parts were emplaced in the gap formerly occupied by the original plug. The rails were welded to those already in place using a MIG welding machine provided by GTS staff. The bottom parts of the rails were secured by installing a set of wooden feet (thick wooden pieces of about  $40 \times 40$  cm/section) and they were judged stable (Fig. 9). Water was pumped out as much as possible from the area of the former plug and the pump was installed permanently to drain the water from overcore drilling and plug demolition. A metal pathway was put on top of the new rails section for easier personnel movement in the drift.

Fig. 9: Detail of wooden feet and pathway on the newly installed tracks.

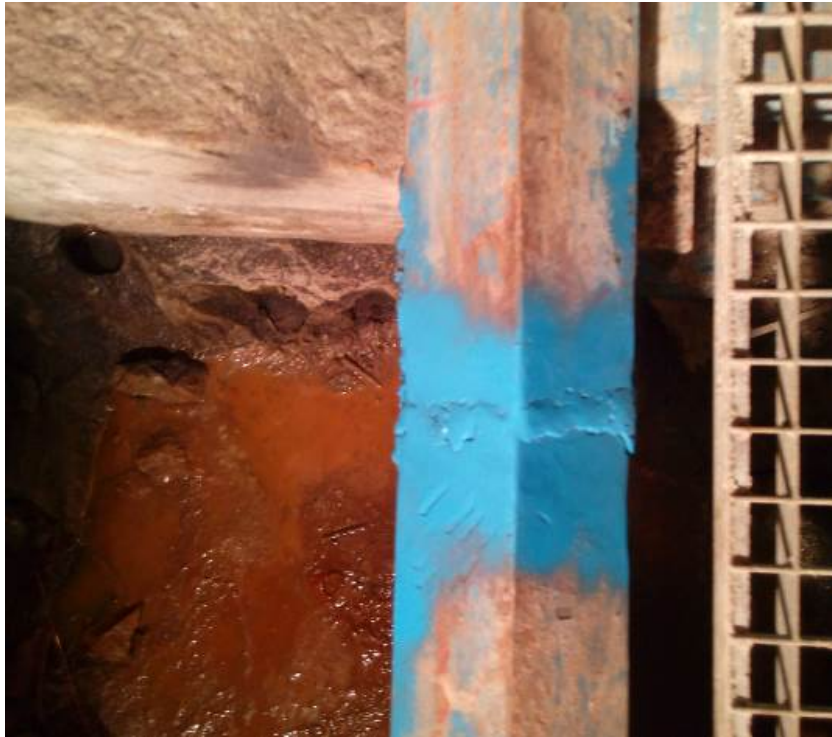
Fig. 10: Detail of welded rail sections.

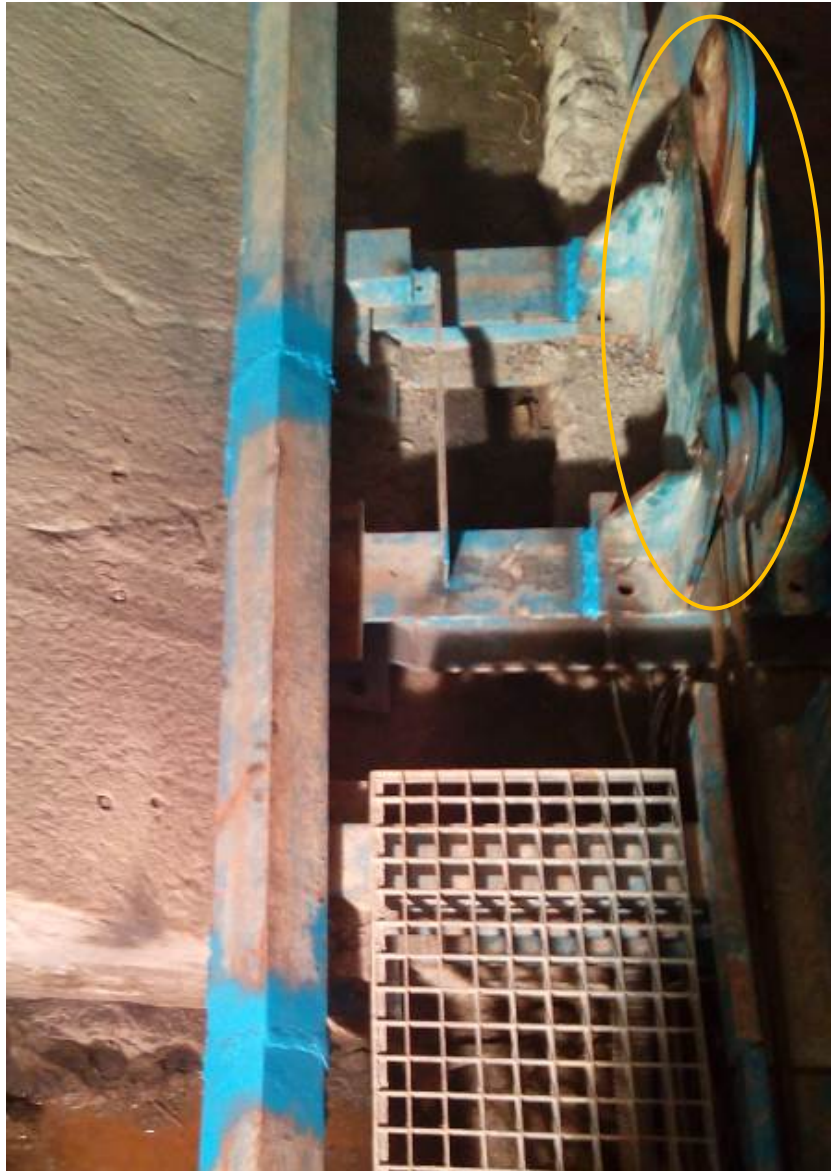
The return pulley was, in addition to being cleaned, greased and smoothed, moved to a position next to the gap of the former plug, so as to ease the installation of drilling and excavation machinery. The return pulley is shown in Fig. 11.

Fig. 11: New position of the return pulley.

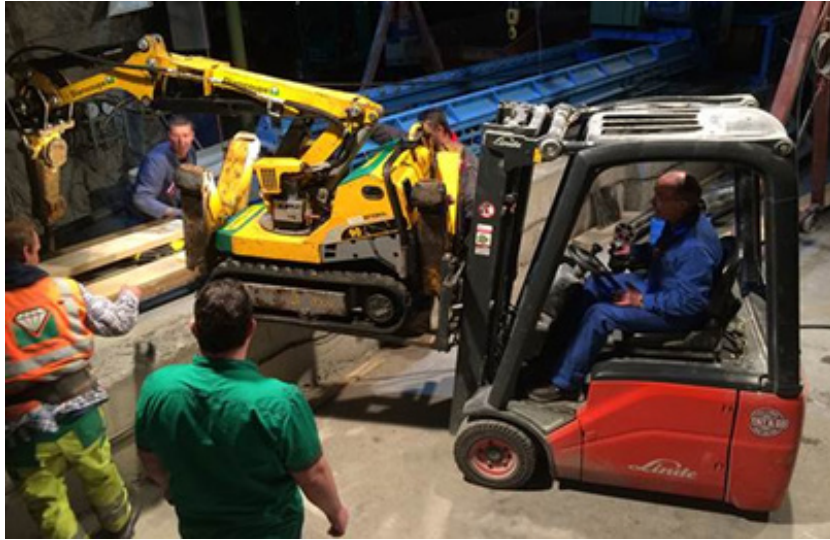
Fig. 19: Robot installation on the drift.

The demolition of the shotcrete plug started on 07.04.2015 with the mobilization and installation of the demolishing robot on the plug face. Instead of the manual hydraulic drilling machines used during dismantling of heater #1, for this final dismantling procedure an autonomous arm-shaped little sized robot was selected as it was considered to be faster, safer and more precise.

A specialized local firm, Diamcoupe SA or Diamantbohr AG, was hired for this purpose using a robot Brokk 90 (Fig. 19): one technician was responsible for the control of the robot operations and another worker helped in cleaning the site and discharging the waste. Two AITEMIN people performed the supervision of the work and helped in the waste removal. Nagra staff also provided general support (waste disposal, water pumping installation etc).

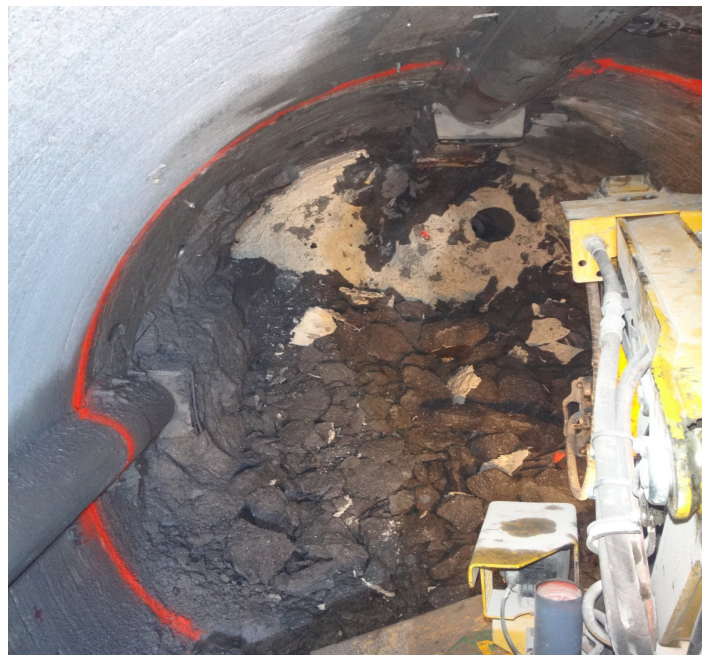
Fig. 20: Marking of plug face on the gallery and left cable duct.

The position of the plug face was marked on the wall for further reference, see Fig. 20. Cable ducts positions were considered so as to avoid hitting them. The locations of wall total pressure cells were approached by the robot smoothly, trying not break any of the sensors' tails, which contain mercury.

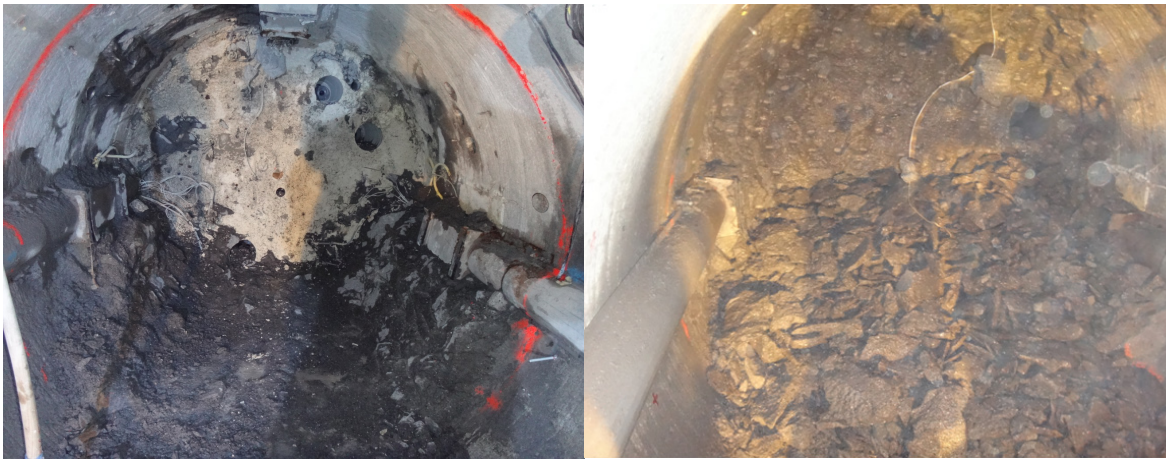
Fig. 21: Detail of the base made with concrete debris in order to facilitate the robot movements.

Some amount of concrete debris was left on the bottom part of the tunnel to act as a base and facilitate the robot movement (see Fig. 21). Separately, a layer of 18 cm thickness of concrete was left intact on the lower part of the gallery in order to sample the concrete/rock interface in sections S32 and S33.

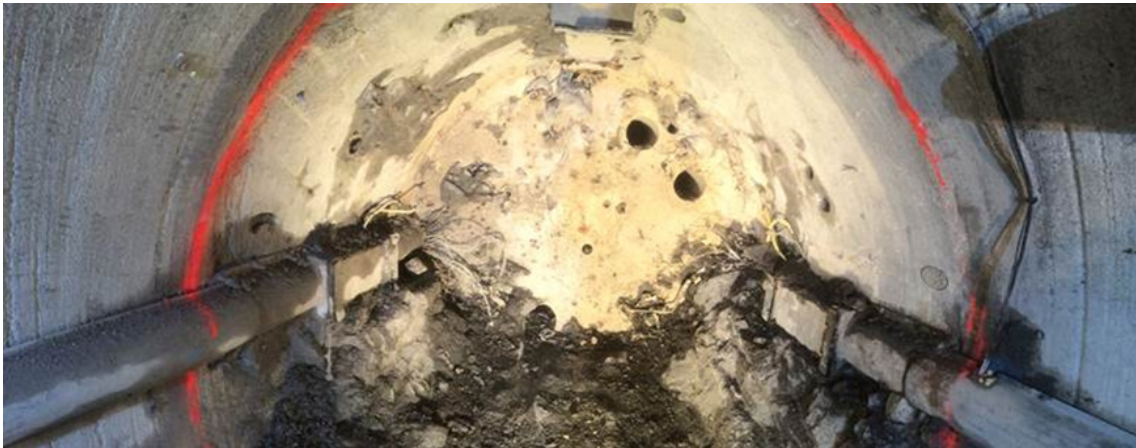
Fig. 22: Detail of the excavation advance and the impermeable mat at the rear of this first part.

The advance of the excavation was leveled off better with the use of the robot than that performed on the dismantling of heater #1 (see Fig. 22). About 12 tons of shotcrete were disposed off in this first part.

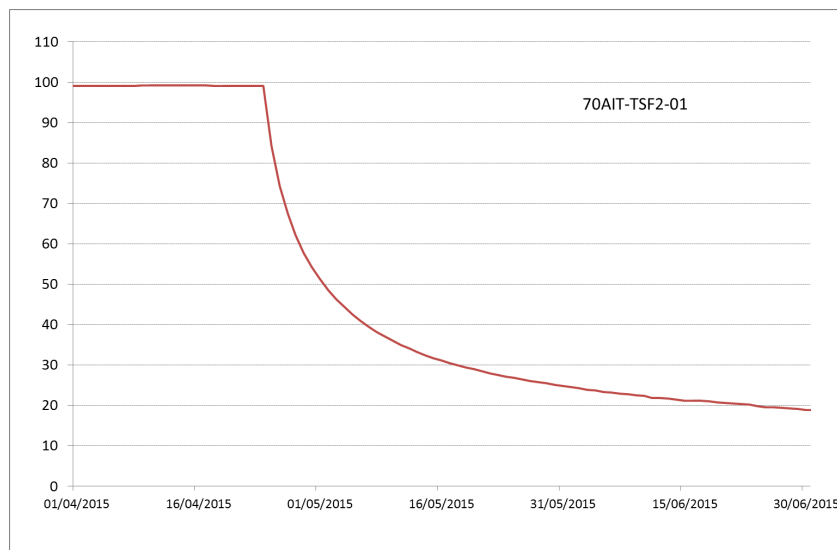
In order to achieve a temperature level desired for the upcoming dismantling works, heater #2 was switched off on 24.04.2015 after 6'630 days of heating. The designed control temperature of 100 °C at the heater/bentonite interface was targeted to decrease to the range of 25 – 30 °C at the start of excavating the zone, so the power was switched off around one month prior to this date. The switching was made in a single step as done in the partial dismantling, but the temperature decrease was faster in this case. Working conditions were achieved in about 20 days contrary to the 30 days needed during the first dismantling.

Fig. 26: Control temperature decay after power off.

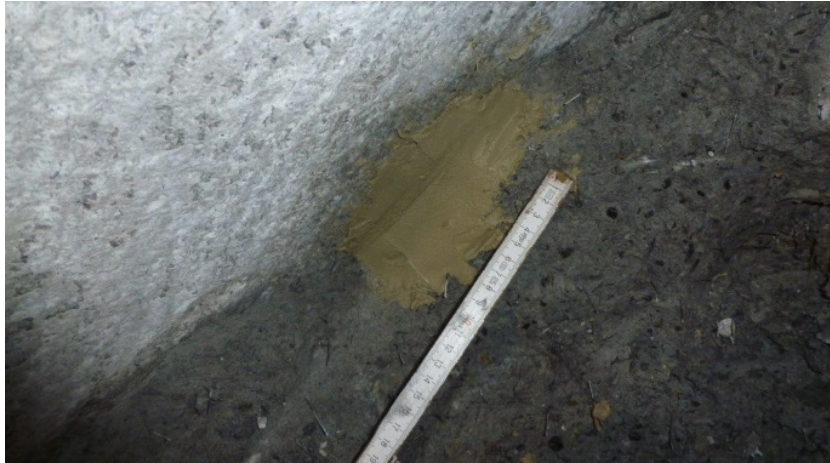
Fig. 27: Hand-made gypsum tracker.

This time some little hand-made gypsum markers/trackers were placed in the plug/rock contact to check if this remaining part of the plug (about 1 meter) moved towards the entry of the gallery during the excavation works due to the pressure imposed by the swelling bentonite buffer. It turned out that there was no movement whatsoever. See detail of this tracker on Fig. 27.

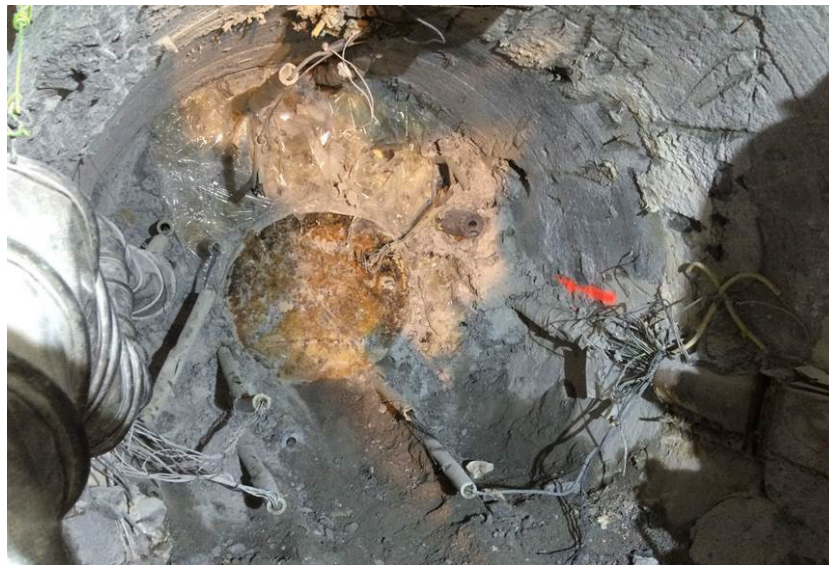
Fig. 29: Plug dismantled and dummy face exposed.

This second part of the plug dismantling was done in about 8 workdays; see final status in Fig. 29, making a total of 14 days for the whole plug and related sampling. The whole process is considered to be fast and safe. However, the vibration induced by the robot and the necessary spraying of water to avoid the dust certainly impacted on the successful sampling of an intact shotcrete/rock interface.

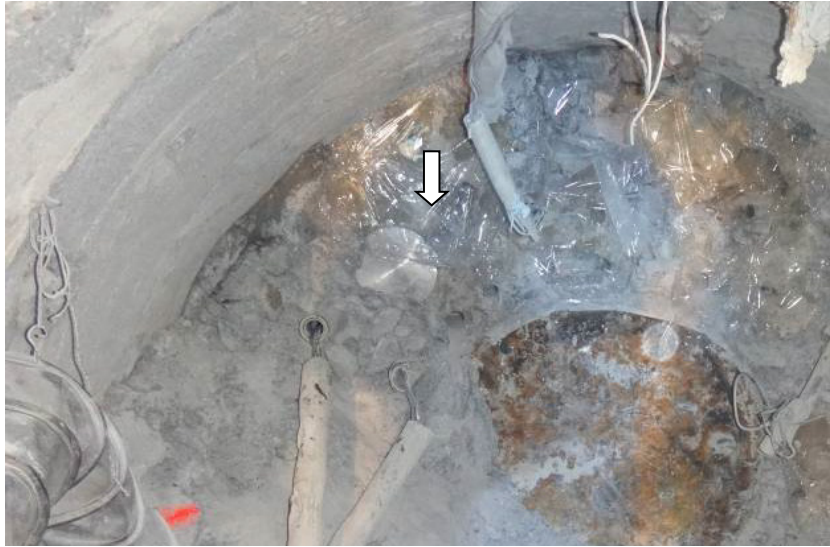
Fig. 30: View of PSP-01 before removal.

The concrete/buffer interface of the experiment was represented by Sampling Section 36 (bentonite layer 74) or instrumented Section P. This section was sampled from 07.05.2015 to 13.05.2015. Both pressure cells (PSP-01 and PSP-02) presented good condition but PSP-01 (S-S-36-1, see Fig. 30) was hit during the coring of CC-34-9 producing an oil leakage and loss of data reliability whereas PSP-2 data remained consistent until removal on 07.05.2015 (see Fig. 28).

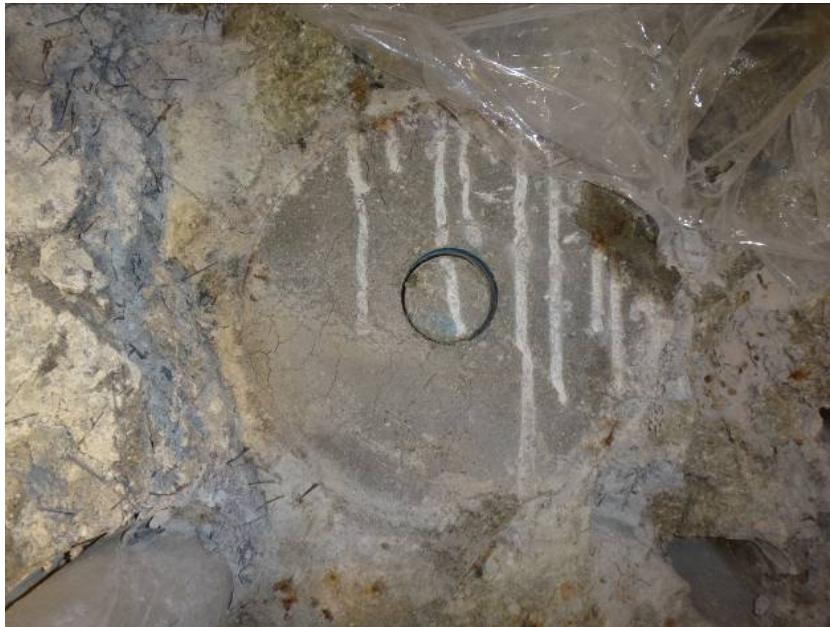
Fig. 31: Emplacement of B-C-36-5 in the interface of PSP-01.

In general, bentonite core samples were taken with a manual drilling tool provided with a suitable crown and obtaining samples of about 4.5 cm in diameter. Sample B-C-36-1 was shifted from the planned position in the centre of the block downwards to avoid hitting sensor WCSQ-03. B-C-36-3 was taken twice because the border between blocks was not clearly distinguished. A new sample (B-C-36-5) not included in the plan was taken on the interface with PSP-01 (see Fig. 31).

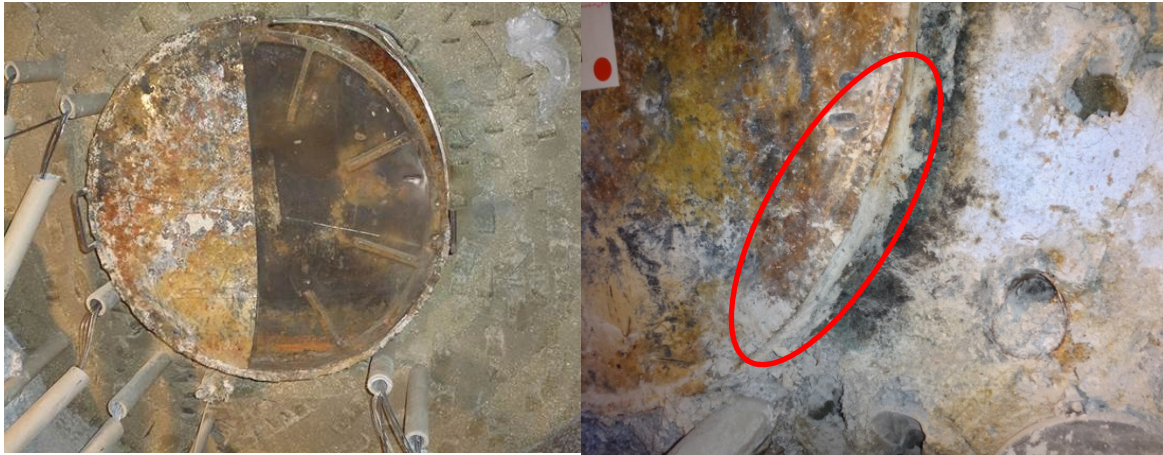
Fig. 33 View of the "dummy canister" (left) and its adhesion to the liner segment (right).

Initially it was planned to remove the "dummy canister" before starting the dismantling of the bentonite around the liner, but this was not possible because it was stuck to the liner (see Fig. 33) due to the pressure formed by the bentonite and the intrusion of bentonite in the inner gap by the holes of the liner. Therefore, after the removal of the shotcrete plug and stating that the dummy canister could not be removed as expected, the bentonite layers from 74 to 66 around the first liner segment were dismantled (see Section 4.8 and 4.9). These dismantling works were performed from 12.05.2015 to 22.05.2015.

- A new bentonite sample (B-S-37-1) was taken. It consisted of a piece of bentonite between the liner and the "dummy canister" showing corrosion products. It was taken where the liner was remarkably curved (see Fig. 33, upper right).

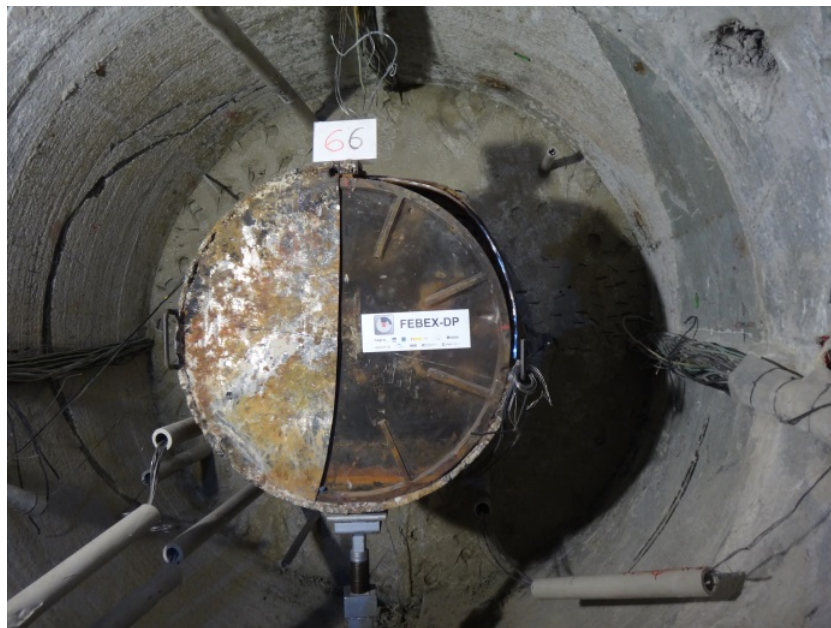
Fig. 34: Steel support for the dummy canister.

Before finishing the removal of bentonite layers around the liner, the set "liner + dummy canister" was secured with a steel support (Fig. 34) located at the bottom.

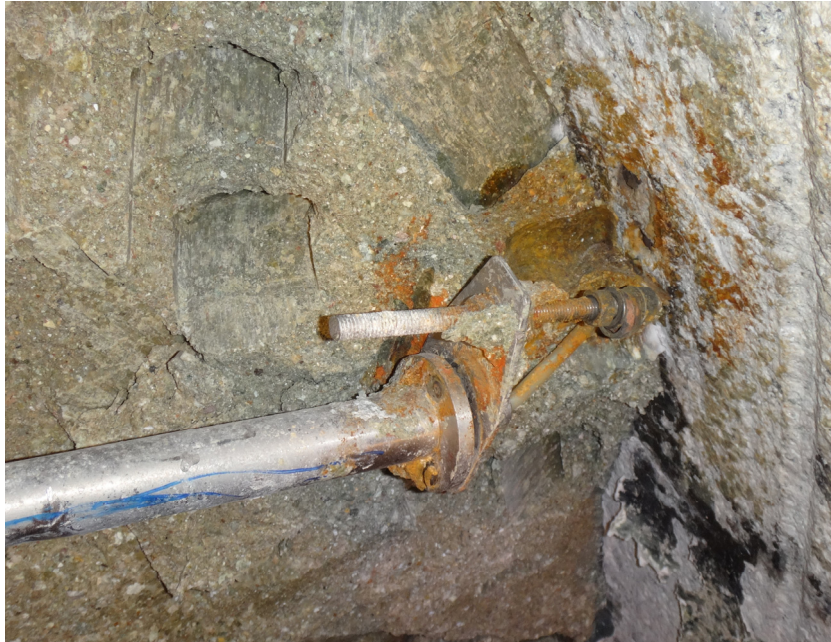
- Sampling Section S38, located in bentonite layer 67:
  - At this step it was agreed to skip the planned Sampling Section S40 (comprising 4 cores samples) and move those core samples to Section S38. So samples B-C-40-1 to 4 were converted to samples B-C-38-1 to 4.
  - A new sample, B-S-38-1, was taken from the vicinity of the extensometer anchorage, showing two different corrosion areas, see Fig. 36.

Fig. 36: Area sampled for new B-S-38-1.

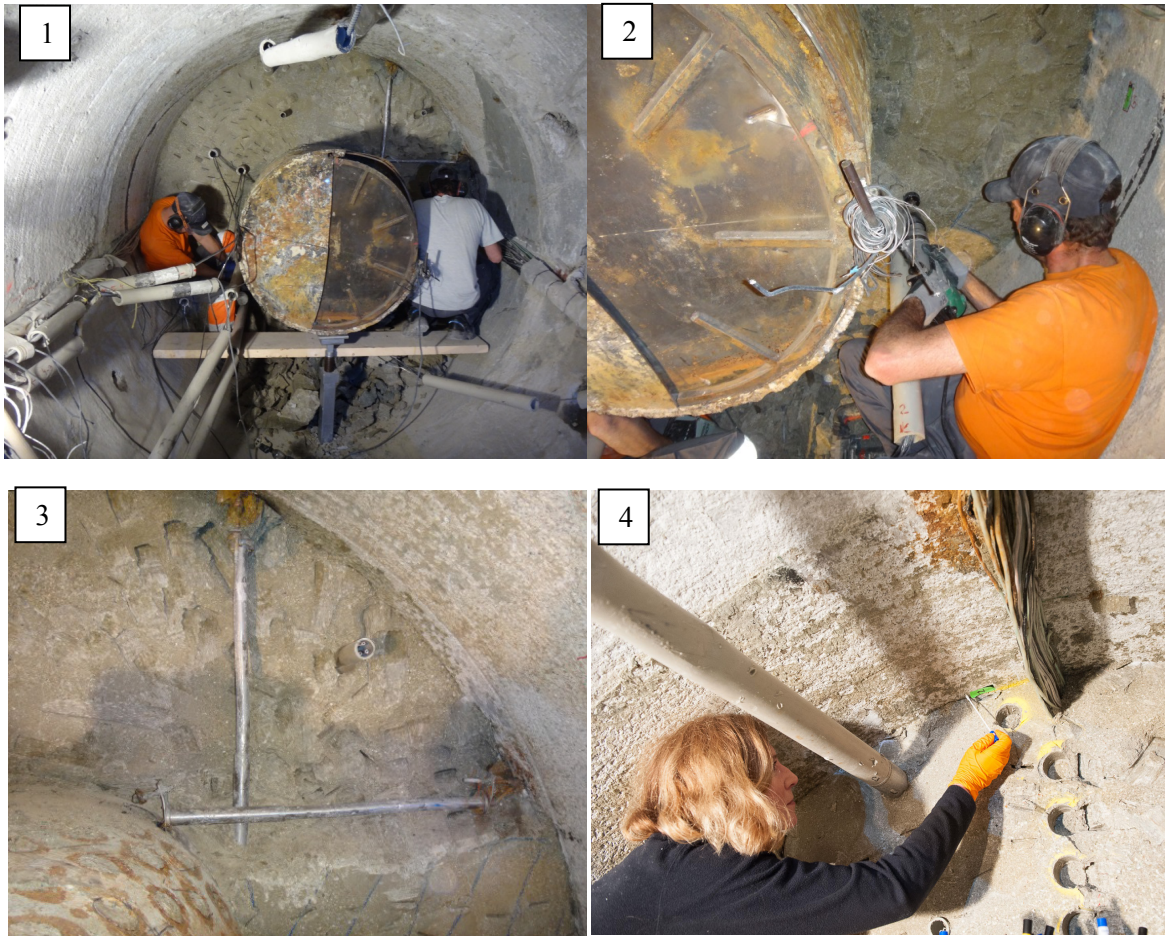
Fig. 37: Photos of sampling around the dummy canister.

Photos 1 and 2 show sampling operation and layer dismantling. Photo 3 shows extensometers ready to be dismantled. Photo 4 shows microbiological sampling.

- Removal of sensors S-S-38-6 and S-S-38-16 was not done because the dummy canister was still in place (see removal sequence in Fig. 37).
- Sampling Section S39 was planned in bentonite layer 66 but due to the presence of the dummy canister it was agreed to move the samples to bentonite layer 64.

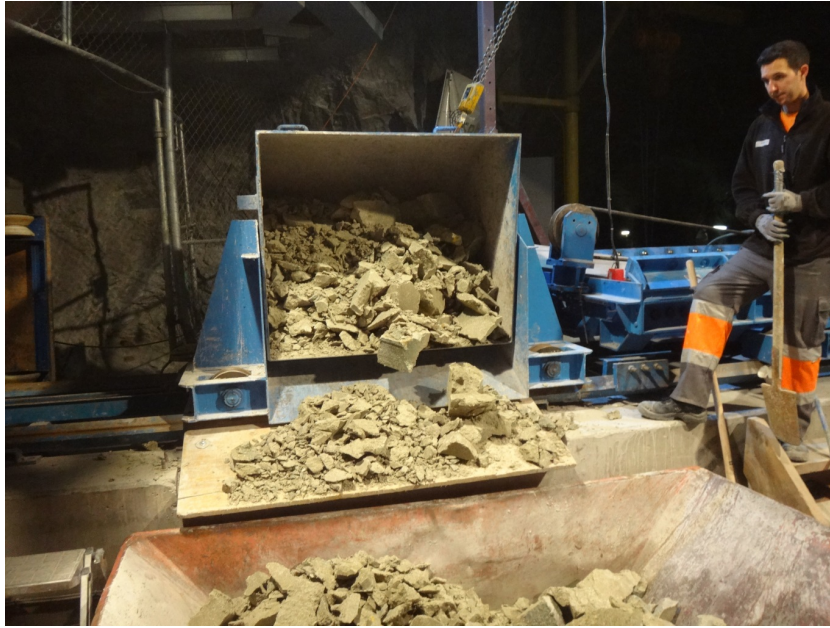
Fig. 38: Dumping of bentonite debris.

Blocks not required for analysis were dumped in the site dump wagon, located close to the bentonite buffer front. Once the dump wagon was filled, it was transported along the drift up to the drift entry where the bentonite was dumped into a container placed nearby the concrete platform outside the drift (Fig. 38). When three or four containers were full, the waste bentonite was transferred to an authorized dump site outside the GTS using a truck. About 14 t of bentonite were dumped during the dismantling operation carried out between the concrete plug and the front of heater #2.

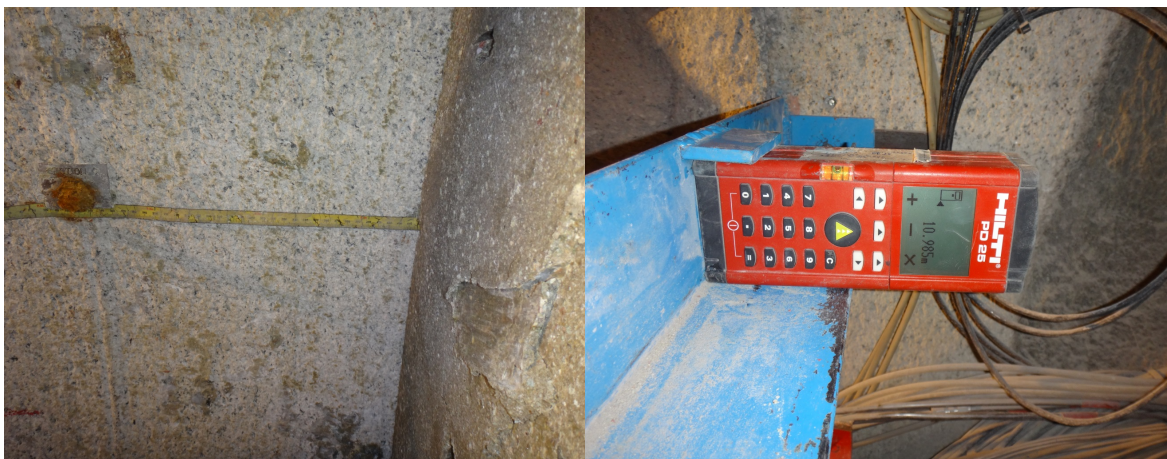
Fig. 39: View of the metric tape (left photo) and the laser device (right photo).

The  $x$  local coordinates for each bentonite layer were registered by means of a laser located at the  $x = 0$  coordinate (Fig. 39, right side). Measurements were taken in three places: along the left and right rock walls (mid-height), with the laser device and at the upper part of the bentonite front using the metric tape placed during FEBEX installation (Fig. 39, left side). Also, each bentonite layer was fully documented (taking photos, making sketches, logs and records of the operations and samples see Section 4.11.3).

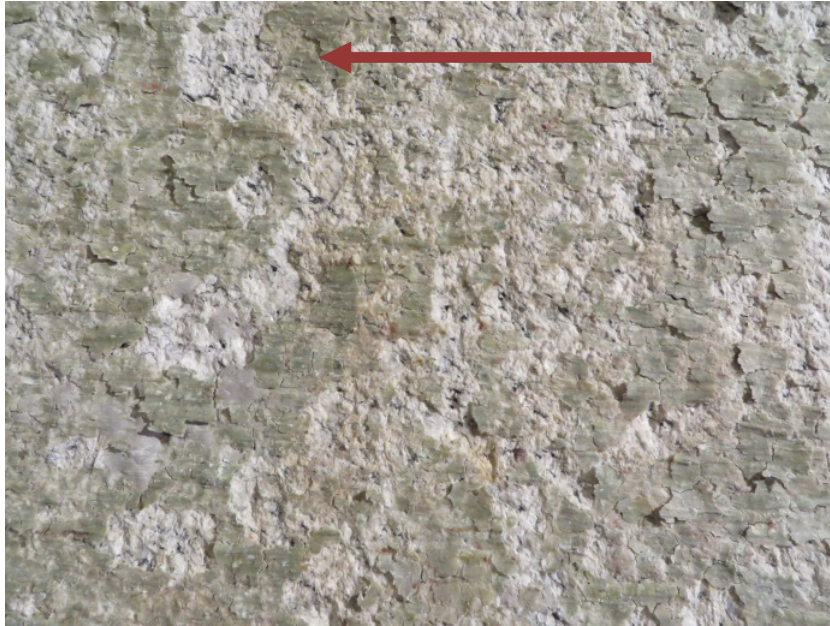
2.4 cm in layer 60. Small longitudinal grooves in the direction of the gallery axis could also be observed on the surface of the bentonite in contact with the rock, and in the thin film of bentonite that remained adhered to the rock in the already dismantled area (see Fig. 40). These observations suggest a displacement of the buffer (or at least of the exposed part of it) towards the drift entry.

Fig. 40: View of longitudinal marks on the bentonite layer adhered to the gallery.

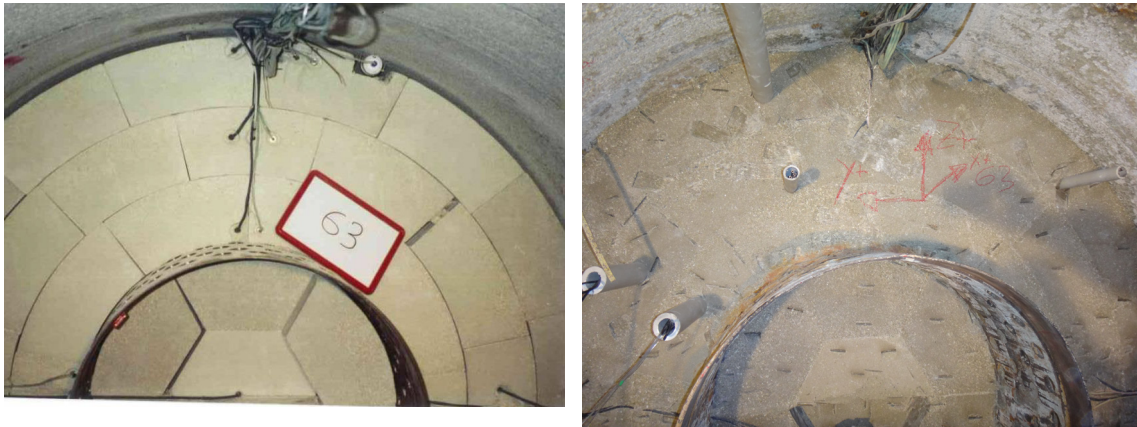
Fig. 41: View of bentonite layer 63 after installation (left) and during removal (right), Section 41.

- As expected, no free water was observed at the bentonite/rock interface, or in the exposed rock in this section.
- The bentonite showed a solid appearance, even in the area close to the rock. No mud or gel was found. The blocks seemed to be quite dry in the centre, producing dust when drilled, and became more humid in the outer ring with a noticeable darker cold grey colour. The consistency of the outer ring was much waxy, while in the inner ring the texture was more friable (less cohesive).
- All the construction gaps were completely closed (see Fig. 41) including the gaps between the blocks, around cables and around sensors (see "Extra Report 7 - The disappeared gaps in bentonite layer 45" (Kober 2015b)).

Note the gaps closure.

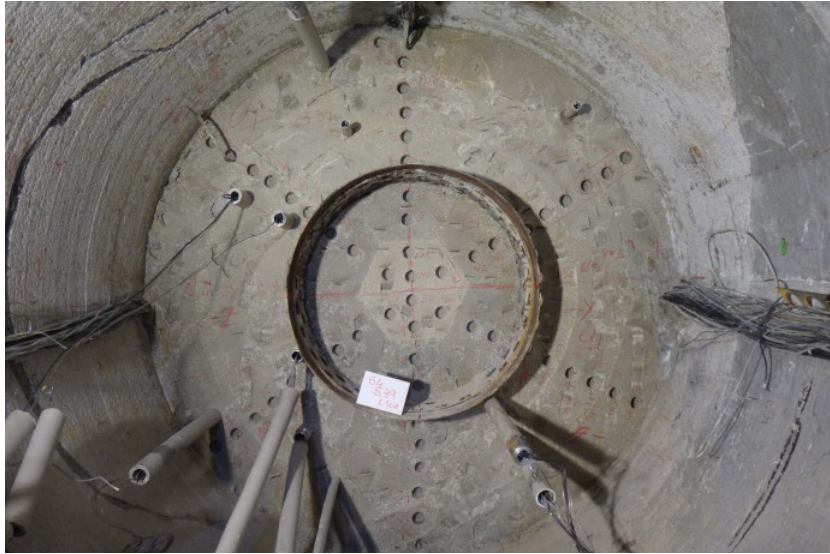
Fig. 42: View of bentonite layer 64 during dismantling.

- Sampling Section S39 was planned for bentonite layer 66 but it was agreed to move the samples to bentonite layers 65 and 64 due to the presence of the dummy canister (see Fig. 42):
  - Two blocks, not foreseen in the sampling plan, were taken from bentonite layer 65 at the outer ring.
  - Due to the new location in layer 64, it was possible to sample the blocks emplaced inside the liner and additional cores from B-C-39-37 to B-C-37-56 were taken for analysis. Details about the sampling procedure can be seen in Fig. 43.

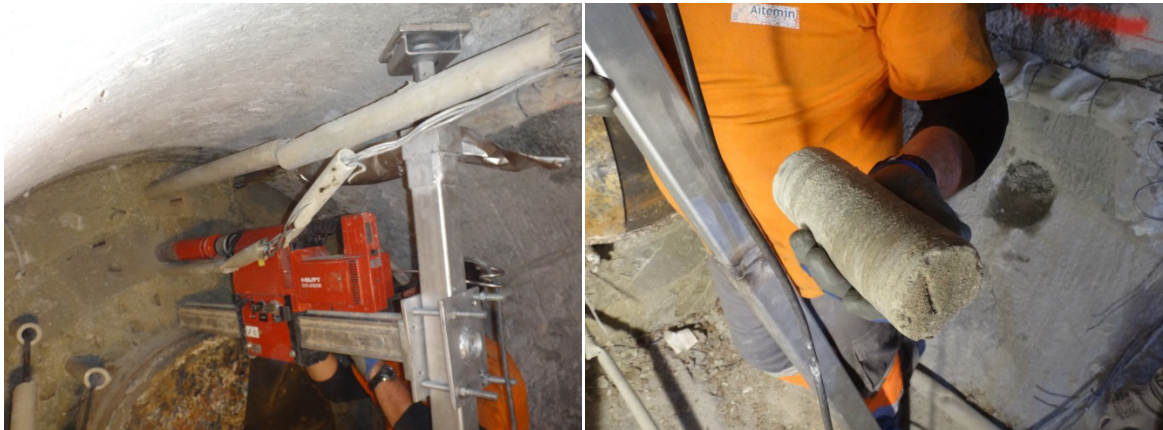
Fig. 43: Details of the bentonite sampling.  
Drilling machine at the left side and obtained core at the right.

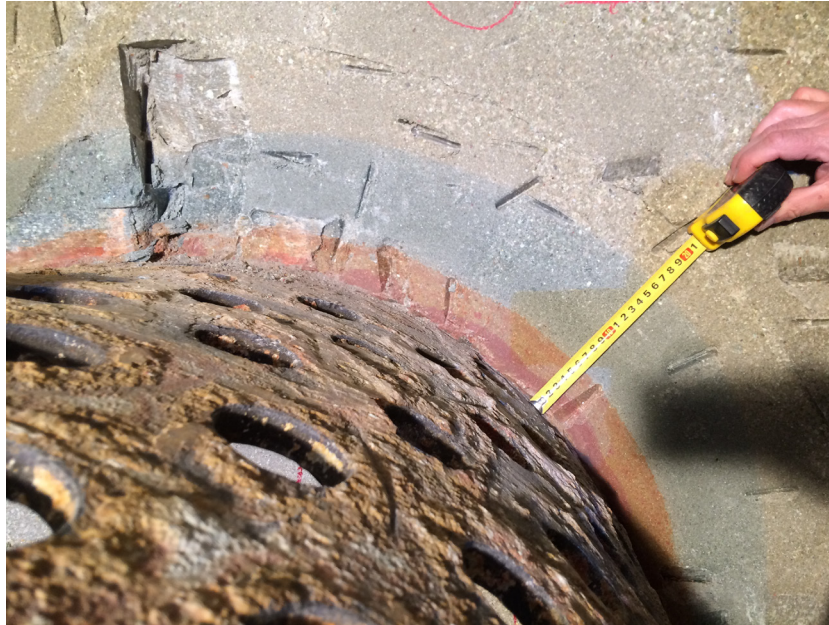
Fig. 44: Details of the colour aureoles of Fe-oxidation/reduction fronts close to the liner.

- Sampling Section S41, was taken as planned in bentonite layer 63:
  - Two not foreseen samples were taken, BM-B-41-1 and 2, consisting in bentonite blocks in contact with the liner and showing some diffusion of oxidation products (Fig. 44).

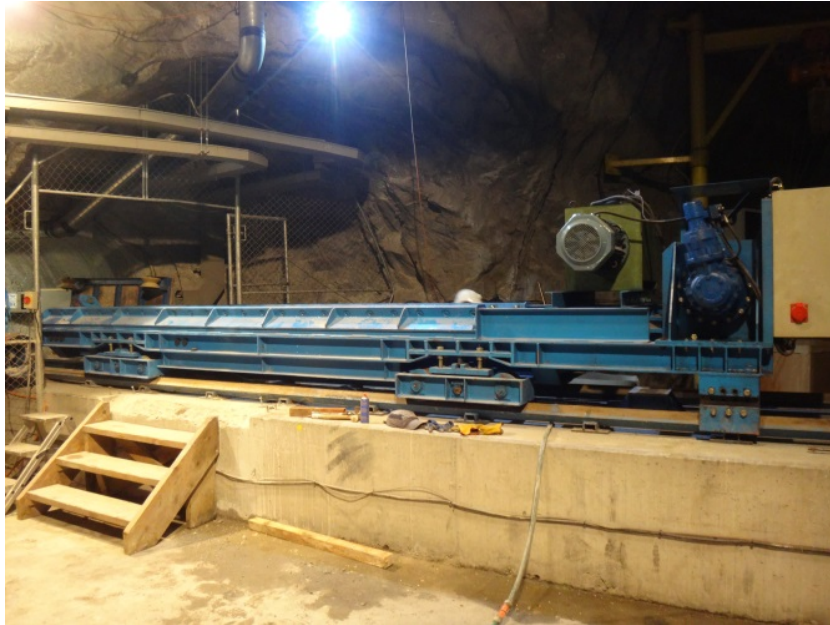
A general view of the modified equipment is shown in Fig. 45. The basic structure of the vehicle is a robust, low profile chassis having a bed of rollers and rolling balls, adapted to the dimensions of the heater. This chassis, which is basically the same one that was used for the emplacement operation was modified in the bogies' zone, in order to incorporate the possibility of regulating the height of the rolling bed base line. Instead of having a fixed connection, the link between the bogies and the chassis consists of 16 studs that provide a height variation capacity of approximately  $\pm 25$  mm, in relation to the original reference level. Also the clamps used to fix the vehicle to the tracks were made more robust, in order to absorb the potential reaction forces that might be generated during the extraction operation.

Fig. 45: Extraction car.

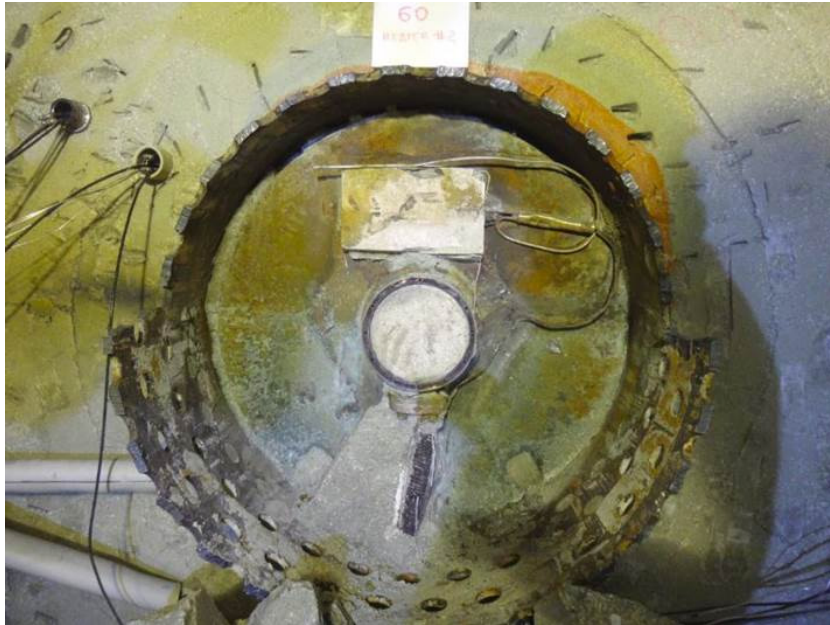
Fig. 46: View of the uncovered heater front.

The extraction of heater #2 took place on 04.06.2015. Once all the bentonite in the previous sections was removed (up to bentonite layer 59) and the heater front cover was uncovered, an initial inspection of the heater situation was carried out (Fig. 46 and Fig. 47).

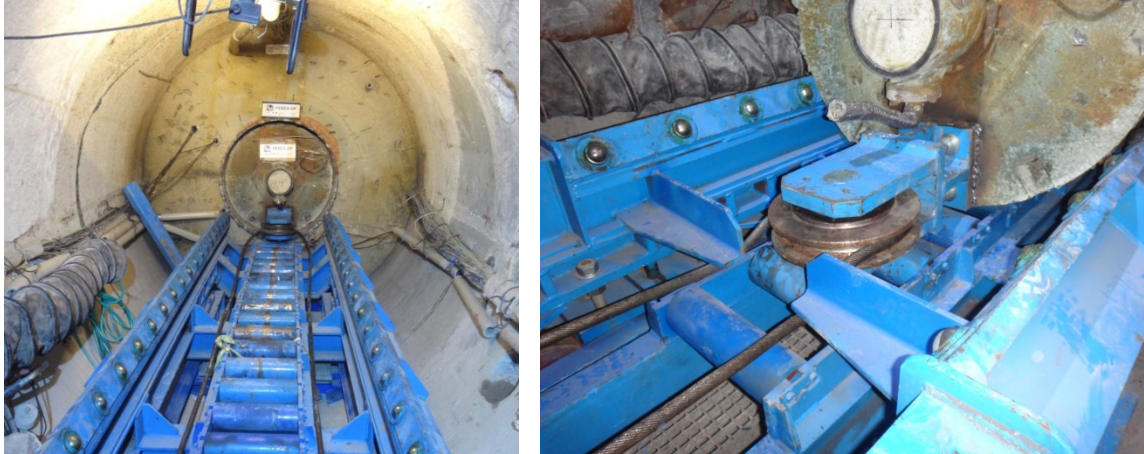
The return pulley of the pulling system was fixed to the front cover of the heater by means of four M20 screws, using the four corresponding holes existing in the heater frontal lid that were in relatively good conditions (Fig. 48, right photo). The silicone rubber that had been injected at that time for protection was loose and deformed, but the holes and the threads were dry,

showing some amount of oxidation dust only. The holes were cleaned and tapped again, and the bolts were introduced without any problem. To increase the safety of the attachment, the end plate of the return pulley assembly was welded to the front cover of the heater.

Fig. 48: View of the extraction car already positioned for the extraction manoeuvre (at the left) and detail of the return pulley installed at the heater front (at the right).

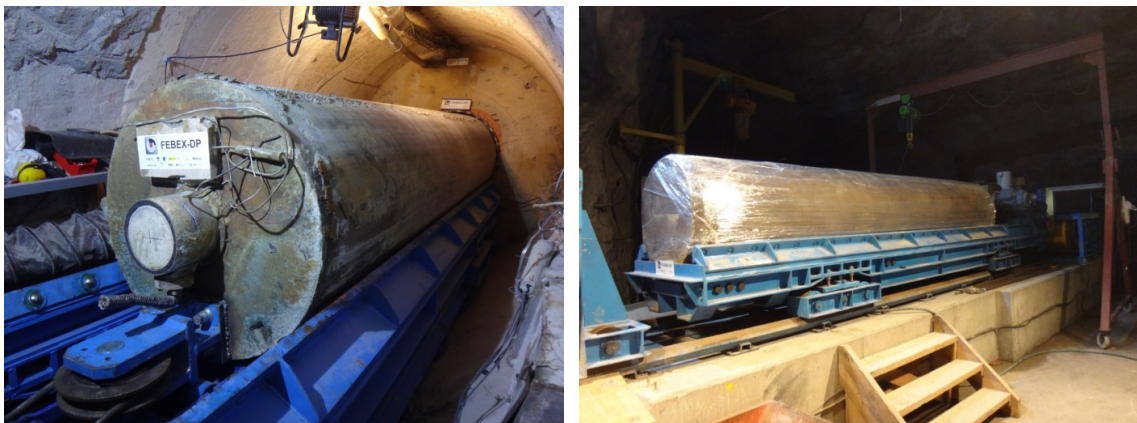
Once the return pulley assembly was safely fixed, the pulling system was put in operation and the heater was extracted gently (see Fig. 49, left photo). The peak pulling force recorded was about 4.6 t at the moment of mobilization and decreasing later to 3 – 4 t during the rest of the extraction.

Fig. 49: Extraction of heater #2 (at the left) and general view of the heater at the drift entry (at the right).

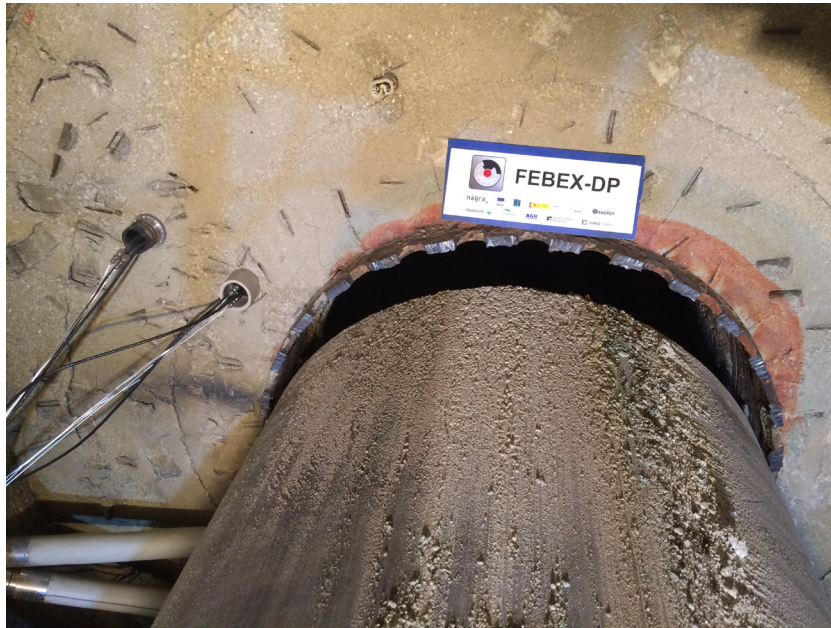
The heater appeared to be dry and with little and quite homogenous corrosion. A red dust covered the body of the heater, together with particles of bentonite fallen from the buffer on top of the canister (Fig. 50). The extraction car with the heater #2 was left at the entry of the drift during the rest of the dismantling phase and the heater was enveloped with plastic film in order to preserve as much as possible its conditions.

Fig. 50: Bentonite drops on top of heater back part.

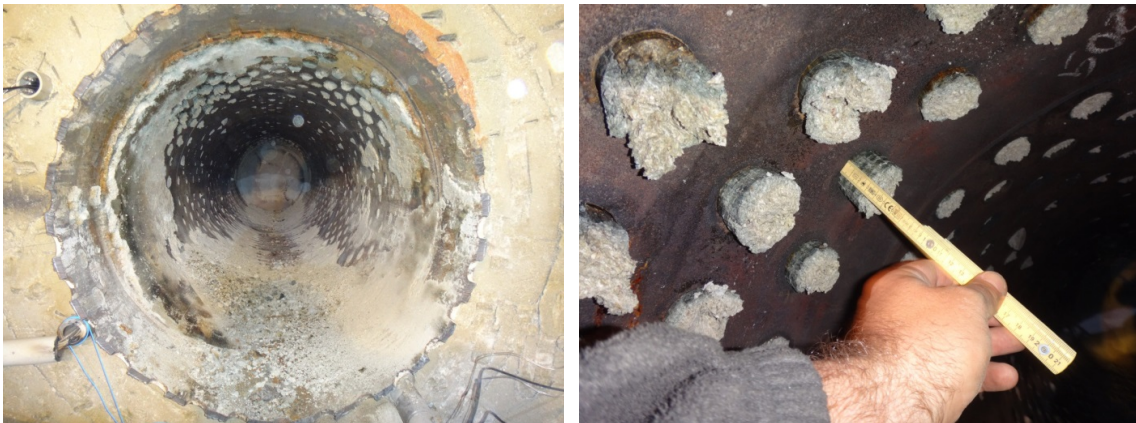
Looking inside the liner all around the former heater location, the bentonite had penetrated the liner perforations at both ends but not in the centre and it was clearly visible (Fig. 51) (see "Extra Report 6 - Impressions from the FEBEX-DP heater retrieval" (Kober 2015b)).

Fig. 51: Inner view of the liner once the heater was extracted (left photo) and detail of the bentonite protrusions inside the liner (right photo).

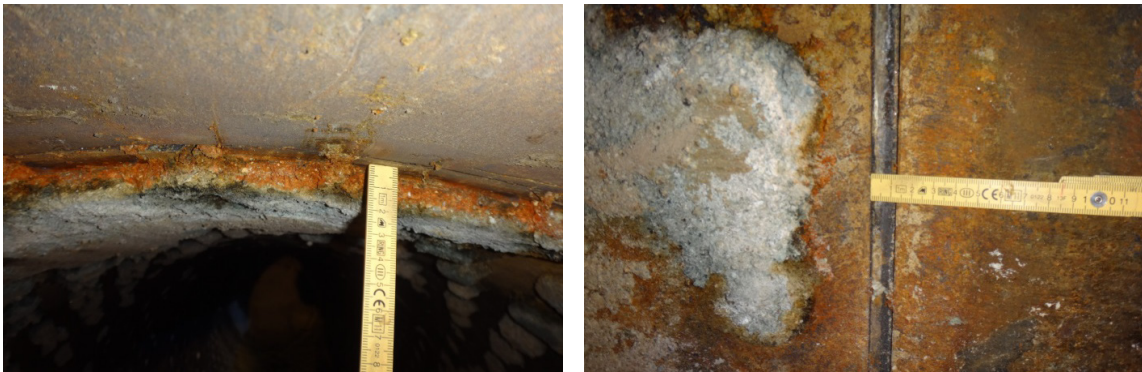
The liner showed the same corrosion aspect as the heater body. No significant vertical movement of the liner (and heater) was found because the distance to the rock floor was the same as recorded during the installation. A small deformation was observed in the liner, which had enlarged in the direction of the vertical diameter (Fig. 52).

Fig. 52: Measurements made on the liner segments were the heater was placed and on the previous one.
