# Arbeitsbericht NAB 16-11

## **FEBEX DP: Dismantling of heater 2 at the FEBEX "in situ" test Description of operations**

March 2016

**National Cooperative  
for the Disposal of  
Radioactive Waste**

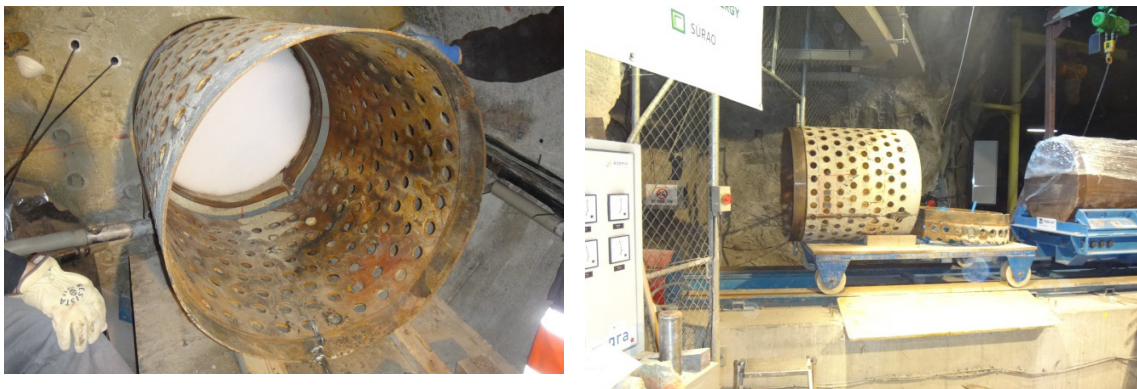
Fig. 53: Dismantling of a liner section.

Four liner sections were removed during this part of the dismantling. When one section of liner was nearly released from the surrounding bentonite, the segment was secured in order not to fall down. A provisional track was then placed from the end of the fixed tracks to the bentonite front. Using the provisional tracks, a light wagon was placed and fixed under the liner to be removed. The liner segment was then moved with the help of levers, chains and jacks until its liberation from the next segment. Once liberated, it fell down on the wagon, where it was secured and transported to the gallery entry, where the planned liner samples were taken (see detail in Fig. 53).

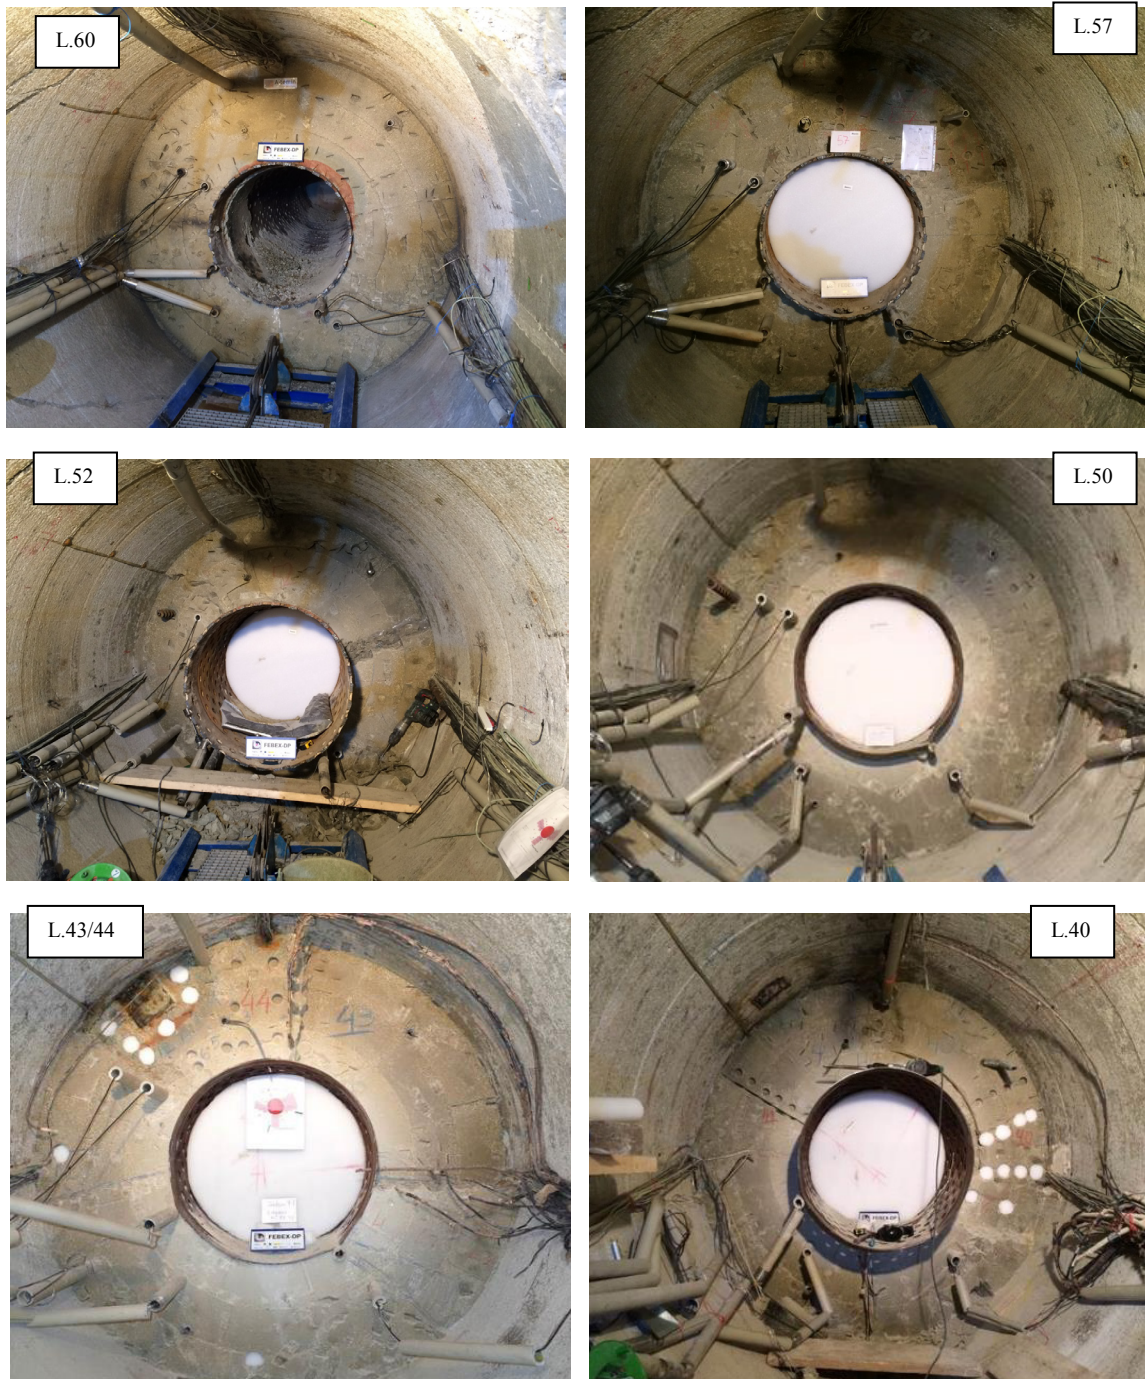
The x local coordinate was registered at both sides of the gallery in those layers where the liner existed and at 5 points aligned in the horizontal diameter when the liner section was ended. Each layer was also completely documented (see Section 4.11.3).

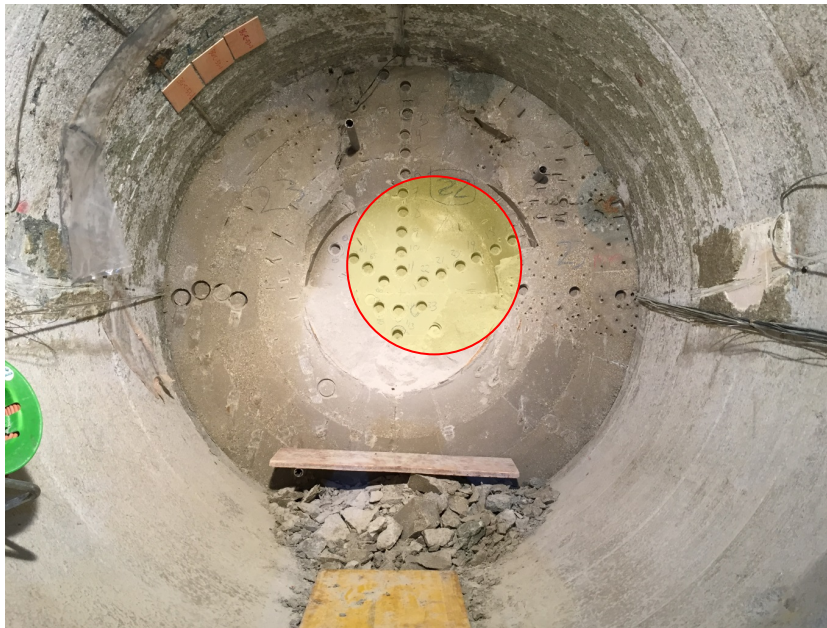
- From bentonite layer 60 and on, the humidity decreased towards the centre of the heater, keeping constant from the centre to the end of it.
- The inner blocks located in contact with the rear part of the heater where found protruding about 4 – 5 cm inside the liner, showing a belly that continued for 3 layers being progressively less accentuated (Fig. 55).

Fig. 55: Protruding bentonite in the centre of the buffer.

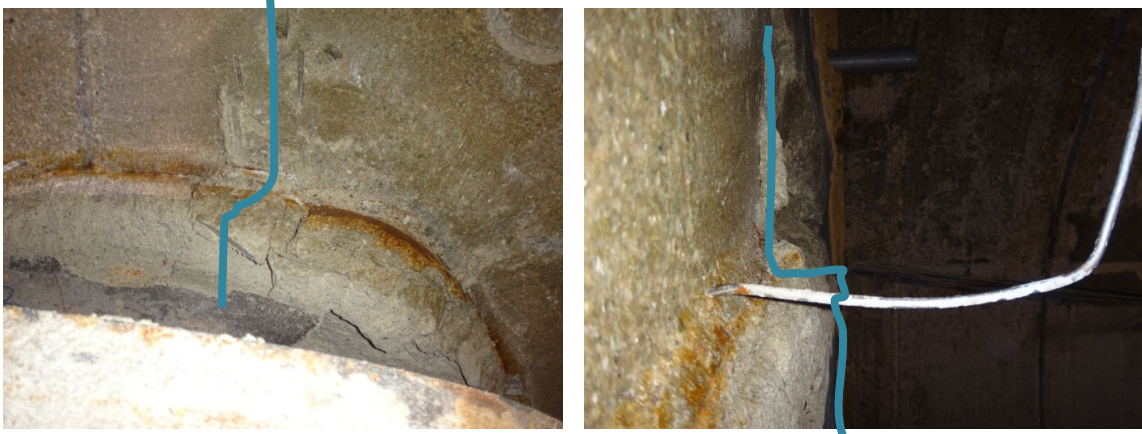
- Block joints were clearly distinguishable in the inner and intermediate ring but all gaps between blocks, at the rock contact and in the cable channels were closed (Fig. 56). The exception for this observation were the last 7 bentonite layers where joints began to be more difficult to observe up to bentonite layer 3 from where it was not possible to differentiate the block joints. Also in the last layers the appearance of the blocks was waxier (see Fig. 57).

Fig. 56: Views of the insertion of inner blocks inside the last liner segment. The blue line shows the step between outer blocks and inner blocks.

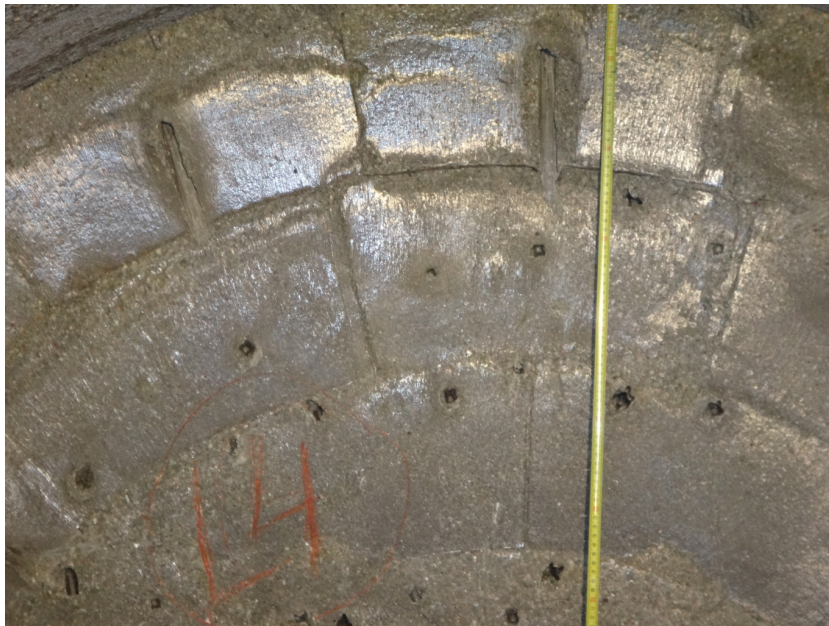
Fig. 57: Waxy aspect of blocks in L4.

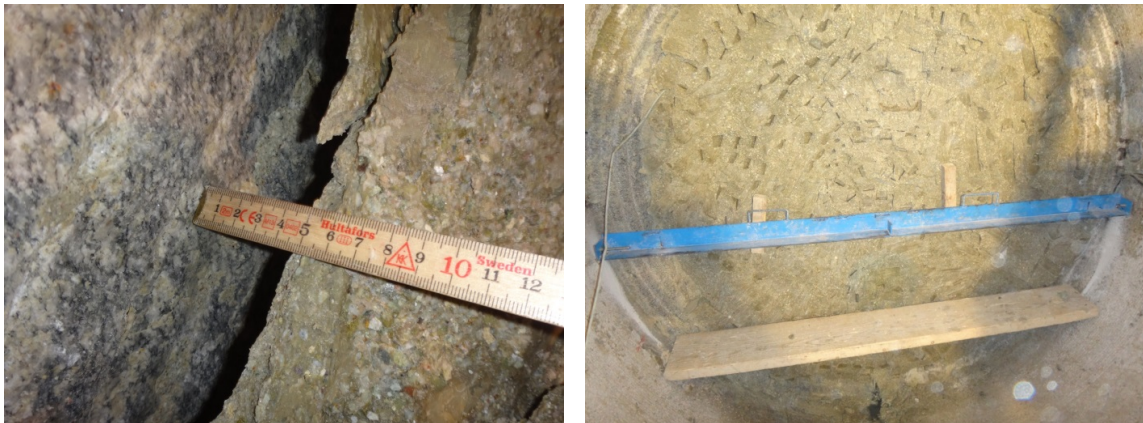
- Once the liner section was finished, bentonite blocks were extracted more easily. It was noticed that blocks were much less adhered between them and it was possible to dismantle three or four at the same time.
- The last bentonite layers (4 to 1) were found detached from the drift end while they were being dismantled (Fig. 58). There was a gap of about 3 – 5 cm between the end of the drift and the layer which seemed to be enlarging and was likely due to the release caused by the dismantling of the remaining buffer. It made it necessary to secure the whole set of layers with a metallic bar anchored to the gallery walls to keep them in place. Consequently, x local coordinates measured for these layers are not reliable.

Fig. 58: View of the bentonite detachment at the end of the gallery.

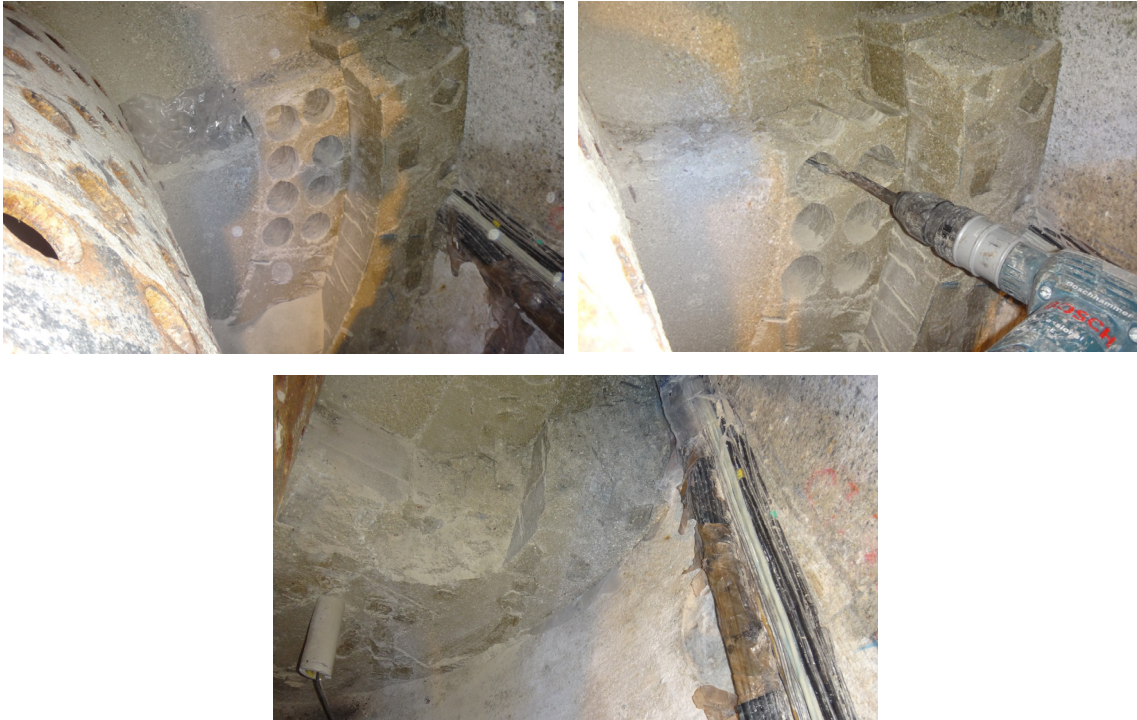
Fig. 59: Extraction sequence of blocks by taking cores.

The operation of extracting the three intact blocks in one radius proved to be quite difficult as they were strongly confined between the liner and the rock (this difficulty became less when advancing towards the end of the gallery). In some cases due to the difficulty of this extraction it was decided to take cores from the inner block and then break the remaining pieces in order to release the pressure between blocks and allow the removal of the other two (Fig. 59).

This method proved to be too slow, so the best solution when possible was to break and remove the blocks at the adjacent radii in order to allow the extraction of the blocks from the sides. It was especially difficult to extract inner ring blocks in one piece due to their dryness. In those cases (3 or 4 pieces), the block was rebuilt and packaged as a whole.

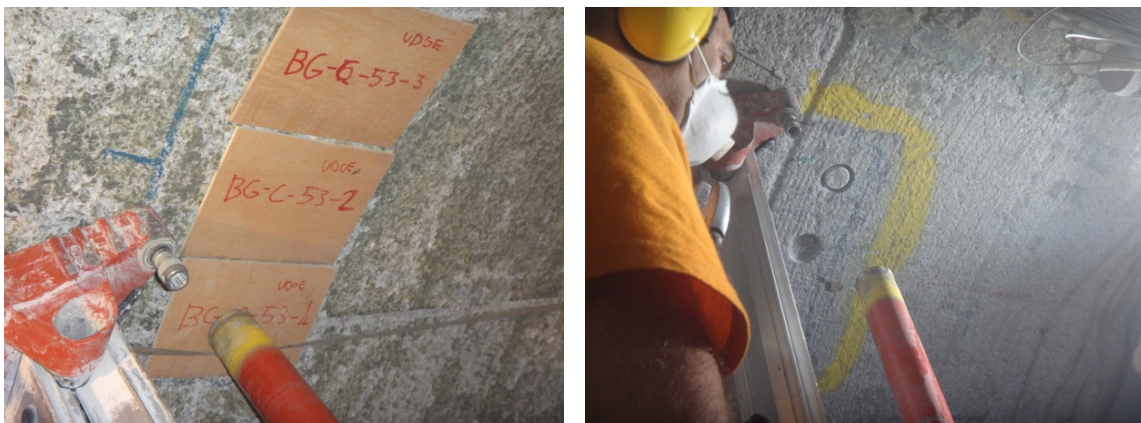
Fig. 60: Granite sampling.

Some rock/bentonite sampling was also carried out during this part of the sampling process. As it was not possible to sample the whole core in one go, it was decided to extract the bentonite part first, then mark the area at the wall where the continuation of the sample had to be taken (in the same position were the corresponding bentonite sample had been taken) and finally to protect the rock area with a wooden plate sealed with silicone. Rock samples were taken when the dismantling of the liner sections provided/left/enabled enough space for installing the drilling machine (Fig. 60).

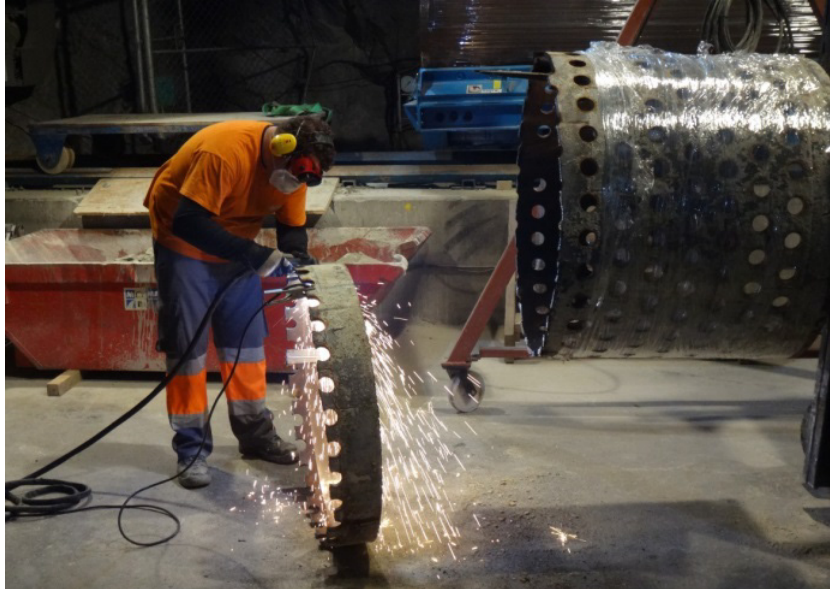
Fig. 61: Cutting the liner for metallic samples.

A similar procedure was performed when sampling the bentonite/liner contact: first the bentonite part was sampled and then, when the liner segment could be retrieved, the metal part was cut outside of the gallery (Fig. 61).

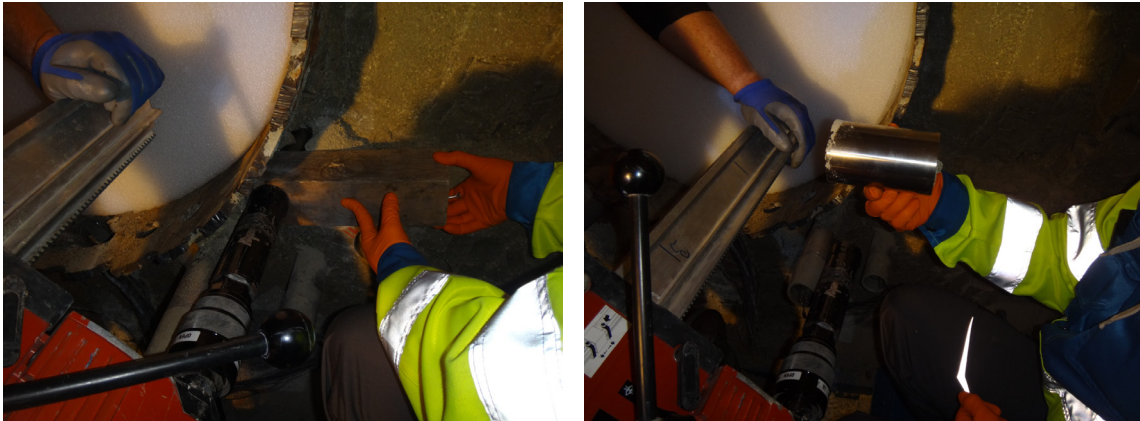
Fig. 62: Pushing of Shelby tubes while Sampling Section S42.

- Sampling Section S42, located in bentonite layer 59:
  - BG-C-42-1 and 2 were supposed to be sampled as cores, but finally were set as swab samples. The swab procedure was not successful, so it was agreed that it will not be used anymore.
  - Several additional samples were taken:
    - BM-S-42-4, sample from the inner blocks in contact with the liner
    - B-S-42-4, composed of two samples in contact with the outer part of the liner
    - B-B-42-4 and B-B-42-5, blocks for the inner part of the liner
    - BM-S-42-Pxx, 10 protrusions of bentonite inside the liner holes
    - M-S-42-1, a piece of resistor cable and duct

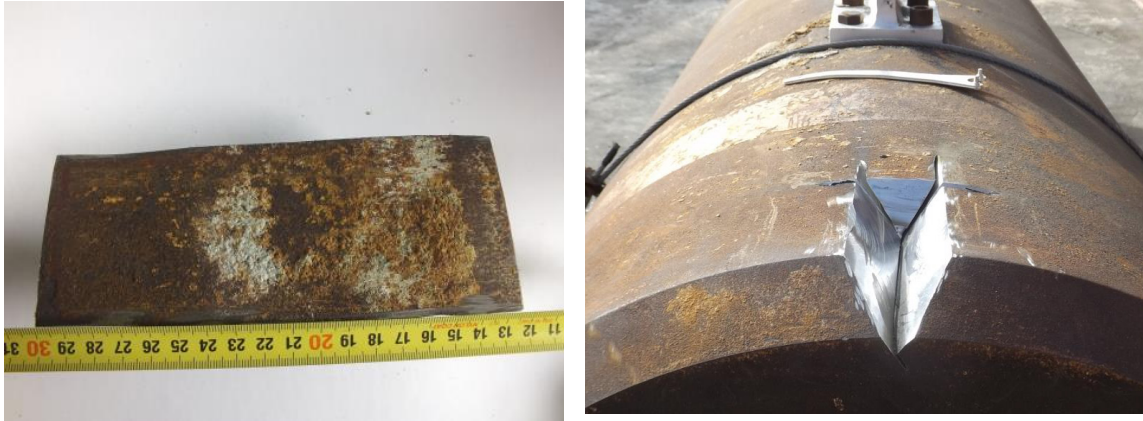
Fig. 63: Metallic sample from heater in Spain.

- Samples BM-D-45-1 and 3 were not taken.
  - Samples M-H-45-1 to 4 had to be taken in the heater. It was agreed that any sample from the heater would be taken in AITEMIN's workshops once the dismantling

operations were finished and the heater transported back to Spain (see Fig. 63). Besides, finally these samples' number and positions for the heater #2 samples were changed.

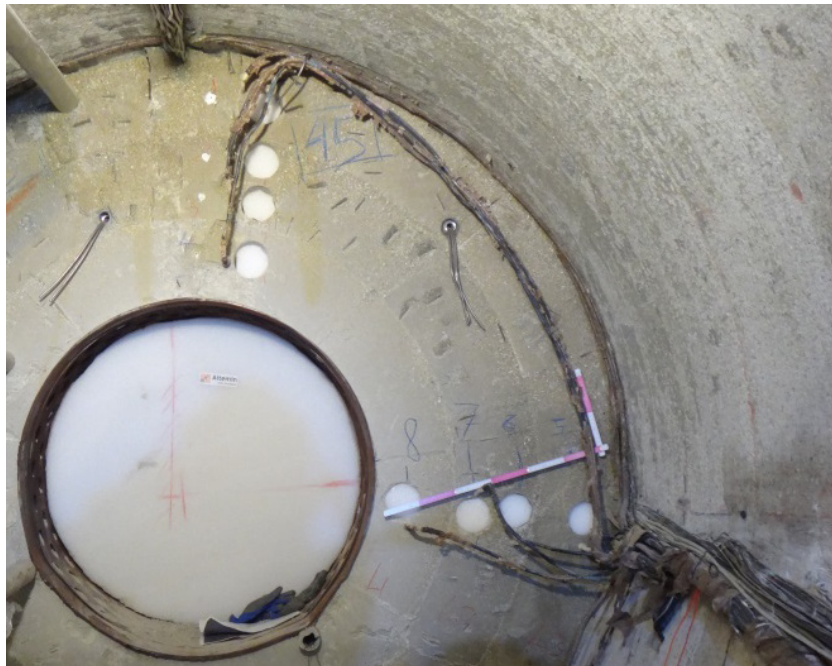
Fig. 64: Cores taken following the TDR sensors inside the bentonite buffer.

- Sampling Section S46, which was located in bentonite layers 46 to 44:
  - A new block (B-B-46-5B) was sampled just facing the fisurometer due to the presence of oxidation products in it.
  - B-C-46-1 to 10 were cores supposed to follow the TDR sensors along its whole length (Fig. 64). It was decided to split these cores in two samples: -A for bentonite layer 45 and -B for bentonite layer 44.

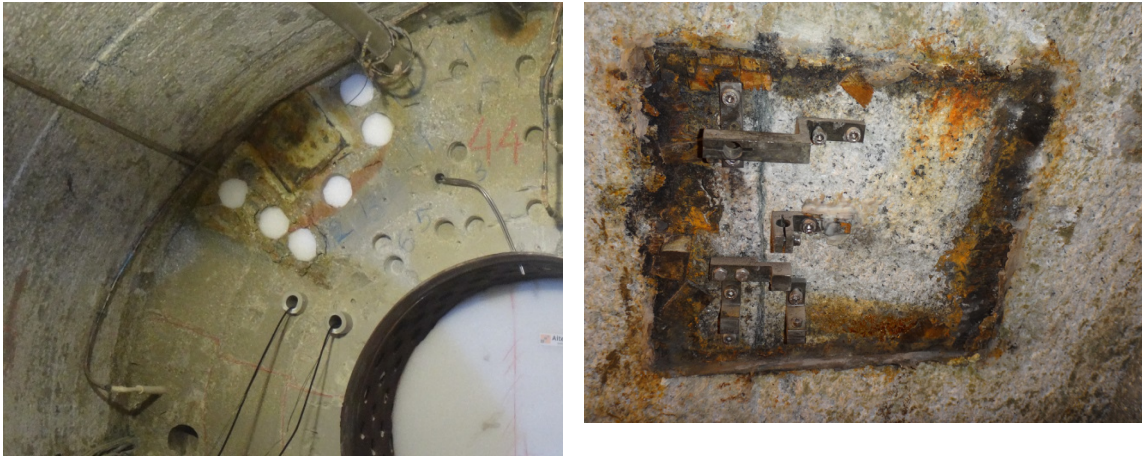
Fig. 65: Left, samples taken around fisurometer. Right, view of fisurometer location once the protective cap has been removed.

- Sampling Section S47 that was located in bentonite layers 44 and 43:
  - A new set of samples, not foreseen in the sampling plan, were taken around the fisurometer (Kober 2015b), see Fig. 65.
  - BG-C-47-1 and 2 were not taken at bentonite layer 44, but 43.
  - B-C-46-1B to 10B were the continuation of cores B-C-46-1A to 10A from layer 46.

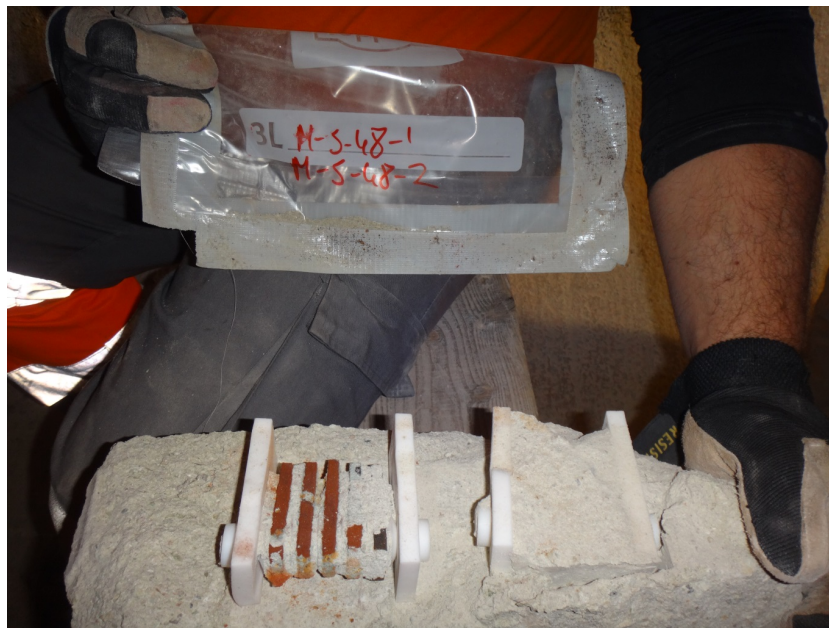
Fig. 66: Metallic coupons in S48.

- Sampling Section S48 was located in bentonite layer 42:
  - B-C-48-12 was a core for microbiology analysis that finally was not possible to obtain in good conditions so it was discarded.
  - One of the metallic coupons (M-S-48-3) set was broken before dismantling (see Kober 2015b).
  - B-M-S-48-1 was not taken.

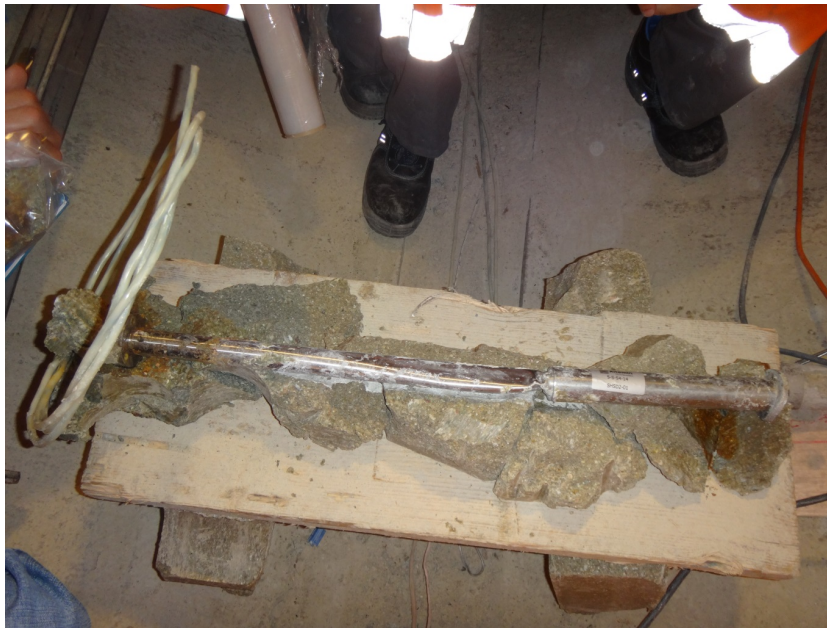
Fig. 67: Extensometer in S54 and reconstruction of samples behind it.

- Locations of cores B-C-53-1 to 6 were changed with respect to the original sampling plan.
- Sampling Section S54 was located in bentonite layer 24:
  - New samples for microbiological analysis were taken (B-C-54-22 to B-C-54-30).
  - New samples of protrusions inside the liner holes (BM-S-54-P1 to P17).
  - Extra samples around the extensometers SHSD2-01 and 03 were taken (Fig. 40).

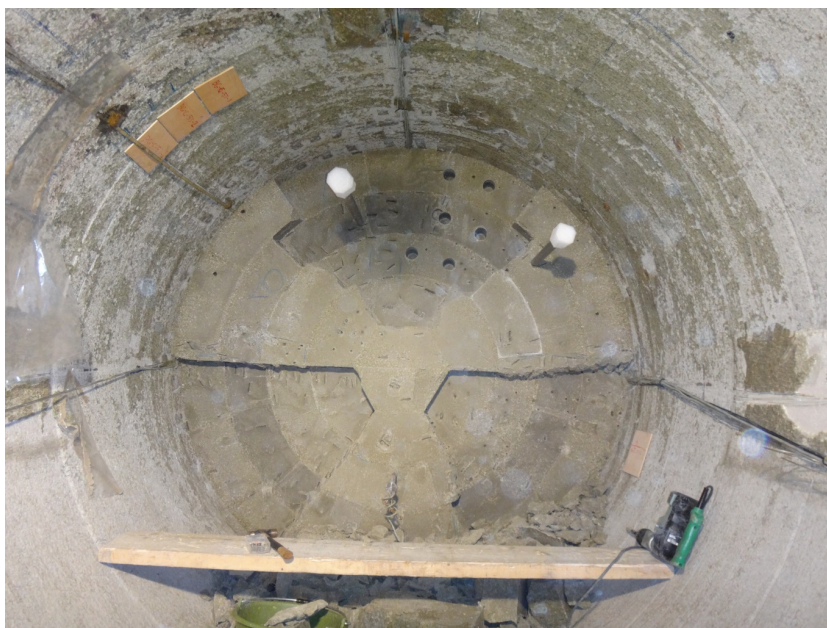
Fig. 68: Protection of Section S57 before beginning of its sampling.

- Sampling Section S55 that was located in bentonite layer 23:
  - New samples were taken, the vertical diameter of blocks (BB-55-1 to 10).
  - Core B-C-55-1 was not taken.
- Sampling Section S56 was located in bentonite layer 22:
  - 9 new samples for microbiological analysis were taken (B-C-56-67 to 75).
- Sampling Section S57, which was located in bentonite layer 19 (Fig. 68):
  - Cores B-C-57-1 to 6 were taken from a different location than initially planned
  - A new sample containing carvings in the bentonite was picked.

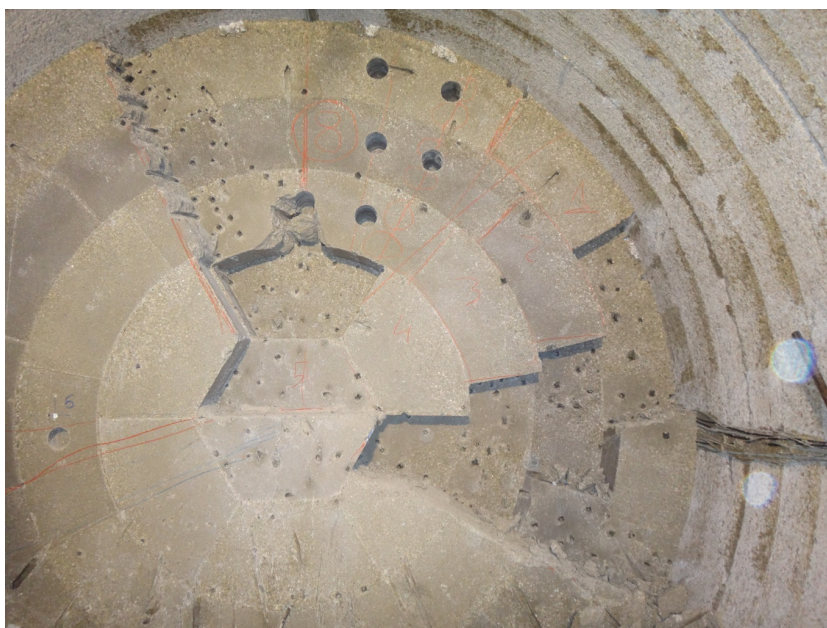
Fig. 69: Partial dismantling of S59.

- Sampling Section S58 was located in bentonite layers 15 to 13:
  - New blocks sampled in bentonite layer 13: B.B-58-1 and 2.
  - New blocks sampled: B-B-L15-1 to 4 and B-B-L14-1 from bentonite layers 15 and 14 respectively.
- Sampling Section S59 located in bentonite layer 8 (Fig. 69): no changes regarding the sampling plan.

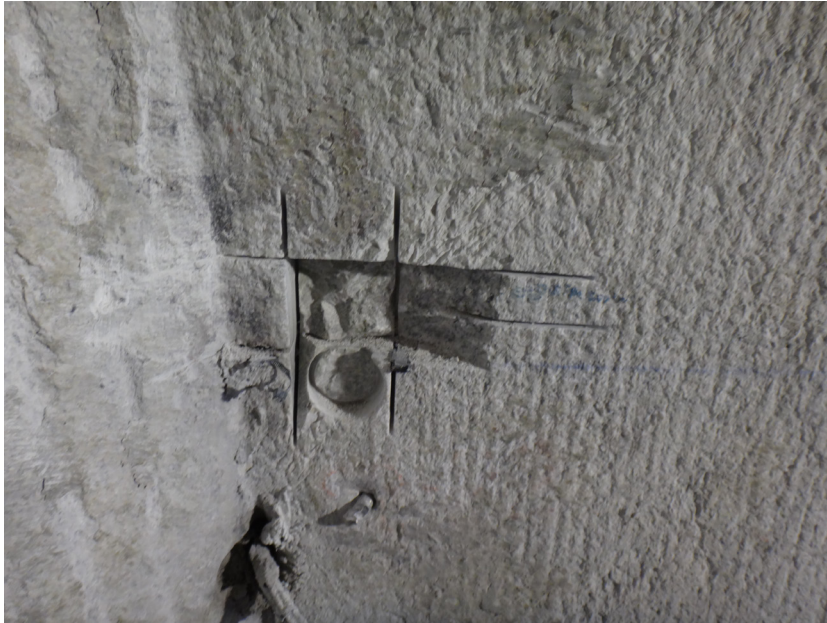
- Sampling Section S60, which was located in bentonite layer 5:
  - It was decided not to take samples BG-C-60-1 and 2.
- Sampling Section S61 that was located in bentonite layer 4:
  - Sample BG-C-61-2, the granite was cut with the help of a radial saw because the drilling bit was broken in the previous granite coring (see Fig. 70).

Fig. 70: Granite cut made with radial saw.

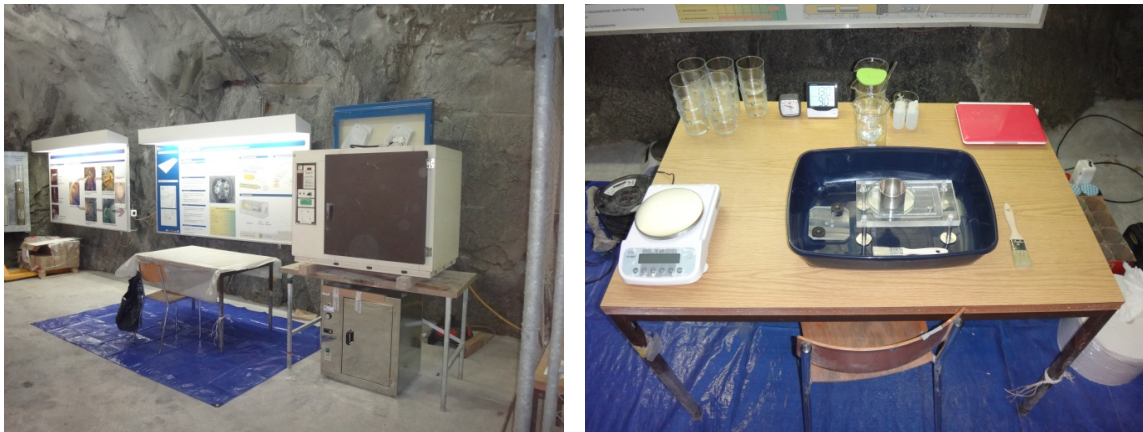
Fig. 72: In situ laboratory, general view at the left hand side and detail of the equipment at the right.

As shown in Fig. 72, the laboratory was installed in a ventilated place of GTS, very close to the location of the computers that control the FEBEX in situ test, due to use of mercury for the in situ analysis. The floor was covered with a plastic carpet (blue colour in the figure below) to contain the mercury in case it would overflow from the trays by accident.

- Brush to remove all the shavings
- Cutting tools as knives, cutter, palette knife and saw.
- Clock to control the time it took to analyse the sample.
- Safety accessories such as a mask with Mercury vapors filter and gloves.
- Analysis tools such as liquid mercury, stainless steel vessel, calibrated table, containment tray, pyrex vessels, syringe and glasses.

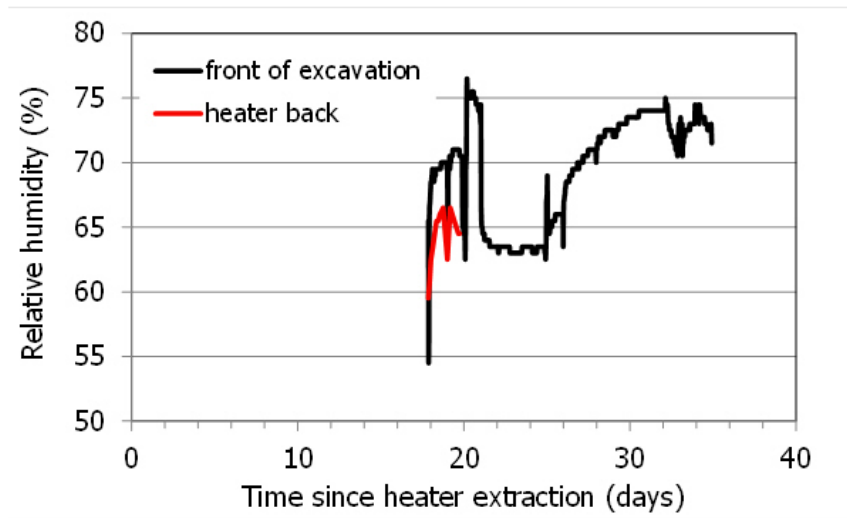
In order to complete the collected data, two portable humidity sensors were located inside the liner once the heater was extracted. One of them was located at the back of the liner while the other one was located at the front. The front sensor was shifted towards the back while dismantling advanced. The recorded data is given by Fig. 73 (Villar et al. 2016).

Fig. 73: Data gathered from the portable humidity sensor inside the liner during dismantling.

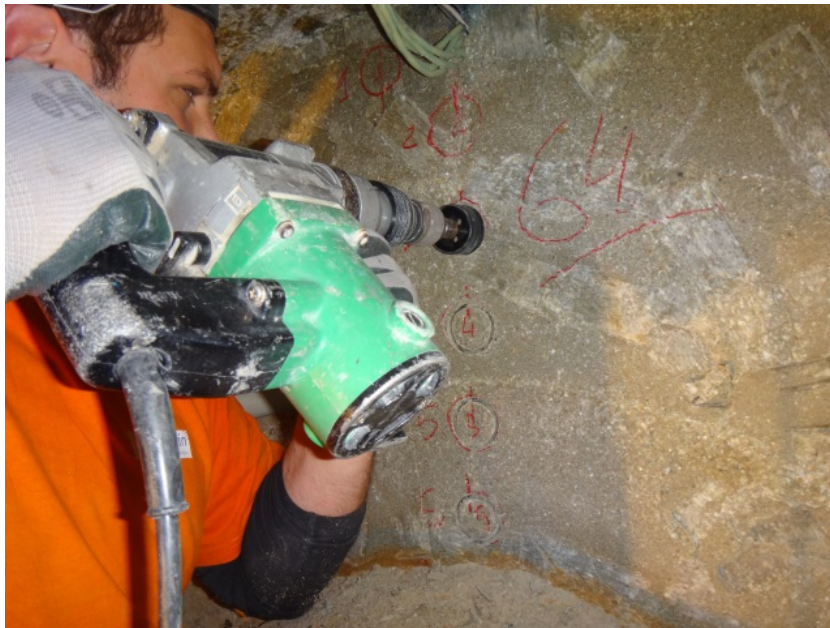
First of all, the locations of the samples to be taken were marked in the bentonite section, according to the sampling book (Bárcena & García-Siñeriz 2015b), with a stainless steel stencil. Then the samples were collected using a hand drilling machine provided with a crown drill bit, as shown in Fig. 74.

Fig. 74: Samples extraction with crown drill.

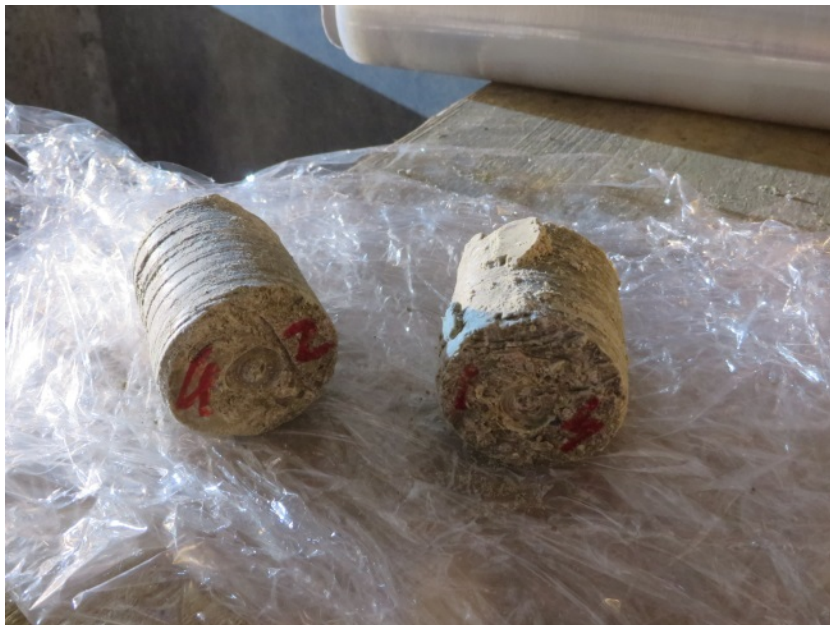
Fig. 75: Covered samples with film.

Once removed, the samples were covered with transparent film to avoid humidity loss until they were analysed, as shown in Fig. 75.

All samples taken for in situ analysis were cylindrical and about 5 cm long and 5 cm in diameter.

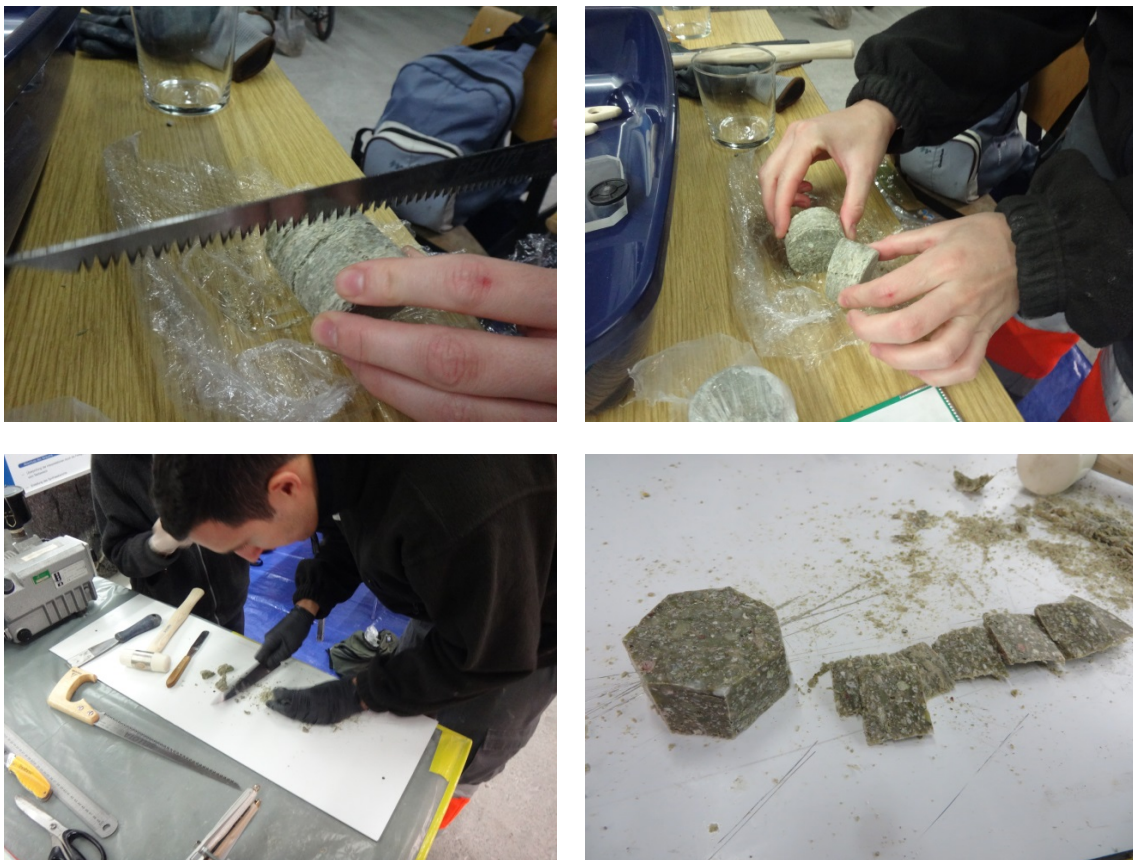
Fig. 76: Samples preparation.

As the humidity at the surface of the samples could be altered by the extraction mechanism, providing potential errors in the water content and dry determination, they were reshaped by cutting/removing the edges.

As shown in Fig. 76, the preparation procedure followed three steps:

1. The samples were cut in two subsamples of about 2.5 cm long each one.
2. Each subsample was molded removing the superficial layer.
3. The subsample was cleaned with a brush to remove the shavings.

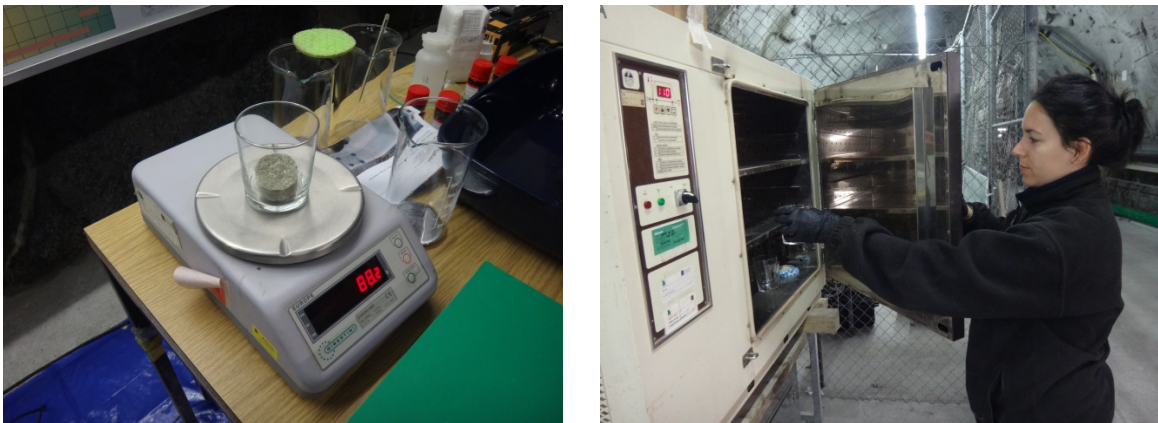
Fig. 77: Procedure for water content determination, weighting at the left hand side and introduction in the oven at the right.

The gravimetric water content ( $w$ ) is defined as the ratio between the weight of water and the weight of dry solid expressed as a percentage.

1. Measure the tare of the crystal glass to be used by weighting it in the scale.
2. Place the subsample in the glass to get the total weight.
3. Introduce the glass with the sample in the oven, as shown in Fig. 77 (right hand side), set at 110 °C.
4. After 48 hours, the glass with sample was extracted from the oven and weighted again.
5. The difference in weight, dry solid, was used to calculate the water content in percentage.

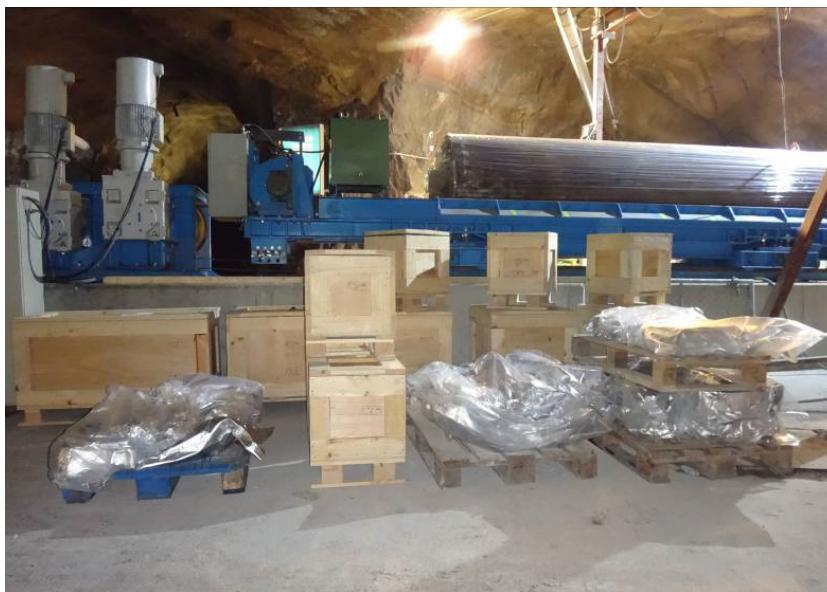
Fig. 79: Area for preparing the shipment of samples.

An large enough area (Fig. 79) located next to the concrete platform outside the drift, at the opposite side of the dump container, was used to prepare the samples' boxes and packages to be sent from the Grimsel URL to the partners' laboratories.

Several wooden boxes were designed, produced and delivered from Spain taking into consideration the expected material to be sent per partner. These boxes contained protection material to ensure the integrity of their content. In addition, two fridges were provided by Nagra at the GTS office for storing those samples that needed refrigeration.

Nonetheless, as the excavation progressed, it became clear that the planned boxes/packages for storing the samples were not sufficient: the size of several samples was increased (see tables with modifications), some partners requested partial shipping of samples and the changes introduced in the sampling program led to an increase of the number of samples.
