Arbeitsbericht NAB 16-12

FEBEX-DP on-site analyses report

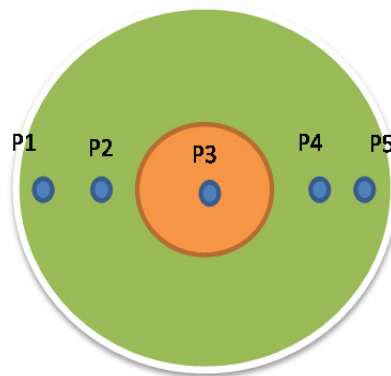
Fig. 7: Location of the points used for measurement of the x -coordinate.

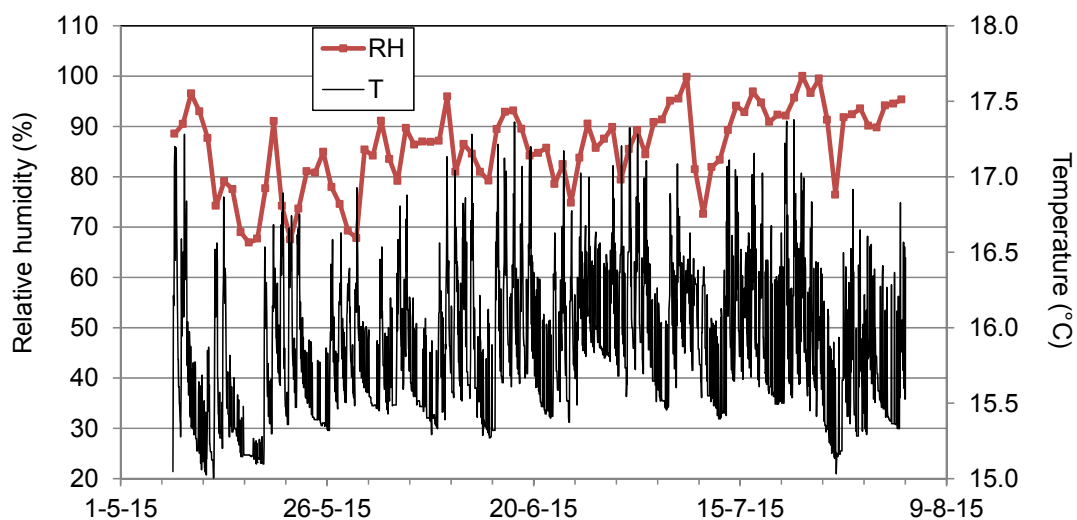
Fig. 8: Relative humidity and temperature in the service area of the FEBEX gallery (at location m. 44) during the bentonite dismantling period.

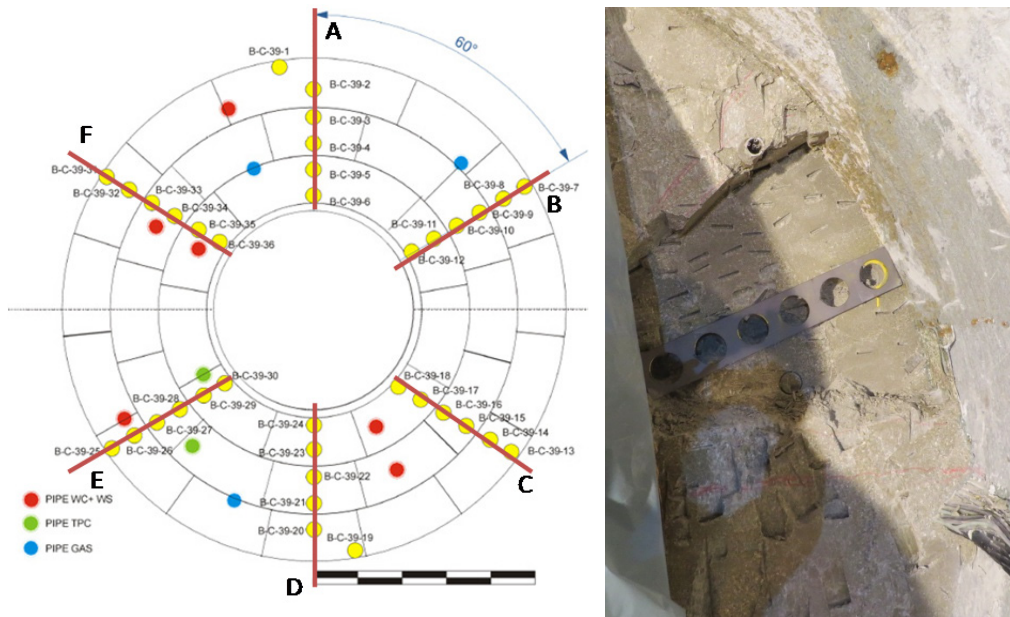
Fig. 9: Position of sampling radii in a section and template used to locate the drillings.

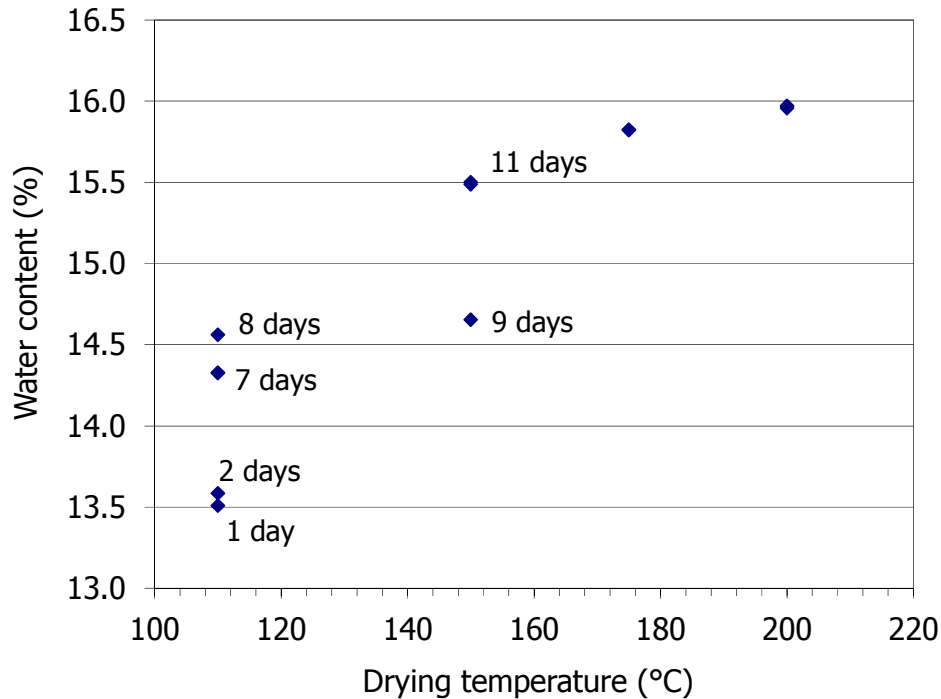
Fig. 16: Effect of drying time and temperature on FEBEX bentonite water content determined at CIEMAT laboratory.

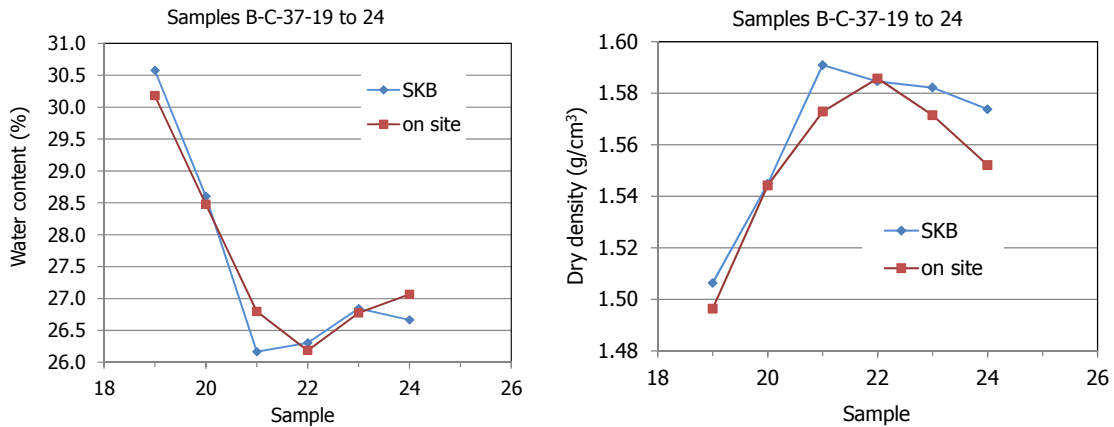
Fig. 18: Water content and dry density of samples from Section 37 (B-C-37-19 to 24, indicated in the x-axes of the figures) as obtained on-site and by SKB.

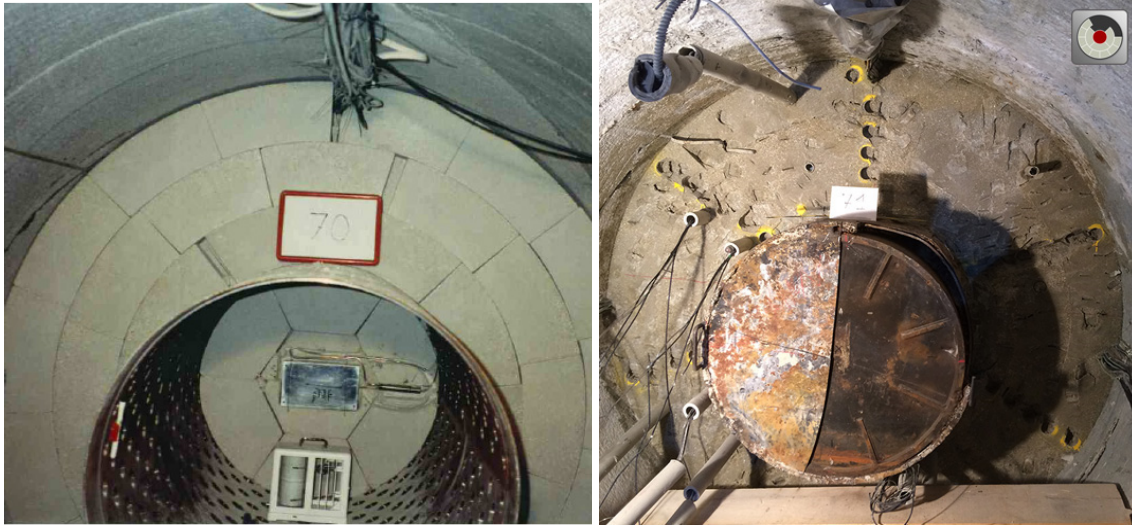
Fig. 21: Initial and final appearance of Slice 70 (Section 37).

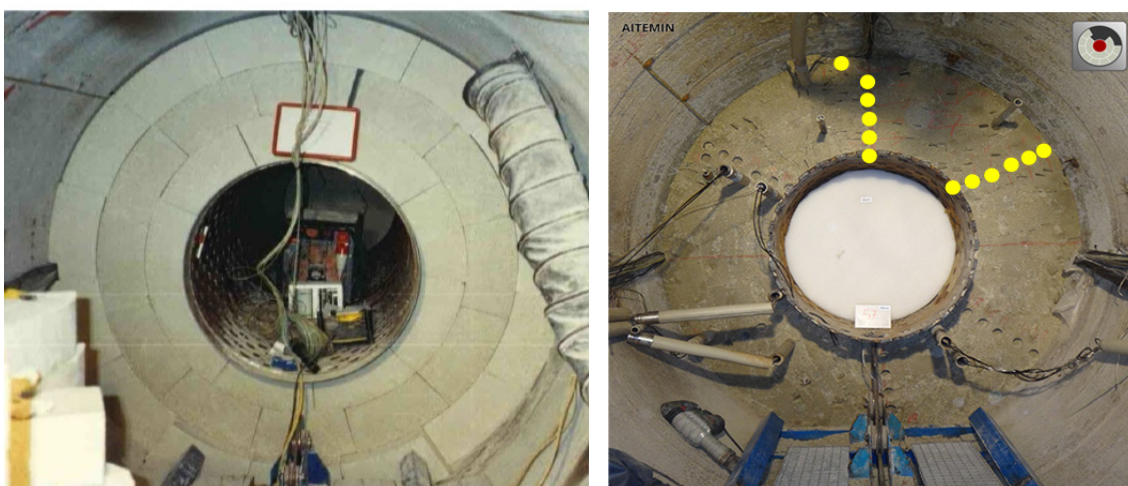
Fig. 38: Initial and final appearance of Slice 57 (Section 43).

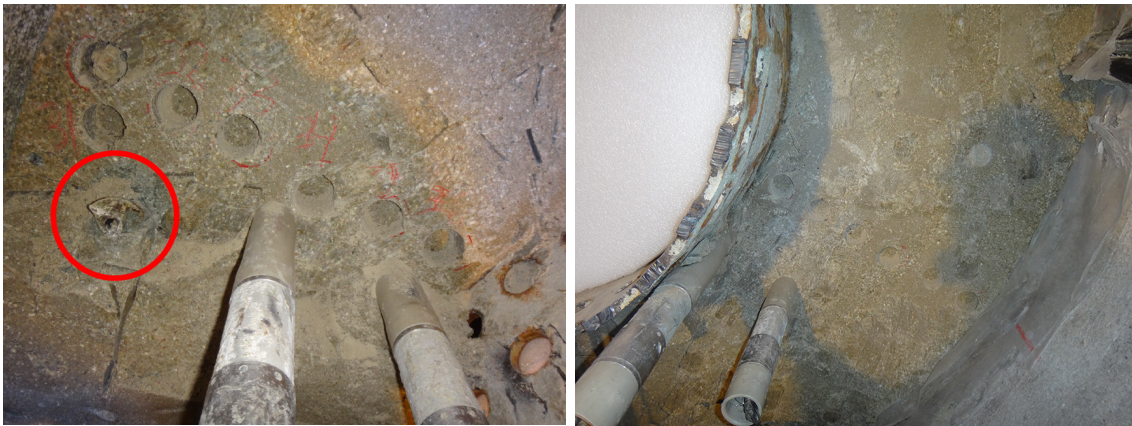
Fig. 39: Upper left part of the barrier showing the pipes and the corrosion halo around an abandoned drill bit (left) and lower right part of the barrier with the plastic sheet between granite and bentonite (right).

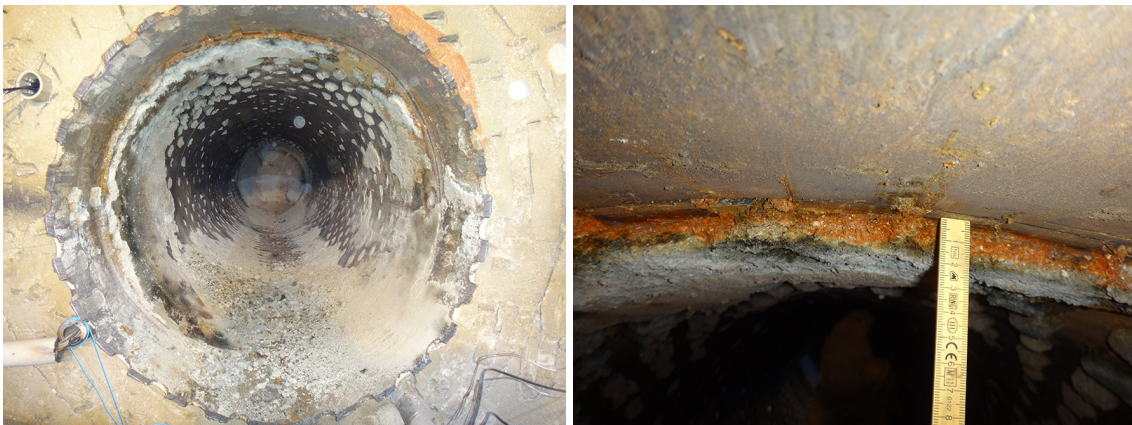
Fig. 40: Appearance of the bentonite intruded between the liner and the heater after extraction of the heater.

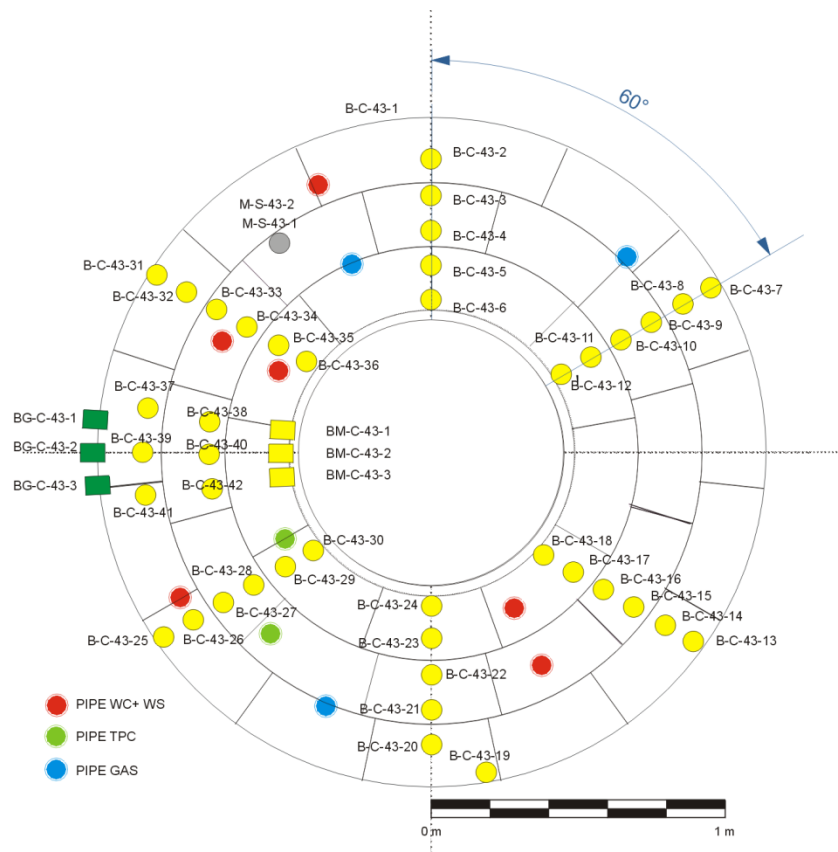
Fig. 41: Location of samples taken in Section 43 (sample B-C-43-19 was finally taken aligned with the others in Radius D).

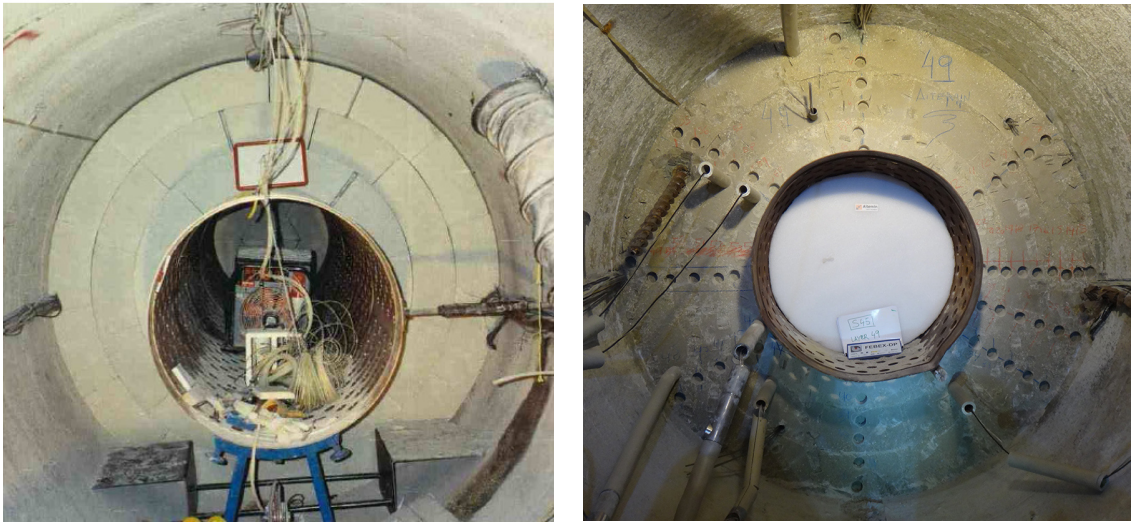
Fig. 48: Initial and final appearance of Section 45 (Slice 49).

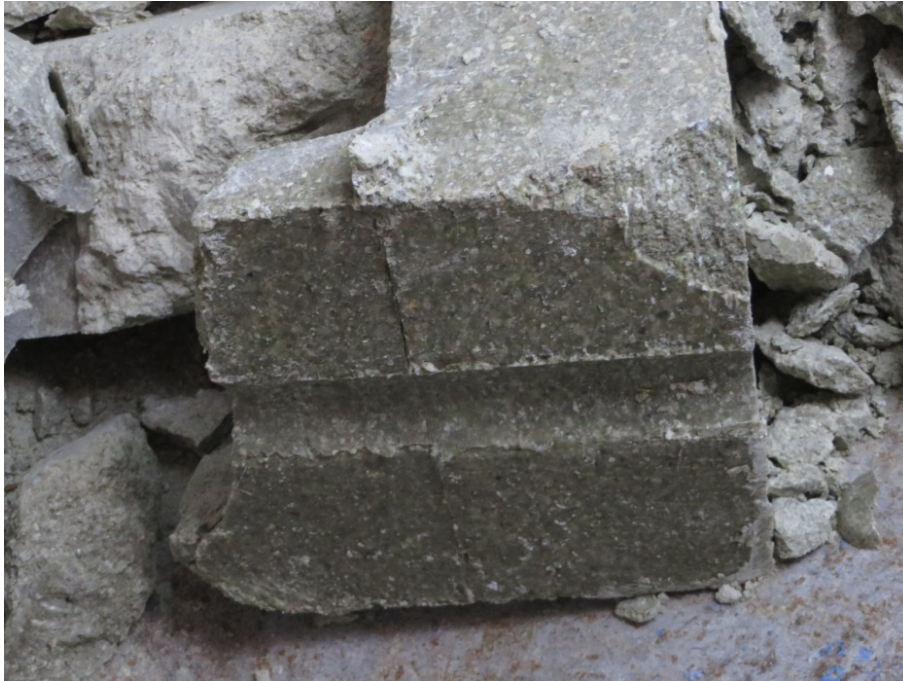
Fig. 103: Appearance of blocks from Slices 52 and 53 retrieved together showing that mechanical bonding occurred.

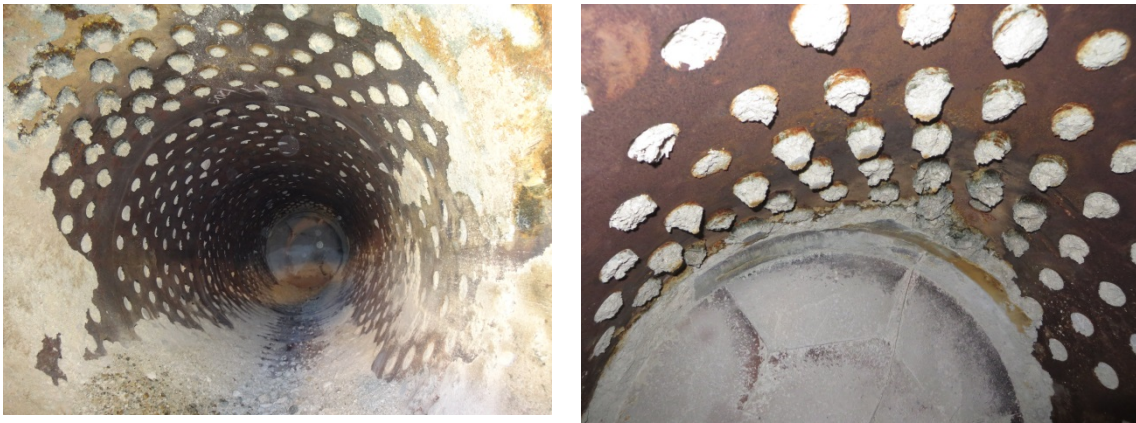
Fig. 106: Bentonite intruded inside the liner.

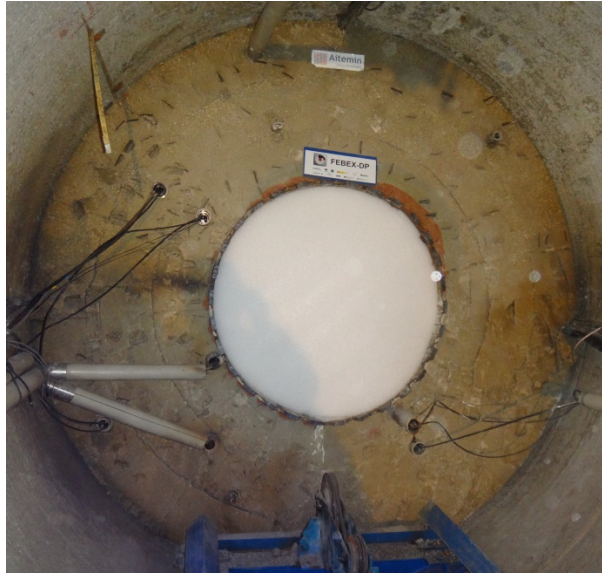
Fig. 125: EPS plug placed at the front of the liner once the heater was extracted.

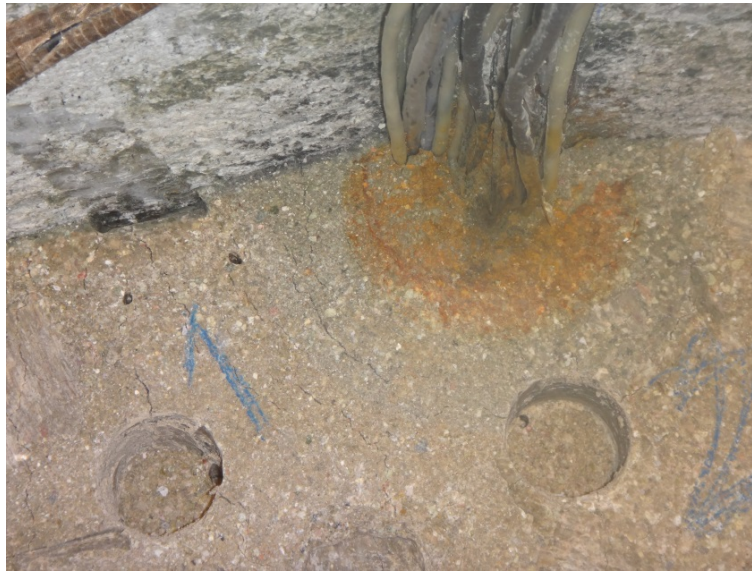
Fig. 126: Desiccation cracks upon exposure of Slice 43 (June 29th 2015)
