Arbeitsbericht NAB 16-21

**Bentonite TDR probe inspection
and data verification report**

May 2017

**National Cooperative
for the Disposal of
Radioactive Waste**

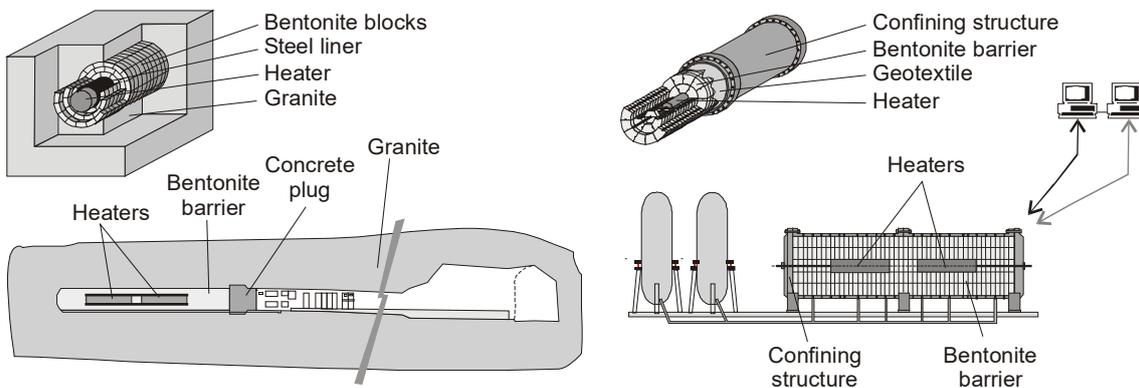
Fig. 1-1: Overall layout of FEBEX in-situ test (left) and mock-up test (right).

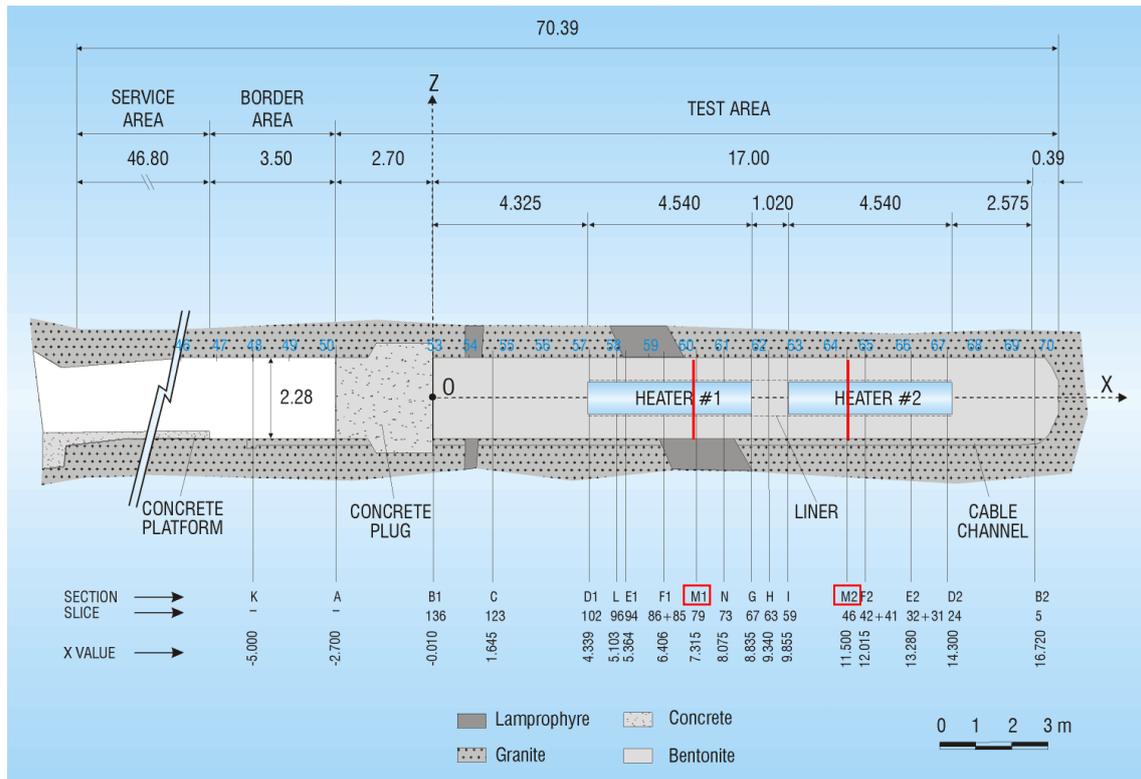
The installation of the in-situ test was carried out at the GTS. A horizontal drift with a diameter of 2.28 m was excavated in the Grimsel granodiorite specifically for this experiment using a TBM (a tunnel boring machine). Two electrical heaters, of the same size and of a similar weight as the reference canisters, were placed in the axis of the drift. The gaps between the heaters and the rock were backfilled with compacted bentonite blocks, up to a length of 17.40 m, this requiring a total 115'716 kg of bentonite. The backfilled section was sealed with a plain concrete plug placed into a recess excavated in the rock and having a length of 2.70 m and a volume of 17.8 m³. Fig. 1-2 shows the dimensions and layout of the test components schematically.

Fig. 1-2: General layout of the FEBEX "in situ" test (FEBEX I configuration).

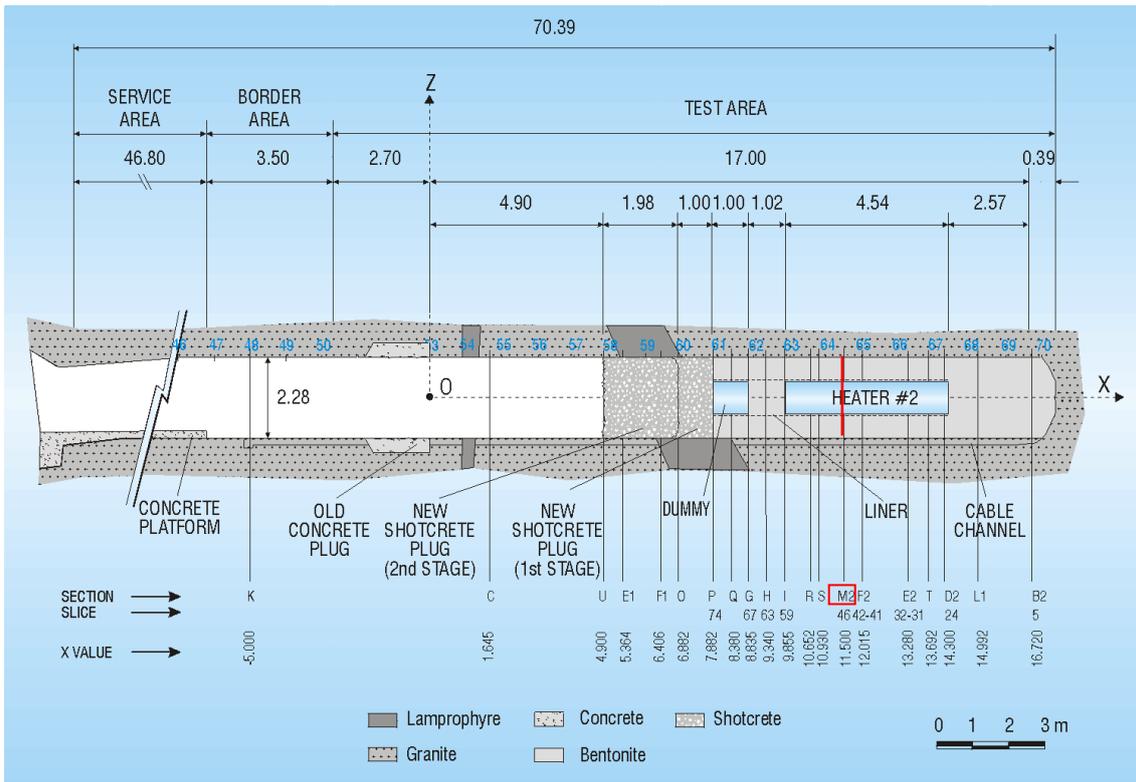
The description of the partial dismantling operation is given in the report "Dismantling of the Heater #1 at the FEBEX "in situ" test. Description of operations" (Bárcena et al. 2003). The configuration of the test, after completing the partial dismantling operation and construction of the full plug length, is shown in Fig. 1-3.

Fig. 1-3: Status of the FEBEX "In situ" test after the partial dismantling (FEBEX II configuration).

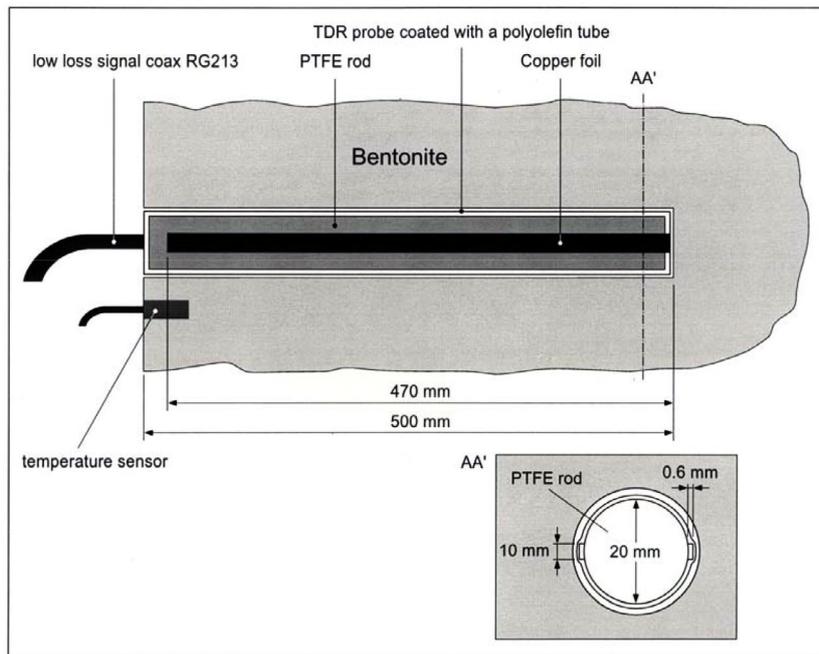
Fig. 2-1: Dimensions of the bentonite TDR probe.

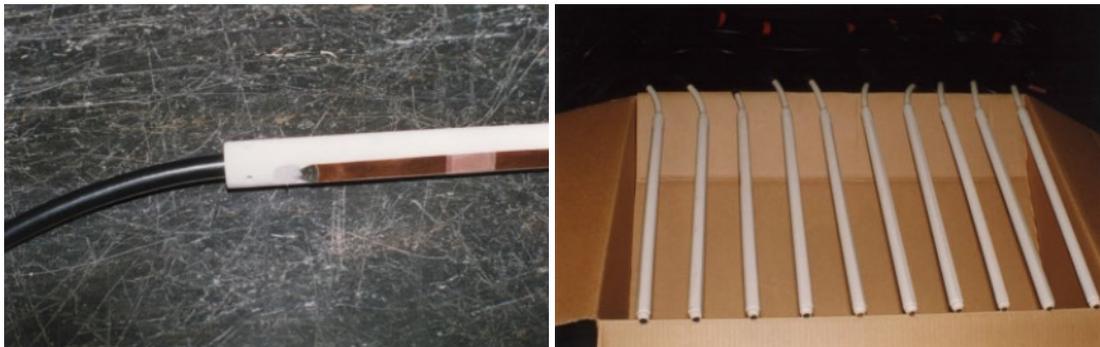
Fig. 2-2: Bentonite TDR probes before installation and without coating (left) and with coating (right).

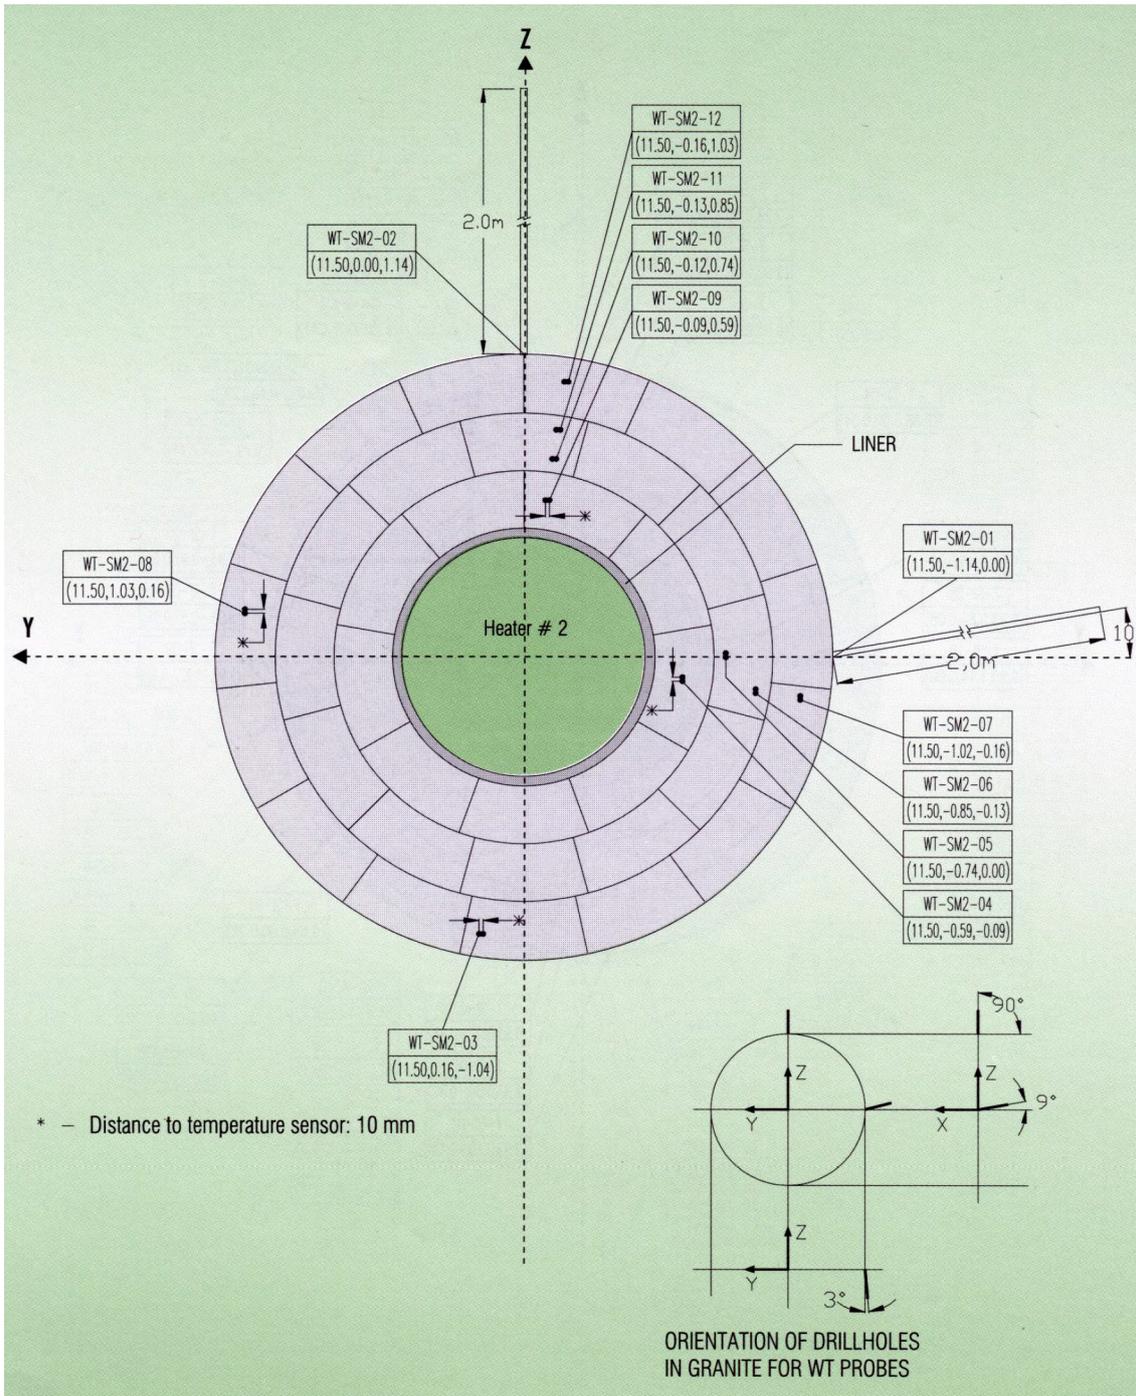
The TDR probes were installed in the bentonite barrier at the positions shown in Fig. 2-3 and 2-4 and Tab. 2-1 (also defined as instrumented Section M2). They were installed parallel to the tunnel axis across slices/layers of the bentonite blocks 46, 45, 44 and 43 (Fig. 2-5), and each slice had a thickness of 12.5 cm, approximately at TM 64.5-65.0 m). For the installation of the probes (parallel to the tunnel axis), 52 cm long boreholes were drilled with a diameter of $22.5 + 0.5$ mm. Small grooves were made on the surface of the bentonite blocks for routing the cables towards the cable channels located in the buffer periphery .

Fig. 2-3: Position of the probes.

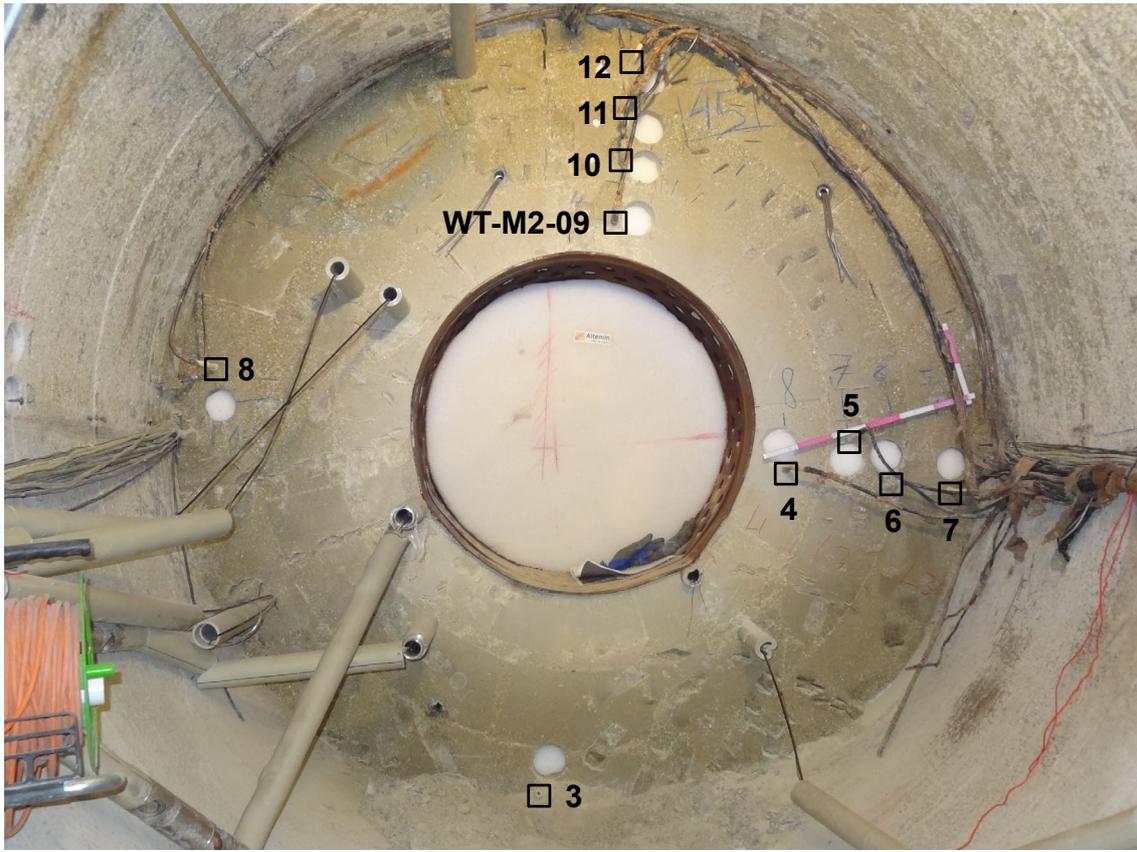
Fig. 2-4: Position of the probes on the face of Slice No. 45.
 Photograph also shows the sampling positions (white circles).

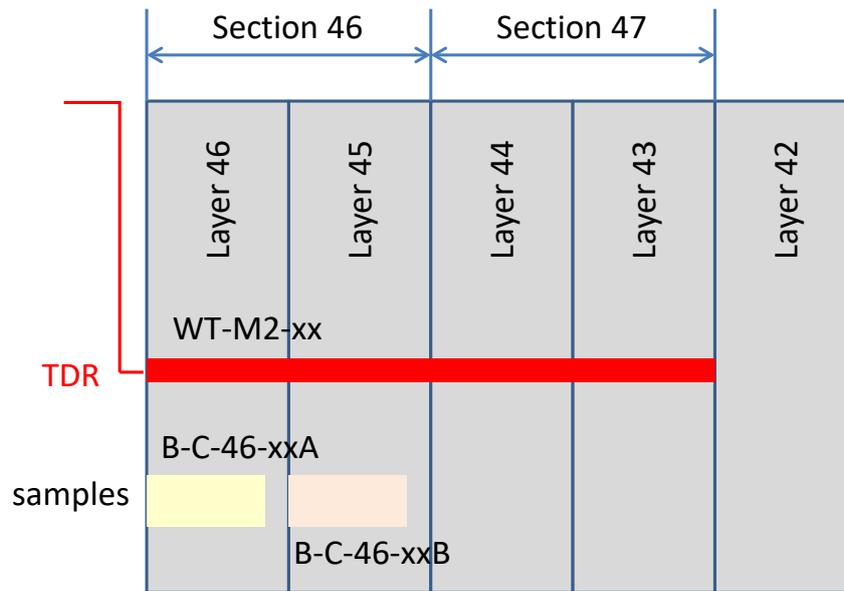
Fig. 2-5: Axial position of the bentonite TDR probe relative to bentonite block slices/layers. Sampling positions are also shown.

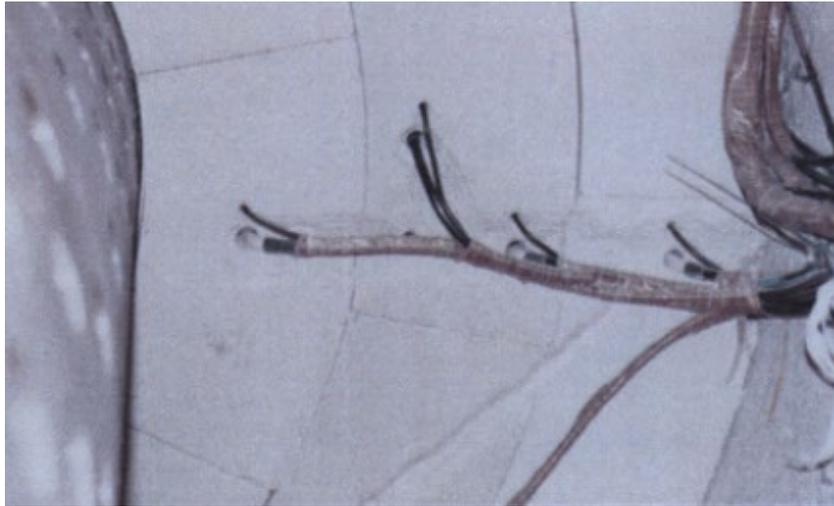
From the outer surface of instrumented Section M2 (bentonite block Slice No. 46), bundles of TDR and temperature sensor cables were routed to the tunnel wall and from there they were loosely attached to the roof and/or the side of the tunnel wall up to the data acquisition devices. As an additional protection, the cable bundles were coated with a Teflon band up to tunnel meter 60.9 (Fig. 2-6).

Fig. 2-6: Installed bentonite TDR probes and temperature sensors in Section M2, bentonite Slice No. 46.

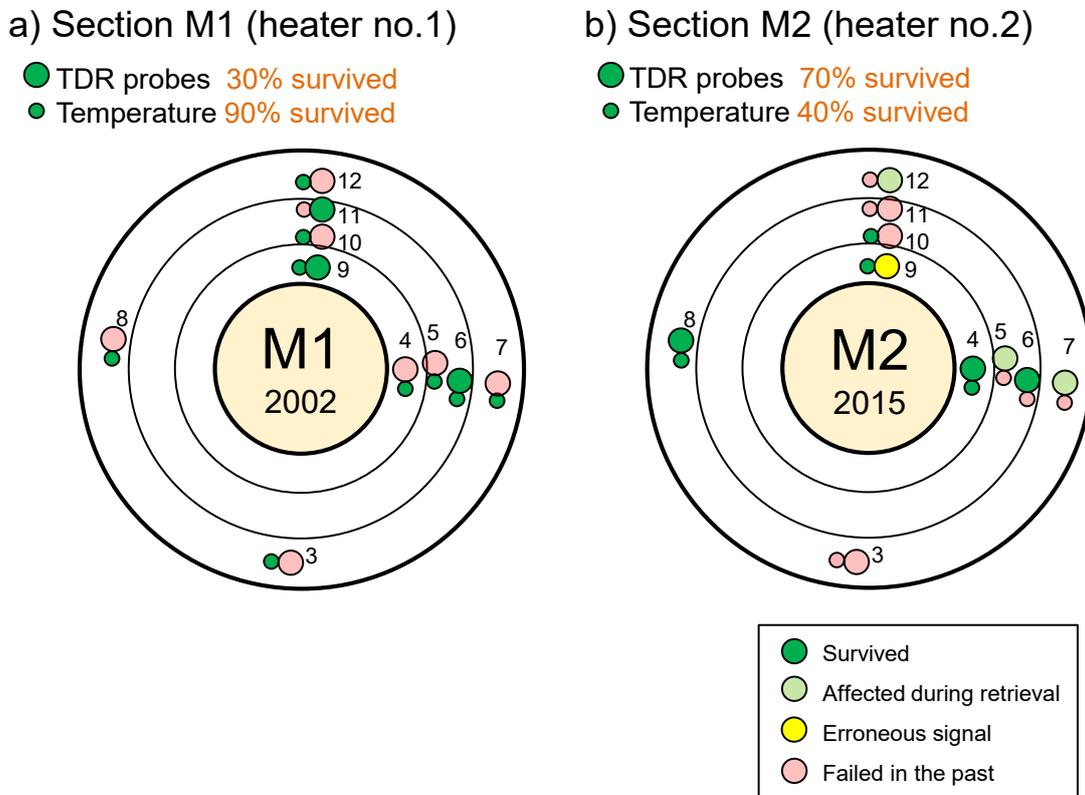
Fig. 3-1b illustrates the functionality of the TDR probes and temperature sensors in Section M2. At the time of dismantling, 40 % of the temperature sensors, and 70 % of the TDR probes had survived (with one TDR probe giving erroneous readings). Despite the significantly long test duration, more TDR probes survived in Section M2 compared to those retrieved in Section M1 in 2002. In the following sections, the retrieval of the TDR probes in Section M2 and the probe inspection results are summarised.

Fig. 3-1: Status of the TDR probes and temperature sensors.

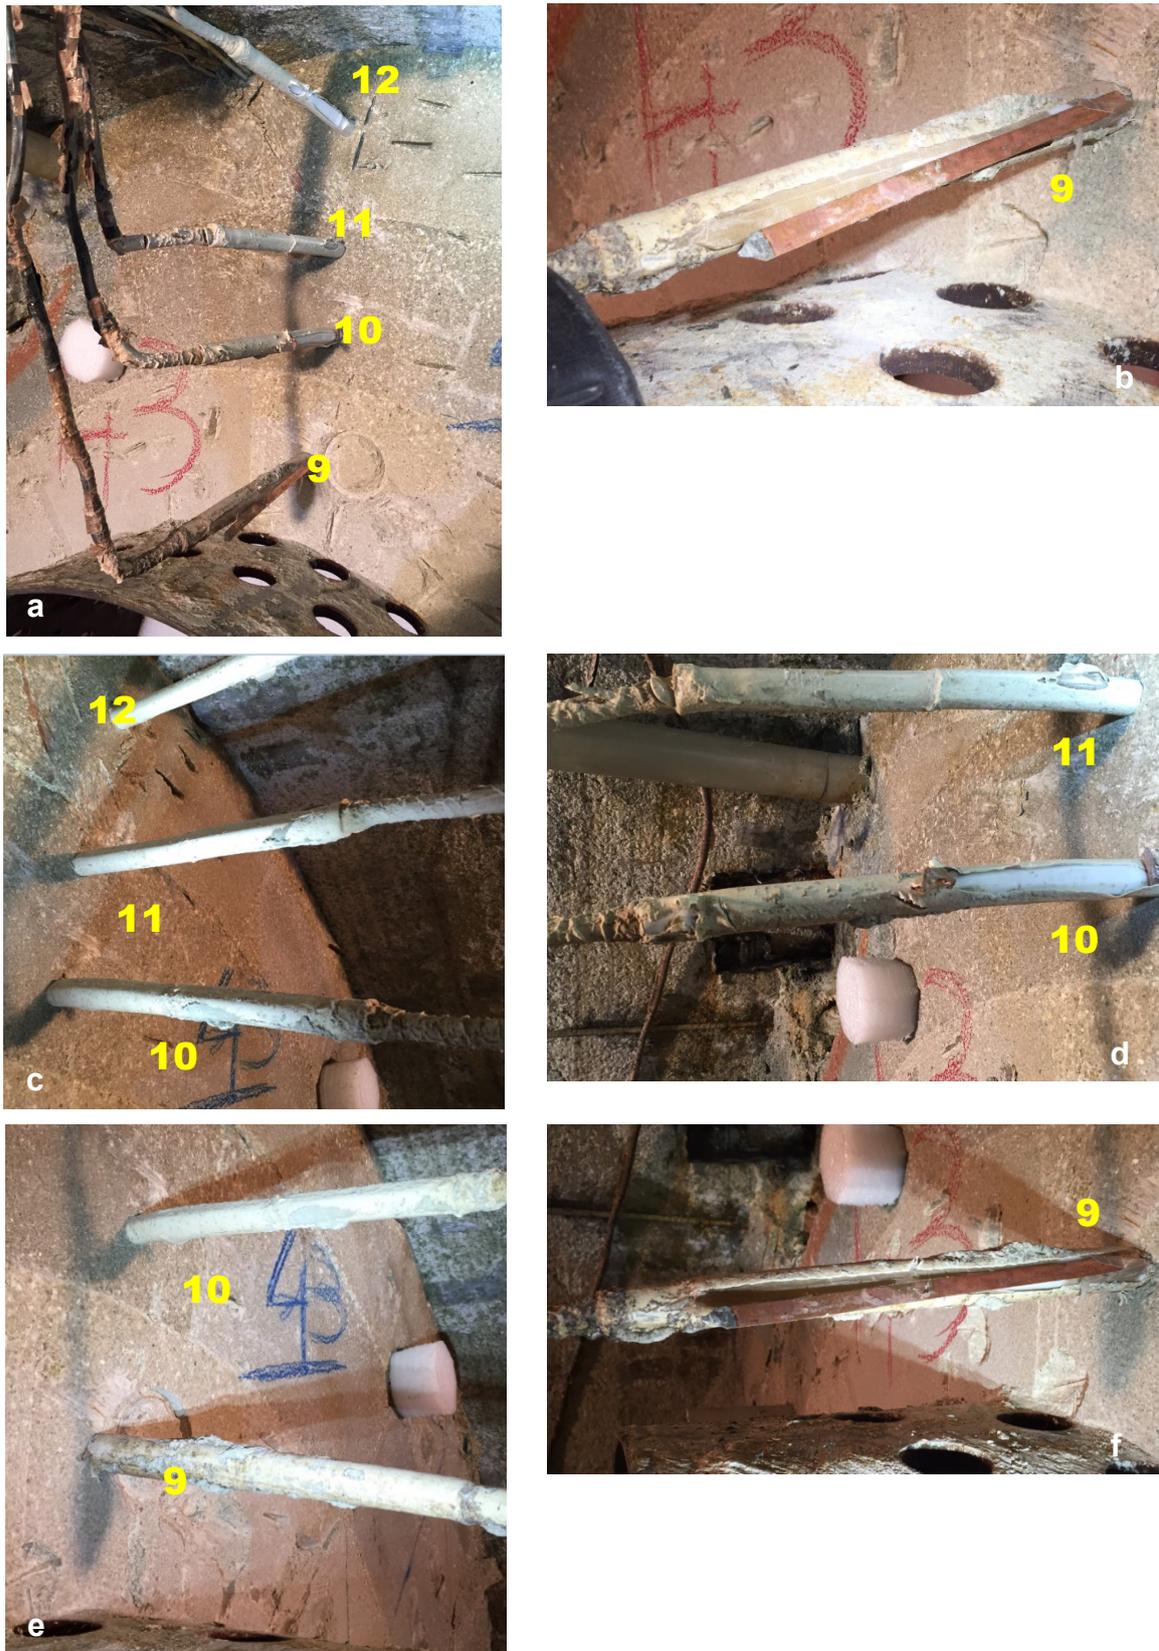
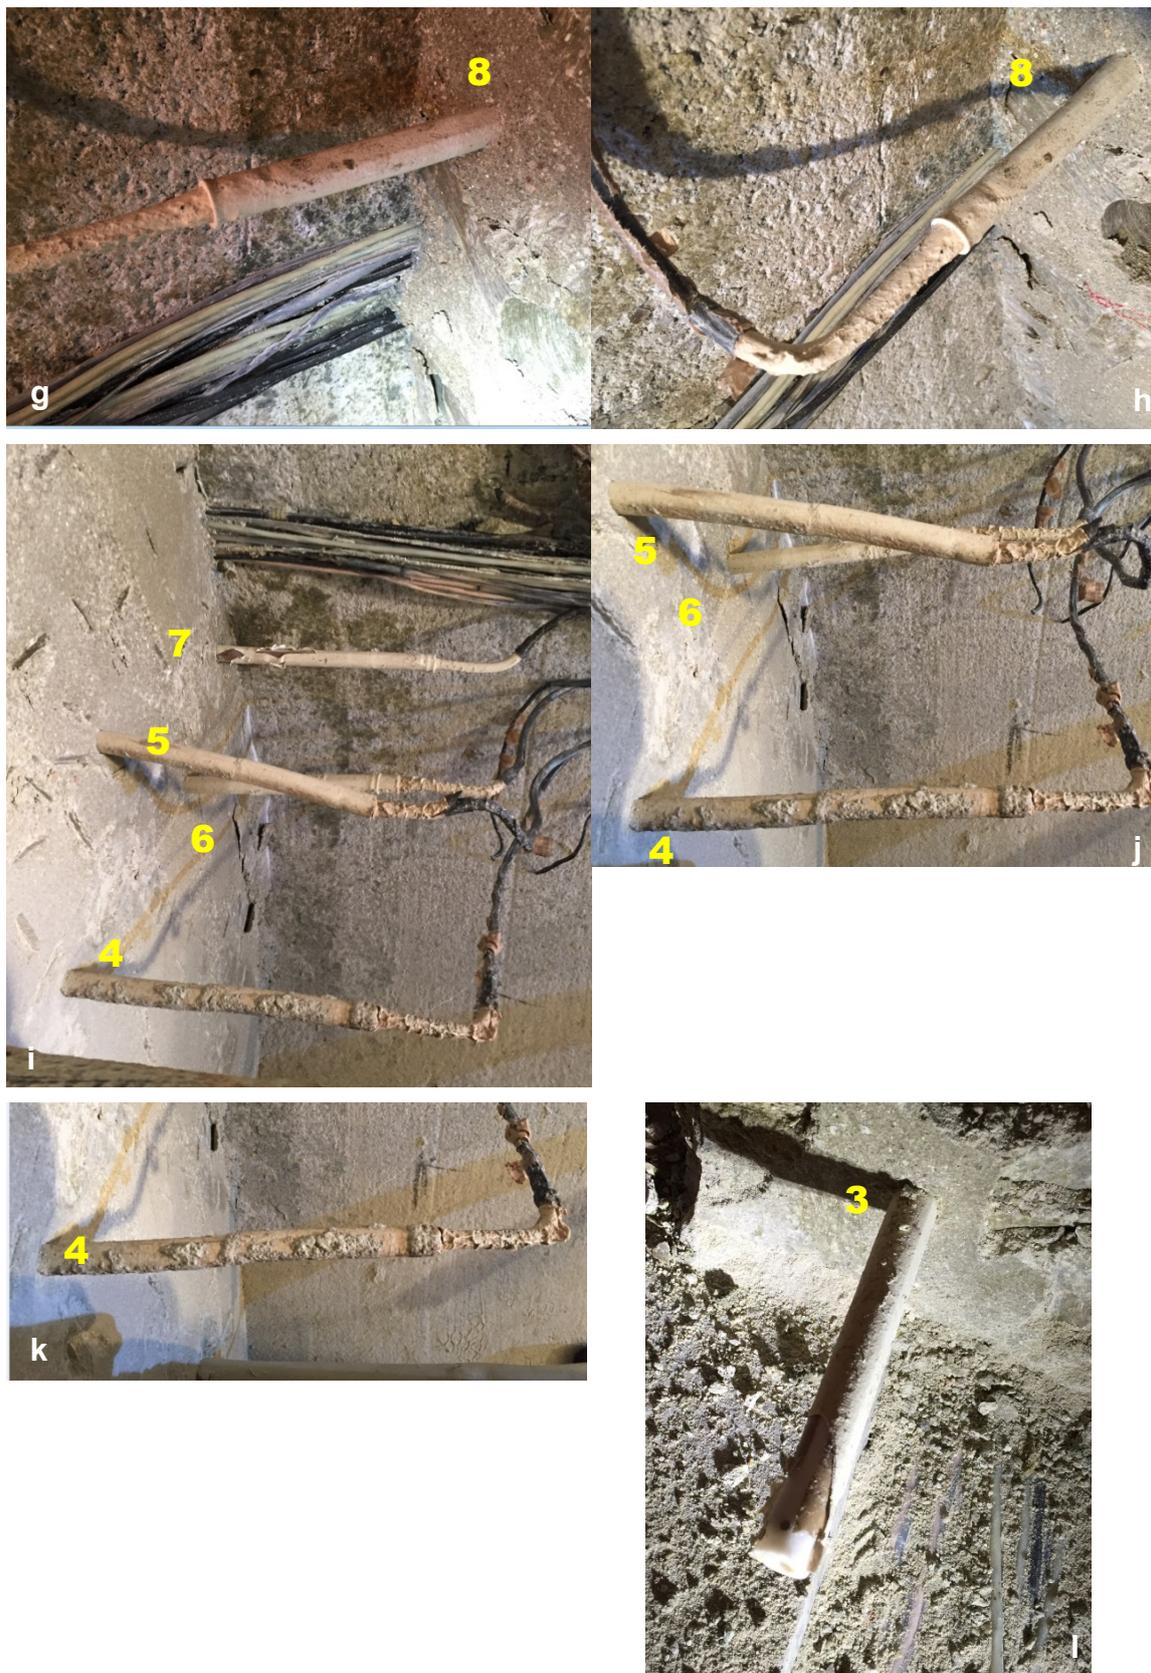
As shown in Tab. 3-1, the retrieval of the 10 bentonite TDR probes took place from June 24 to June 30, 2015. The bentonite block layers were removed in steps using power chisels. Although performed carefully, the chisel damaged the coating film of most of the probes. Fig. 3-1 shows selected photos taken during the removal of bentonite blocks around the TDR probes. The damages on the probes are visible on some photos (for instance a, b, d, f and i). It has to be noted that, as described in the next section, Probe No. 9 seems to have been affected by the heat and moisture. This led to major cracking of the coating film.

Fig. 3-2: Conditions of the TDR probes during dismantling (photos taken by Aitemin).

The first type is mainly characterized by cracking or tearing of the coating film and some of the more severe damage included partial scraping of the coating film, electrode and Teflon rod by the power chisel. The second type included; cracking of the surface coating film, shearing at the bentonite block joints and cracking of the cable protection. The observations are summarised in Tab. 3-2 and detailed photos are shown in Appendix A. Note that because of the damage, the probes were not re-calibrated. After finishing the TDR probe inspection, the co-axial cables were cut, the probes were taken out of the FEBEX tunnel, and the measurements were stopped mid-July.

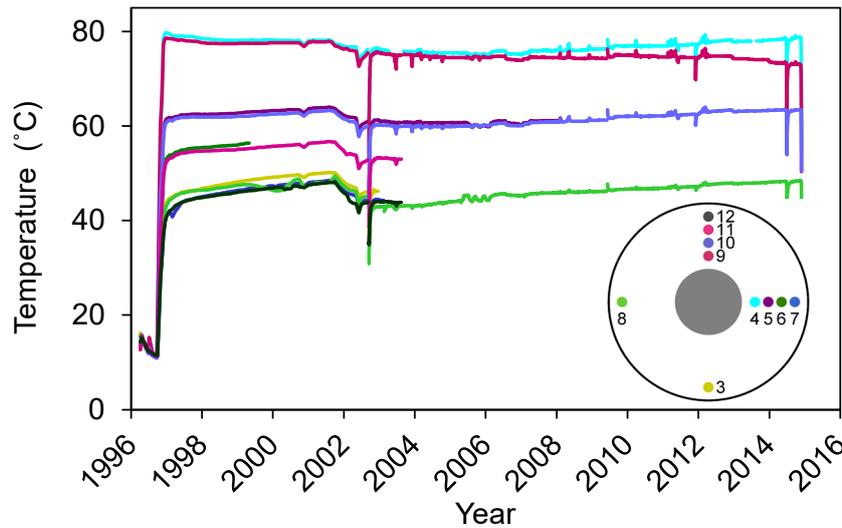
Fig. 4-1 shows the 18-year evolution of the temperature in the bentonite blocks in Section M2. The temperature stabilised within the first 2 – 3 months with a distinct gradient in the radial direction. Power shut-off of heater No. 1 took place in 2002; at some distance away this was registered as a gradual decrease everywhere whereas unexpected power loss of Heater #2 in 2003 caused a significant and sudden temperature drop. As will be noted later in more detail, half of the temperature sensors failed by early 2004.

Fig. 4-1: Changes in temperature in the bentonite blocks around Heater #2 provided by temperature sensors associated to TDR probes (Schlaeger et al. 2016).

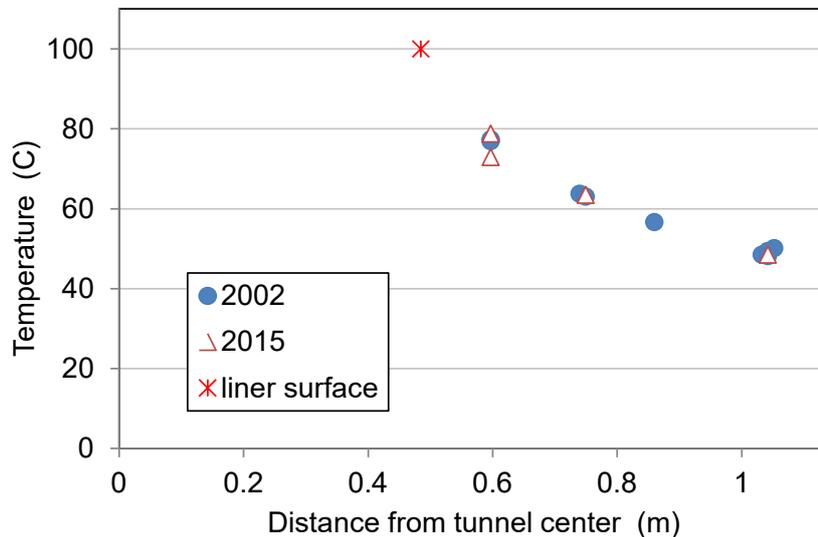
The temperature gradient around Heater #2 just before switching off in 2002 and 2015 is plotted in Fig. 4-2. The heater surface temperature is also plotted at the position of the liner surface. A strong radial gradient is seen with very little variation between 2002 and 2015. The data in 2002 are along two different transects showing the radial gradient has negligible spatial variation.

Fig. 4-2: Radial temperature profiles in the bentonite blocks around Heater #2 in 2002 and 2015.

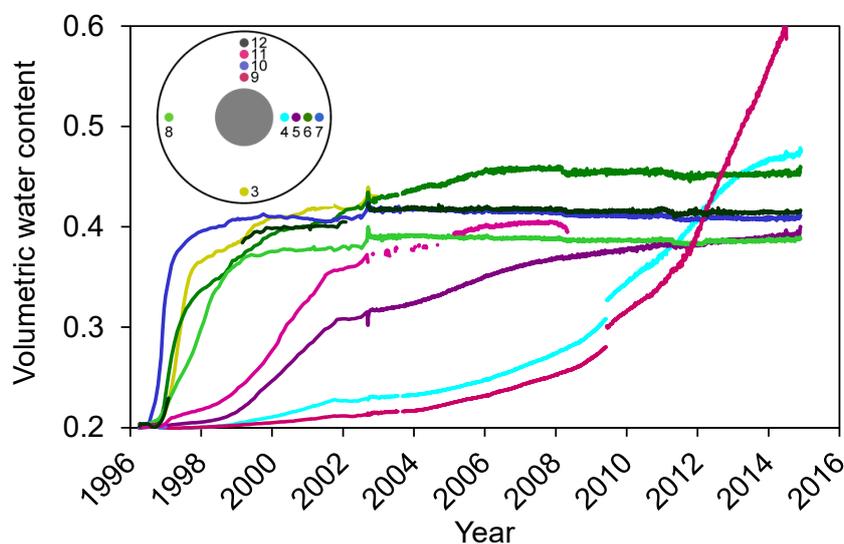
During the overheating incident in late 2009, two TDR probes close to the heater (WT-M2-04 and 09) showed a clear jump in VWC. After this incident, the increase in water content indicated that both of these probes were probably affected. The overheating led to the generation or enhancement of surface coating cracks on these probes which led to water/vapour intrusion inside the probes.

Based on the inspection of the probes described in the previous section, the coating film of these probes was damaged. With a trace of water observed inside the probe, it was suspected that the overheating had caused the damage on the coating film, allowed water to seep in, and led to an overestimation of VWC although to a different extent. Nonetheless, one of these two TDR probes (WT-M2-04) indicated that VWC reached its maximum finally after ~ 17 years just before the dismantling. The other one (WT-M2-09) which was found more heavily damaged, on the other hand, kept showing an unrealistic increase.

Fig. 4-3: Changes in water content provided by the TDR probes in the bentonite blocks around Heater #2 (Schlaeger et al. 2016).

As noted earlier, the VWC data shown in Fig. 4-3 seem to have drifted due to unquantifiable changes in the temperature correction and/or the effect of damage to some of the probes over the long monitoring period. The exact values of VWC is known only in year 1997, 2002 and 2015. The VWC data were subjected to re-scaling so that their values at these three times satisfy the findings described above.

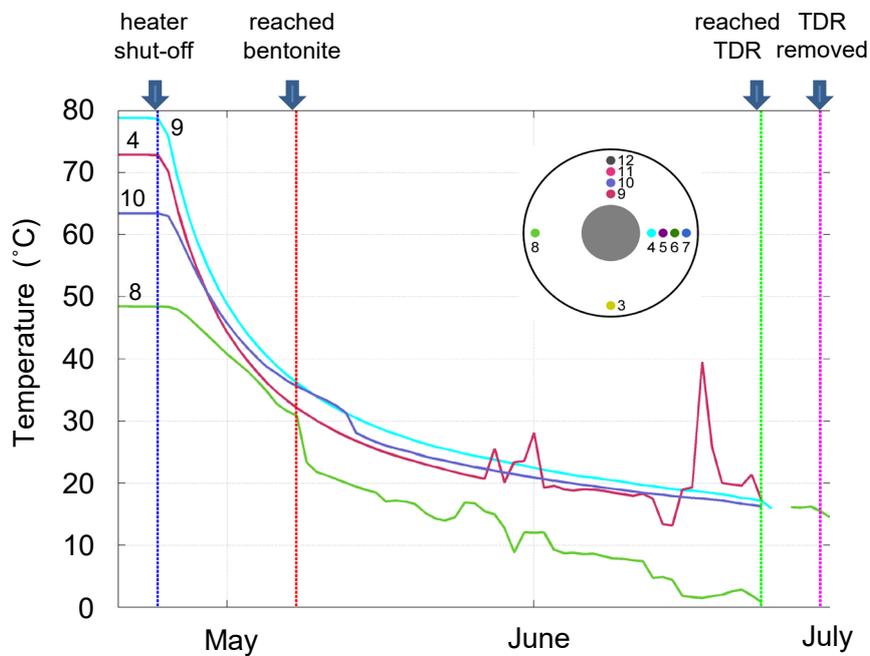
The temperature data from mid-April 2015 (when the dismantling started) until the end of June 2015 (when excavation reached the TDR probes) are shown in Fig. 4-4. At the time of the dismantling, four out of ten temperature sensors were still functional. Sensor No. 08 exhibited unstable readings after the demolition of the concrete plug was completed. It was presumed that the sensor cable got damaged during the removal of the concrete plug. The remaining three sensors showed a temperature of about 16 – 17 °C when the excavation reached the bentonite slices where the TDRs and temperature sensors were installed. Note that temperature sensor 08 started showing about 16 °C afterwards. The temperature values before and after the heater shut-off are summarised in Tab. 4-2.

Fig. 4-4: Temperature recordings in Section M2 during the excavation period, April – June, 2015.

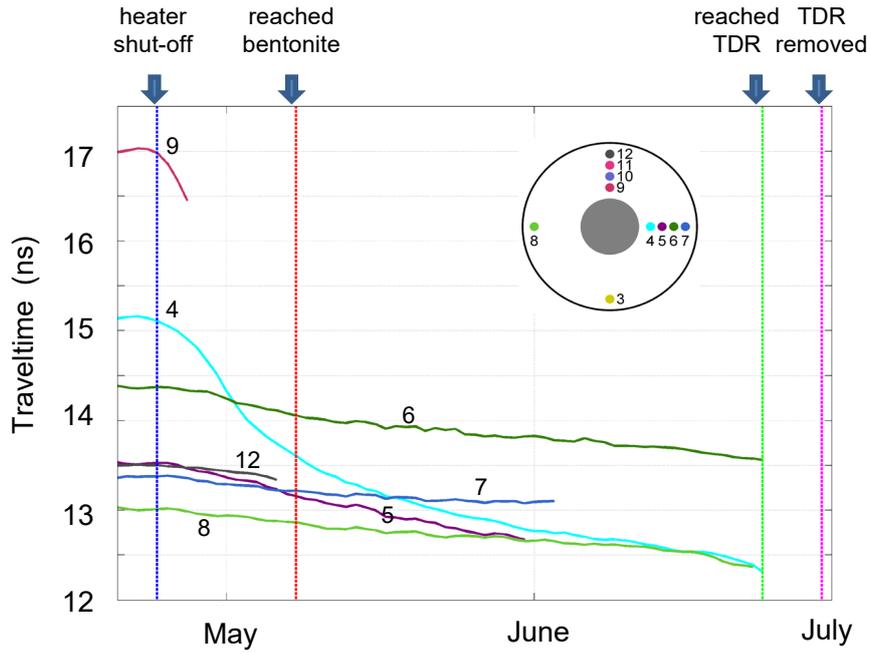
Fig. 4-5 shows the TDR travel time changes after the heater shut-off. Probes 4 and 9 (close to the heater) showed an abrupt decrease whereas the others showed a rather gradual decrease. Furthermore, likely due to some damage to the cables before reaching the probes, four probes (5, 7, 9 and 12) started yielding erroneous signals. For those probes, only the traces assumed correct were shown and analysed.

Fig. 4-5: Travel time data of TDR sensors in Section M2 during the excavation period April – June, 2015.

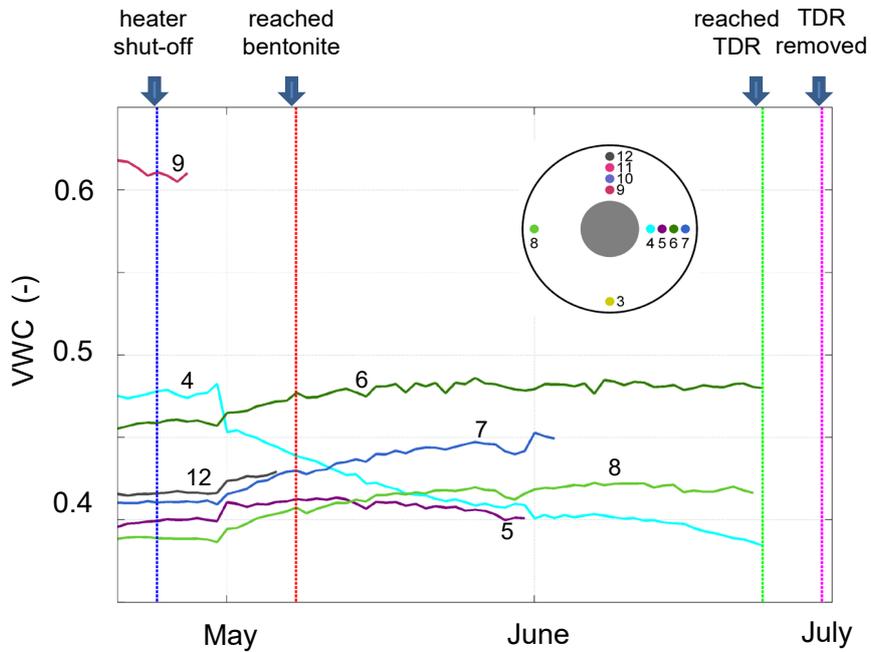
Fig. 4-6 shows the estimated volumetric water content from the travel time with a temperature correction. As noted in the inspection section, TDR No. 9 was severely damaged likely before the dismantling, the high water content value was considered erroneous.

Fig. 4-6: Volumetric water content evolution after heater shut-off April – June, 2015 with temperature correction.

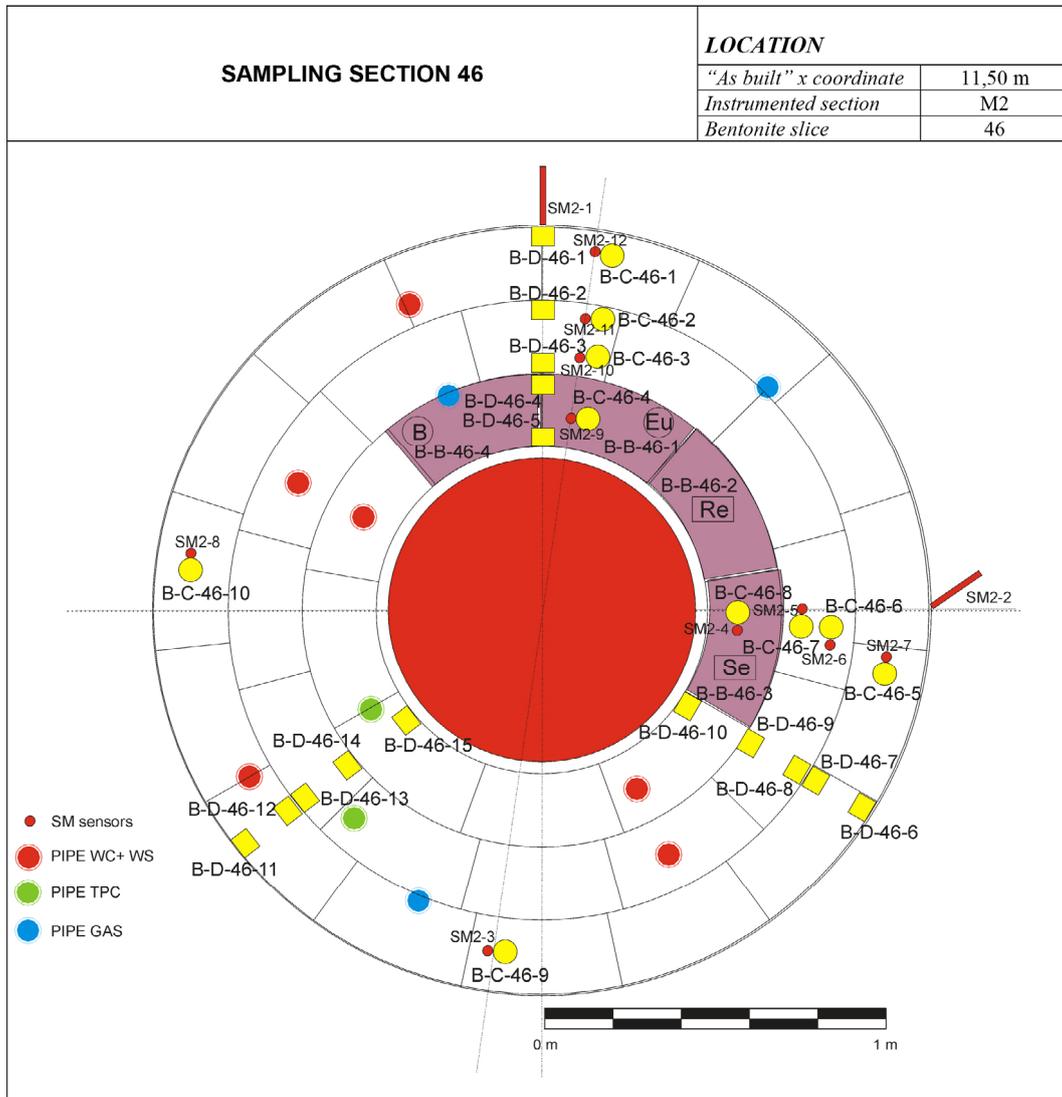
During June 24 – 29, 2015, a total of 20 bentonite samples (B-C-46-1 through 10, two samples in the tunnel axis direction) were drilled in the vicinity of the ten TDR probes for lab analysis. Their positions (from Section 46, Slices 46 and 45) are as shown in Fig. 5-1. The average temperature recorded in the tunnel at approximately 20 m away from the dismantle face during this period was 16.1 °C. The samples were vacuum-packed immediately after the collection and sent to ETH Zürich where the volumetric water content was determined in the laboratory (Plötze 2016). The results are summarised in Tab. 5-1.

Fig. 5-1: Bentonite samples collected near the TDR probes (B-C-46-1 through 10 indicated with yellow circles).

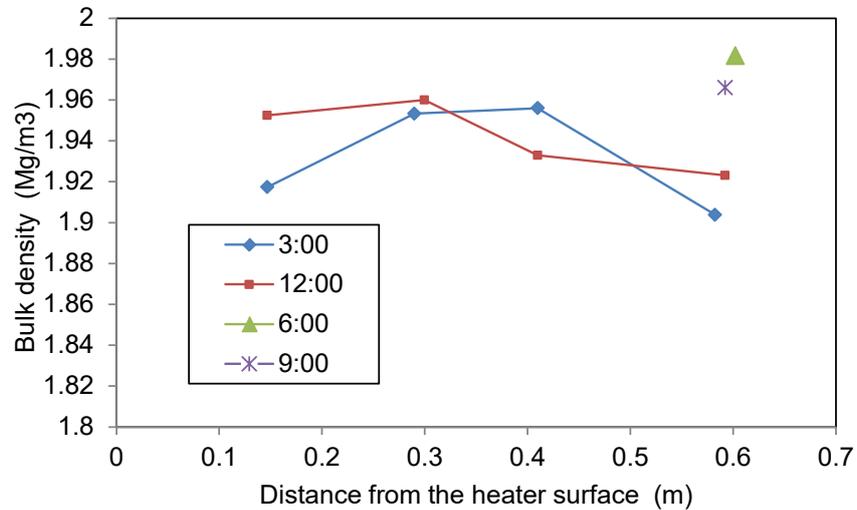
Fig. 5-2 shows the bulk density of the samples as a function of distance from the heater surface. The bulk density ranged from 1.90 to 1.98 Mg/m³ with no distinct trend.

Fig. 5-2: Laboratory sample analysis results (Plötze 2016). Bulk density as a function of distance from the heater. The legend indicates the transect position.

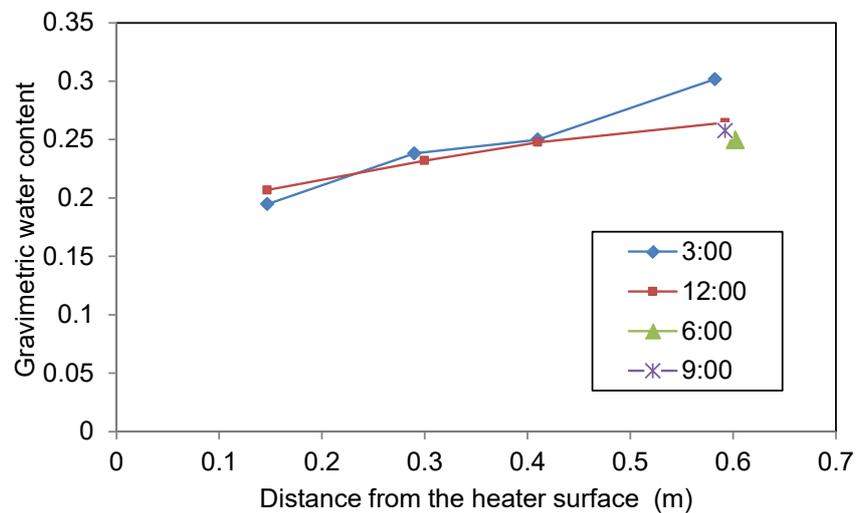
Gravimetric water content in Fig. 5-3 shows, on the other hand, a clear gradient with a highest water content of ~ 0.3 near the tunnel wall and the lowest of ~ 0.2 near the heater surface.

Fig. 5-3: Laboratory sample analysis results (Plötze 2016). Gravimetric water content as a function of distance from the heater. The legend indicates the transect position.

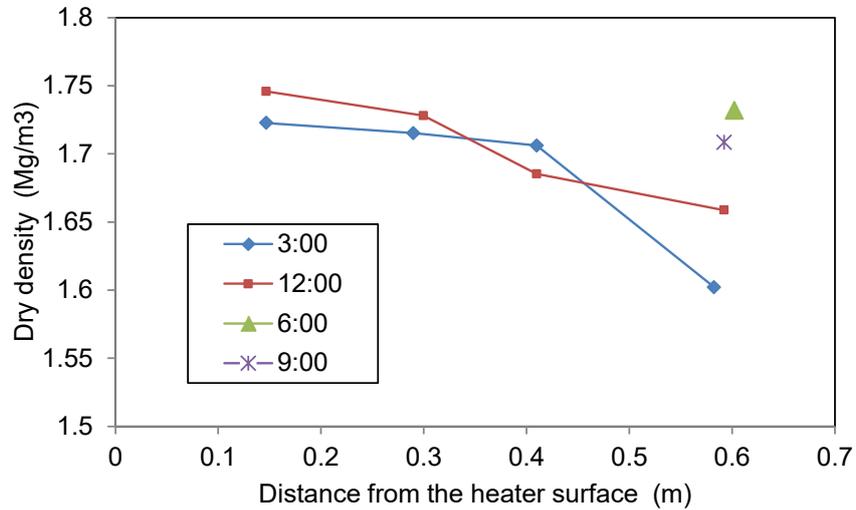
The dry density in Fig. 5-4 also showed a clear trend with the highest value of 1.75 Mg/m³ near the heater surface and lowest of ~ 1.6 Mg/m³ near the tunnel wall. The results from the 6 and 9:00 positions seem to be off-trend from the other two positions.

Fig. 5-4: Laboratory sample analysis results (Plötze 2016). Dry density as a function of distance from the heater. The legend indicates the transect position.

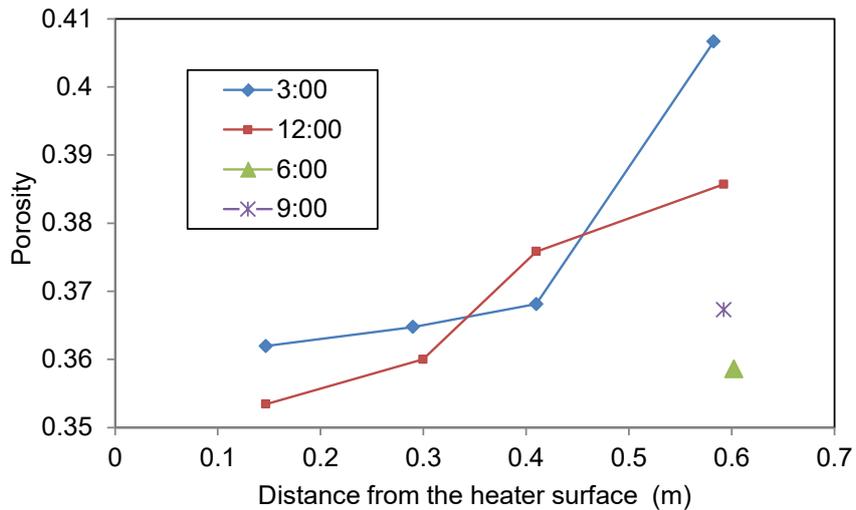
Based on the laboratory sample analysis results, porosity and volumetric water content were estimated assuming a bentonite grain density of 2.7 Mg/m³ (Alonso et al. 2005). The porosity shown in Fig. 5-5 ranged from 0.35 to 0.41 with higher values near the tunnel wall.

Fig. 5-5: Porosity as a function of distance from the heater (estimated from the results by Plötze 2016 using a grain density of 2.7 Mg/m³).

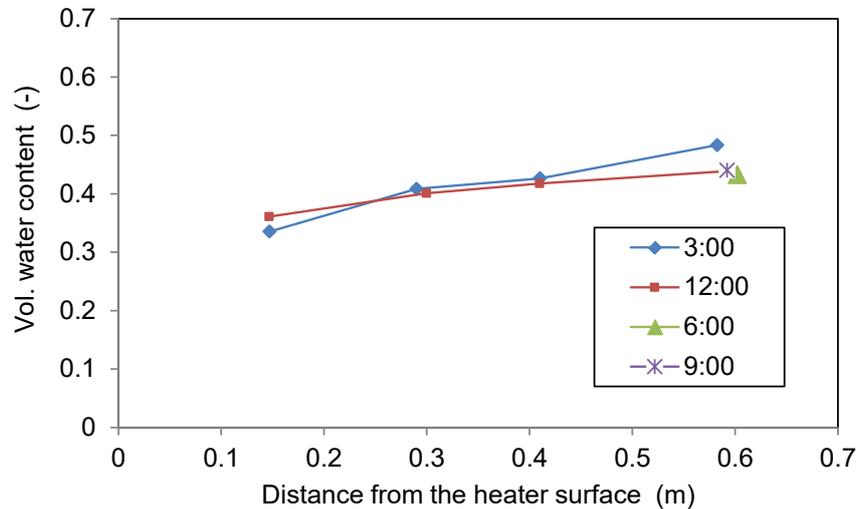
Fig. 5-6 shows the estimated *volumetric* water content of the samples. All the data points follow a similar linear relationship showing lower water content near the heater (approx. ~ 0.34) and higher water content near the tunnel wall (approx. ~ 0.45).

Fig. 5-6: Volumetric water content as a function of distance from the heater (estimated from the results by Plötze 2016 using a grain density of 2.7 Mg/m^3).

The TDR-estimated VWC falls roughly in the range of the VWC of the samples in Fig. 5-6 except for the outlier due to the damage to the sensor. In the next section, the TDR-estimated VWC is further refined.

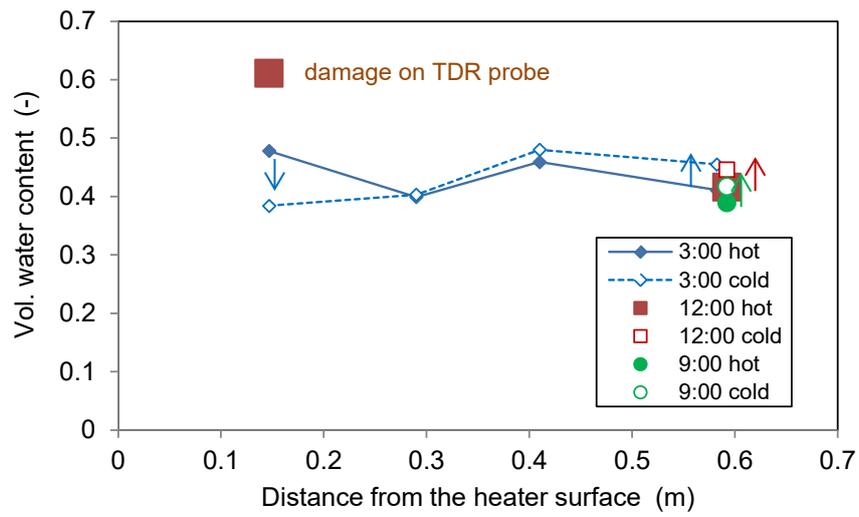
In Fig. 5-7, the TDR-estimated VWC values on April 24 (hot) and June 24 (cold) shown in Tab. 4-3 are compared. There is one outlier (TDR No. 9 near the heater at the 12 o'clock position) due to the overestimation described earlier. As noted with arrows, the VWC did change over this two month cooling period. During the partial dismantling in 2002, redistribution of water was observed likely due to vapour condensation (Huertas et al. 2006). The changes in VWC before and after cooling, however, seemed more distinct. It was suspected that the changes in VWC resulted largely from the long-term drift of the calibration including temperature correction.

Fig. 5-7: TDR-estimated VWC values on April 24, 2015 (just before heater shut-off) and June 24, 2015 (samples were collected).

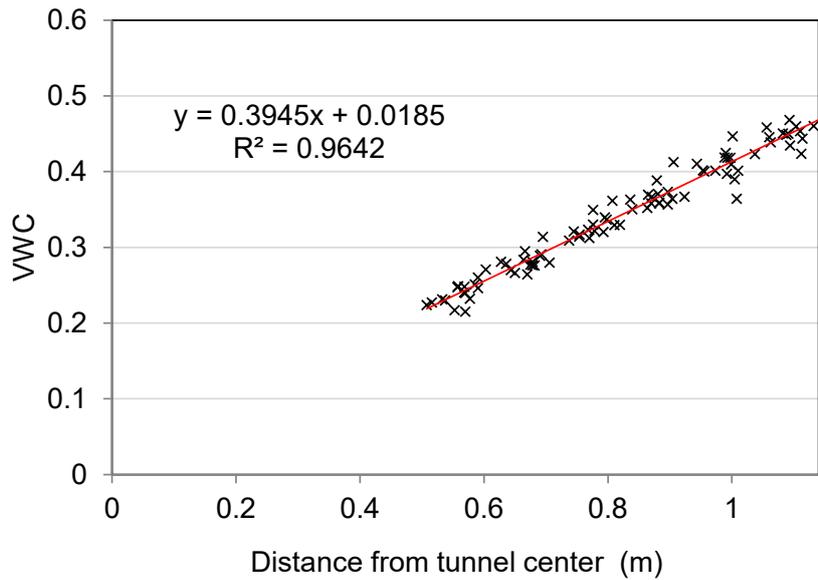
It was then assumed that the moisture distribution in Section M2 (the section of interest in this report) at the same time was similar to that of Section M1 presented in Fig. 6-1.

Fig. 6-1: Volumetric water content of samples around Heater 1 (Villar 2006).

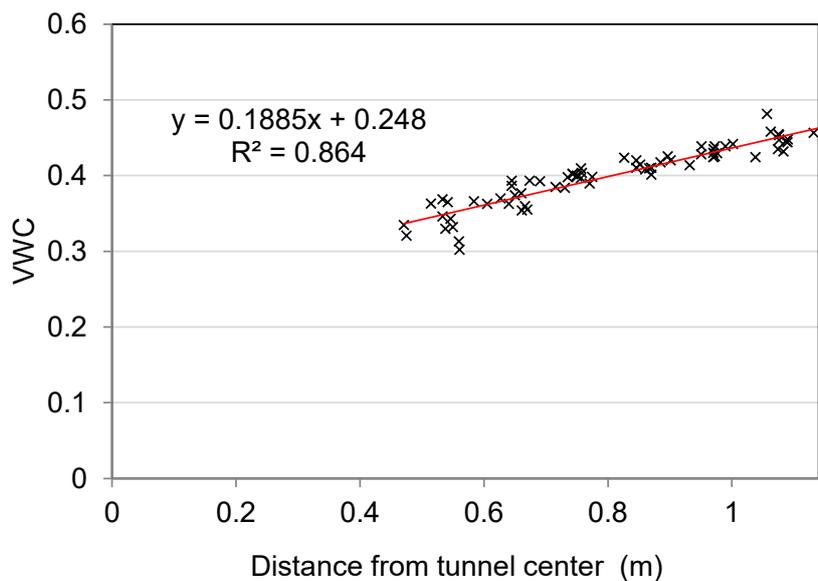
The data indicate that, after the dismantling in 2002, water kept migrating toward the heater and VWC increased from 0.205 to 0.32 over a period of 13 years.

Fig. 6-2: Volumetric water content of samples around Heater 2 (calculated from Villar et al. 2017).
