Arbeitsbericht NAB 16-21

**Bentonite TDR probe inspection
and data verification report**

May 2017

**National Cooperative
for the Disposal of
Radioactive Waste**

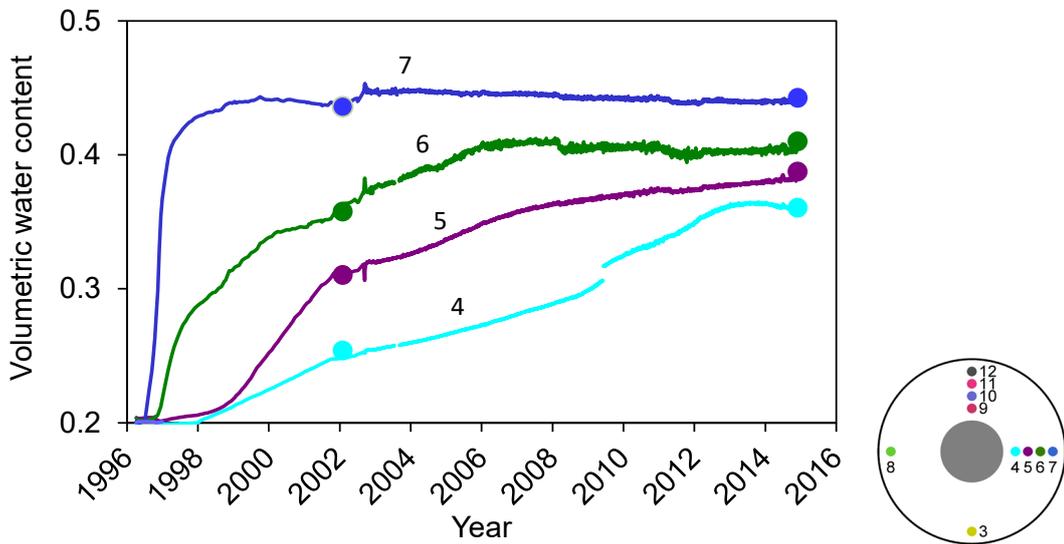
In particular, the VWC values in 2002 measured by the TDRs pass through the points estimated by " $VWC = 0.3945 r + 0.0185$ " (r is the radial distance of each TDR). Similarly, the VWC values in year 2015 pass through the points estimated by " $VWC = 0.1885 r + 0.2480$ ". Fig. 6-3 through 6.5 shows the re-scaled VWC for each measurement transect.

Fig. 6-3: Re-scaled VWC along the transect in the 3 o'clock direction.

The circles are the VWC estimated using the regression functions at the corresponding radial position.

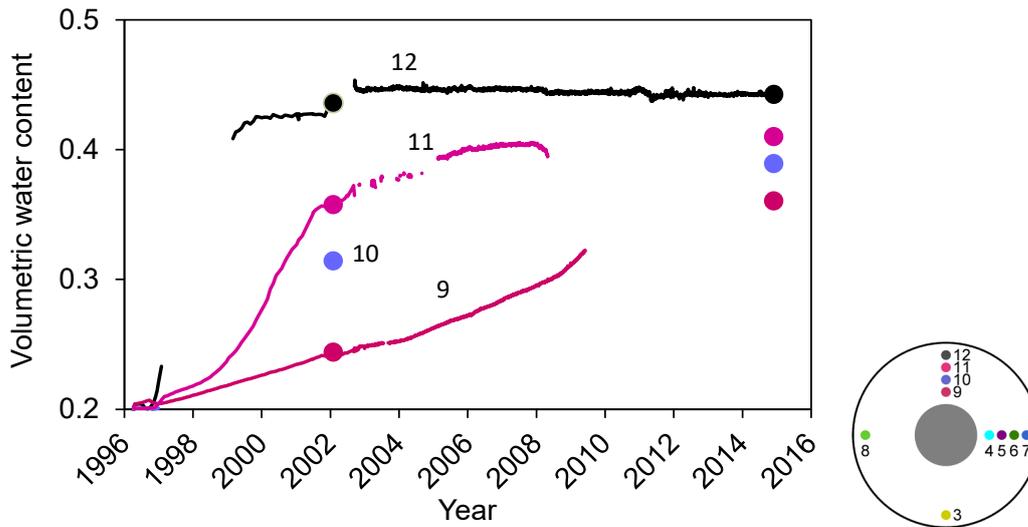
Fig. 6-4: Re-scaled VWC along the transect in the 12 o'clock direction.

Note that at No. 9, data after the overheating event in 2009 were not used due to erroneous behaviour of the sensor. The circles are the VWC estimated using the regression functions at the corresponding radial position.

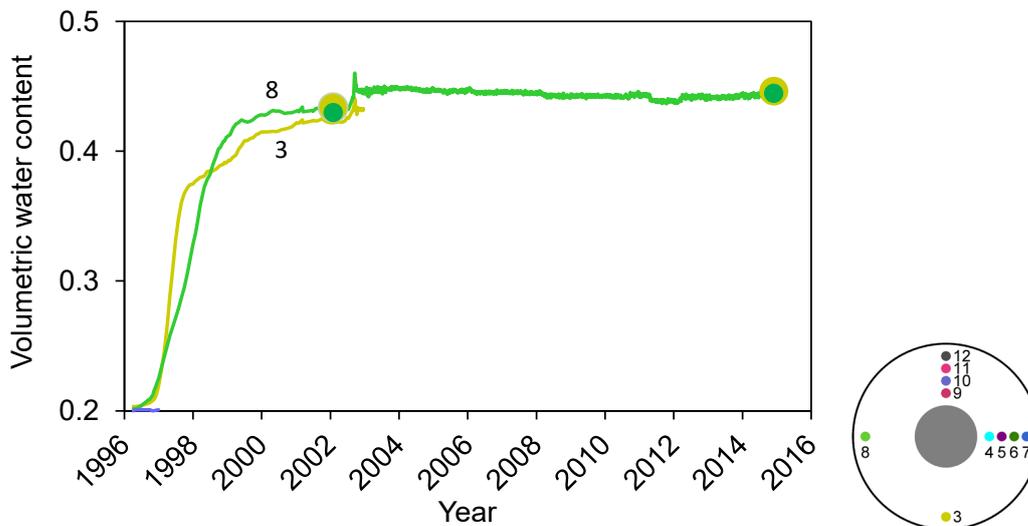
Fig. 6-5: Re-scaled VWC in the 6 and 9 o'clock directions.

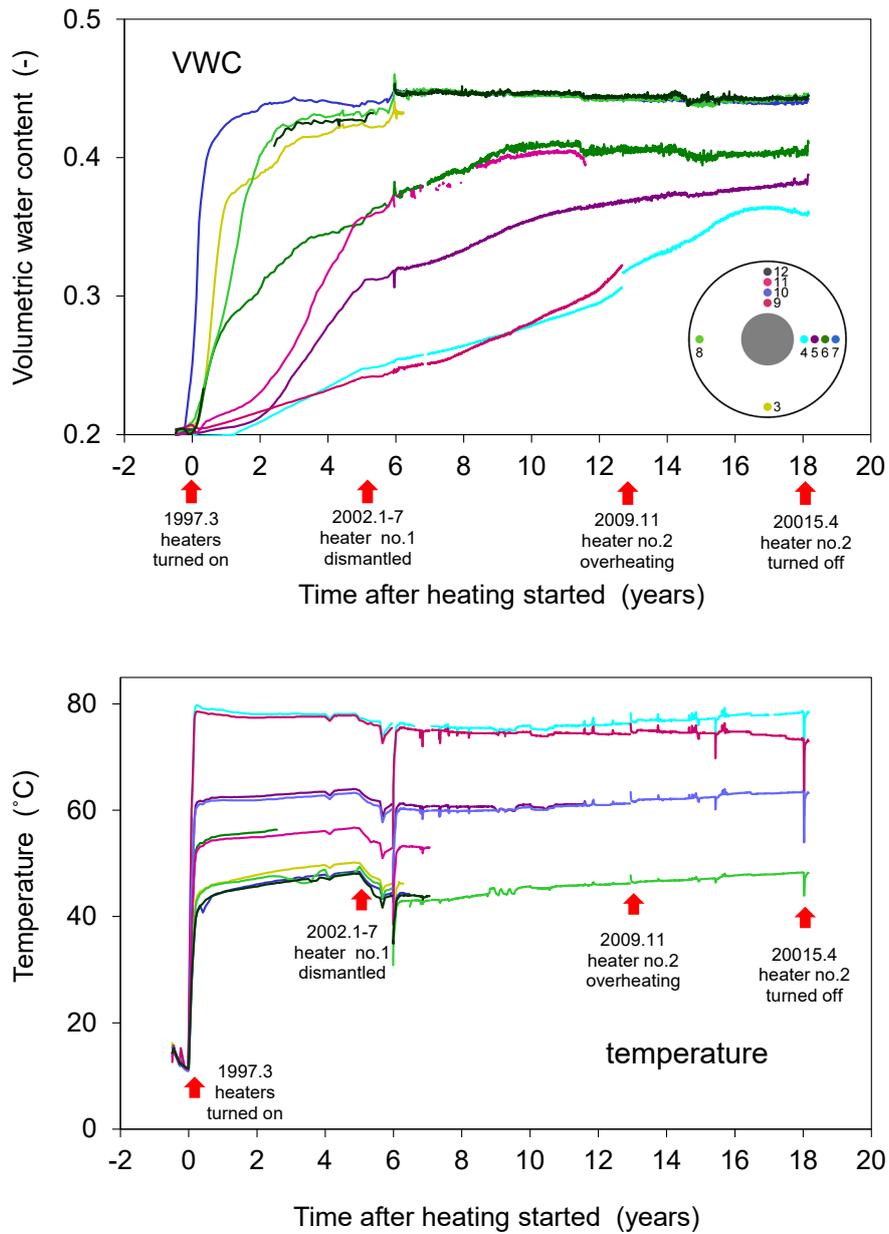
The VWC values at the next set of probes 6 and 11 in the middle block ring stabilised at a VWC of about 0.4 (saturation of 100 %, see Appendix C) after 8-10 years. Probe No. 6 in the 3 o'clock transect showed a faster increase as observed in the outer ring.

The moisture migration toward the innermost block ring took significantly longer due to the large distance from the water-supplying tunnel wall as well as the heat from the heater which hinders the migration. As a result, the saturation increase at probes No. 4 and 9 were gradual and, at No. 4, VWC finally started to level off after about 16 years at a VWC of about 0.36 (saturation of ~ 90 %, see Appendix C).

Fig. 6-6: Re-scaled VWC (top) and temperature (bottom) in Section M2 for the entire 18-year monitoring period.

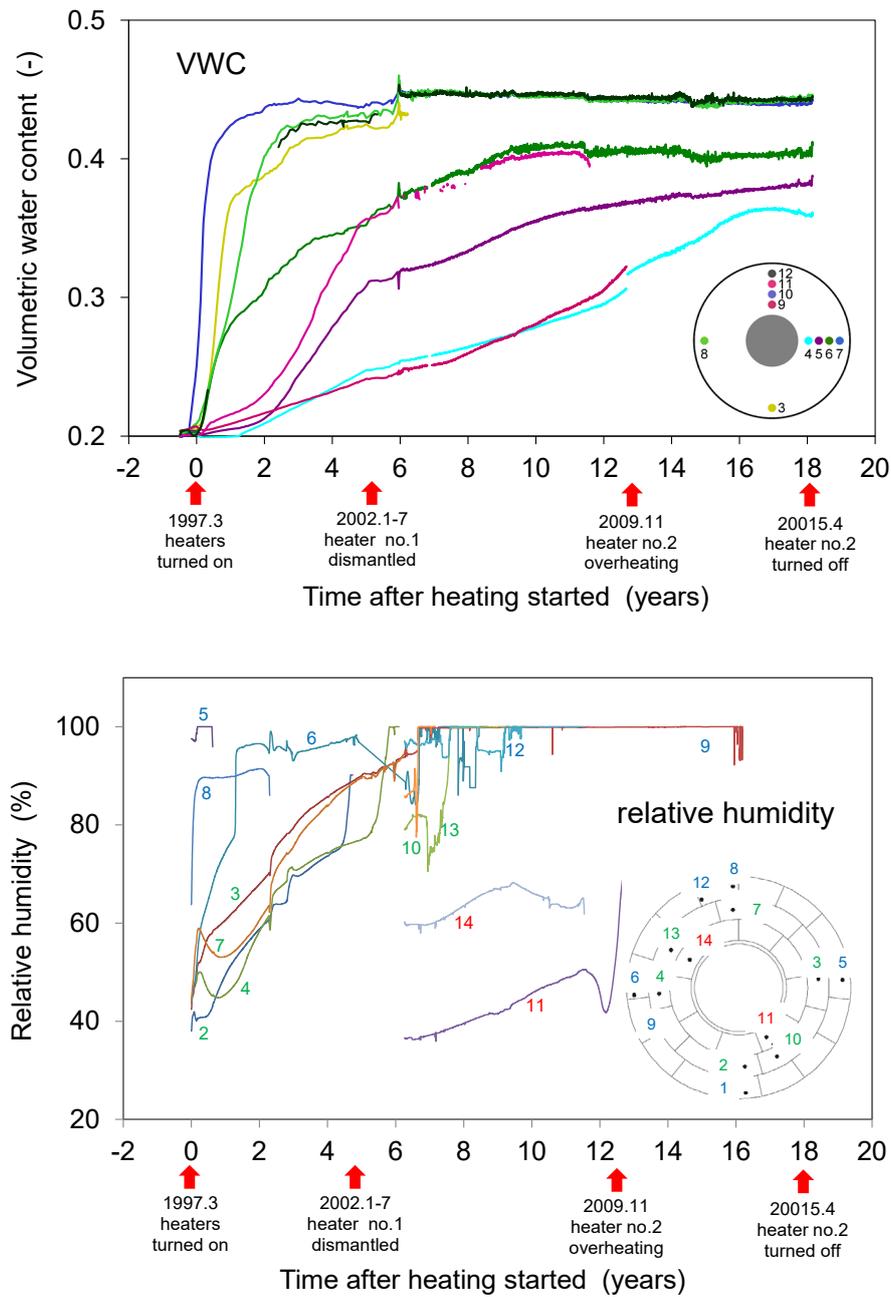
Finally, the *re-scaled* VWC for all the TDRs in Section M2 is compared in Fig. 6-7 with the relative humidity (RH) evolution (Martinez et al. 2016, NAB 16-19). Although the position of the RH sensors was not identical to those of the TDR probes, a strong correlation is seen in these results, e.g., RH in the outer block ring reached saturation in less than two years, the middle ring took roughly eight years whereas the inner ring took significantly longer.

Fig. 6-7: Re-scaled VWC (top) and relative humidity (bottom, Martinez et al. 2016) in Section M2 for the entire 18-year monitoring period.

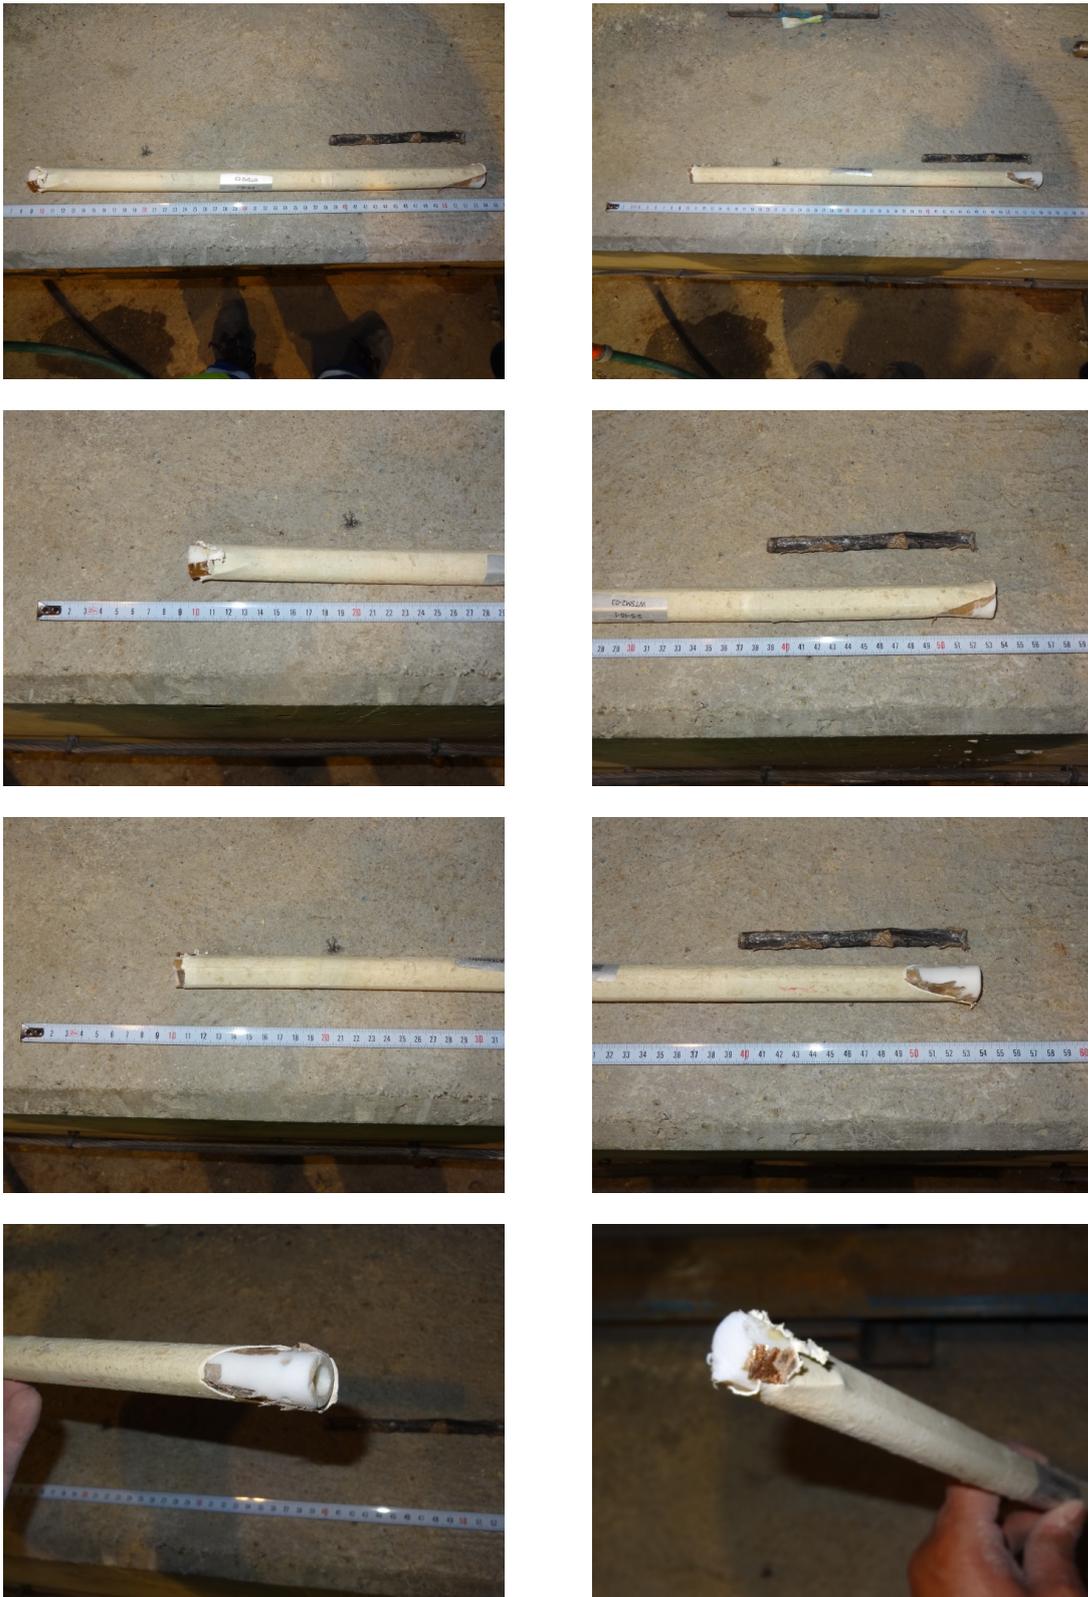
Fig. A-1: State of the bentonite TDR probe WT-M2-03 after retrieval.

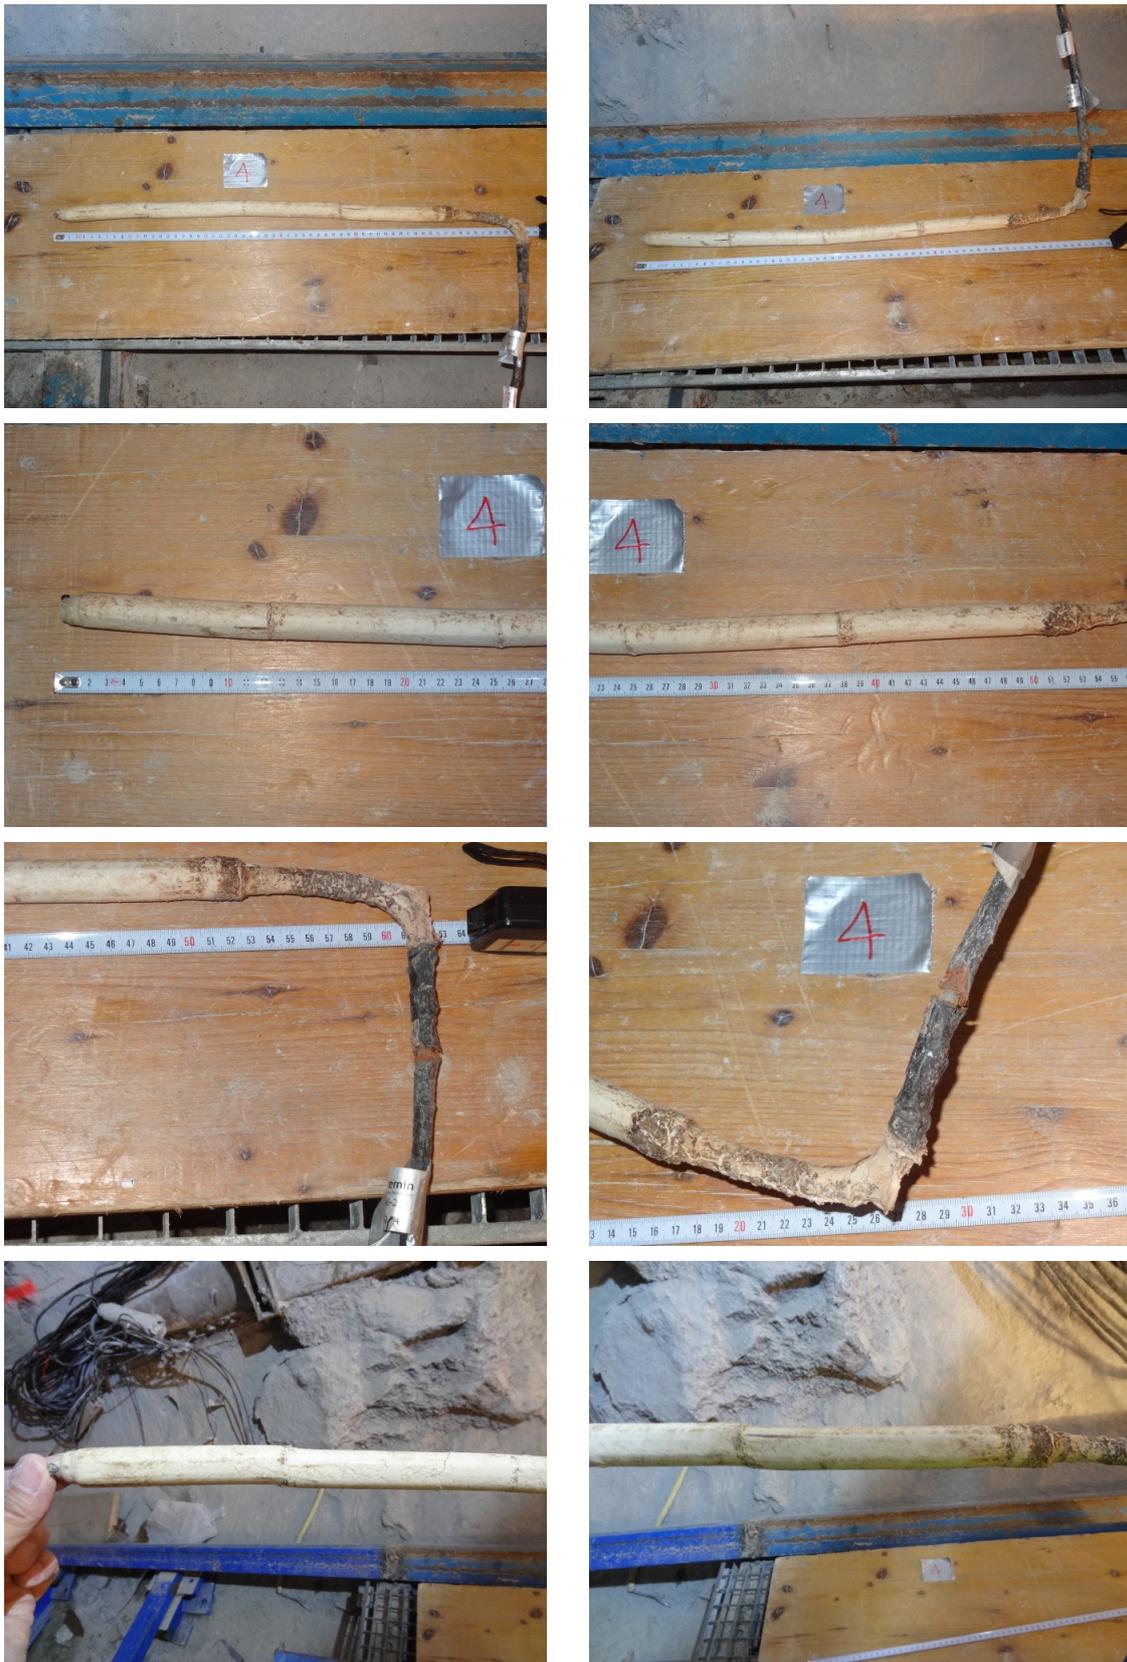
- WT-M2-04 had a minor old crack on the surface coating. Water may have entered here leading to disturbances on the TDR trace.
- WT-M2-09 had old major cracks on the surface coating. The copper electrodes showed corrosion-like stains. It was presumed that water had intruded inside the coating film and affected the TDR trace.

Fig. A-2: State of the bentonite TDR probe WT-M2-04 after retrieval.

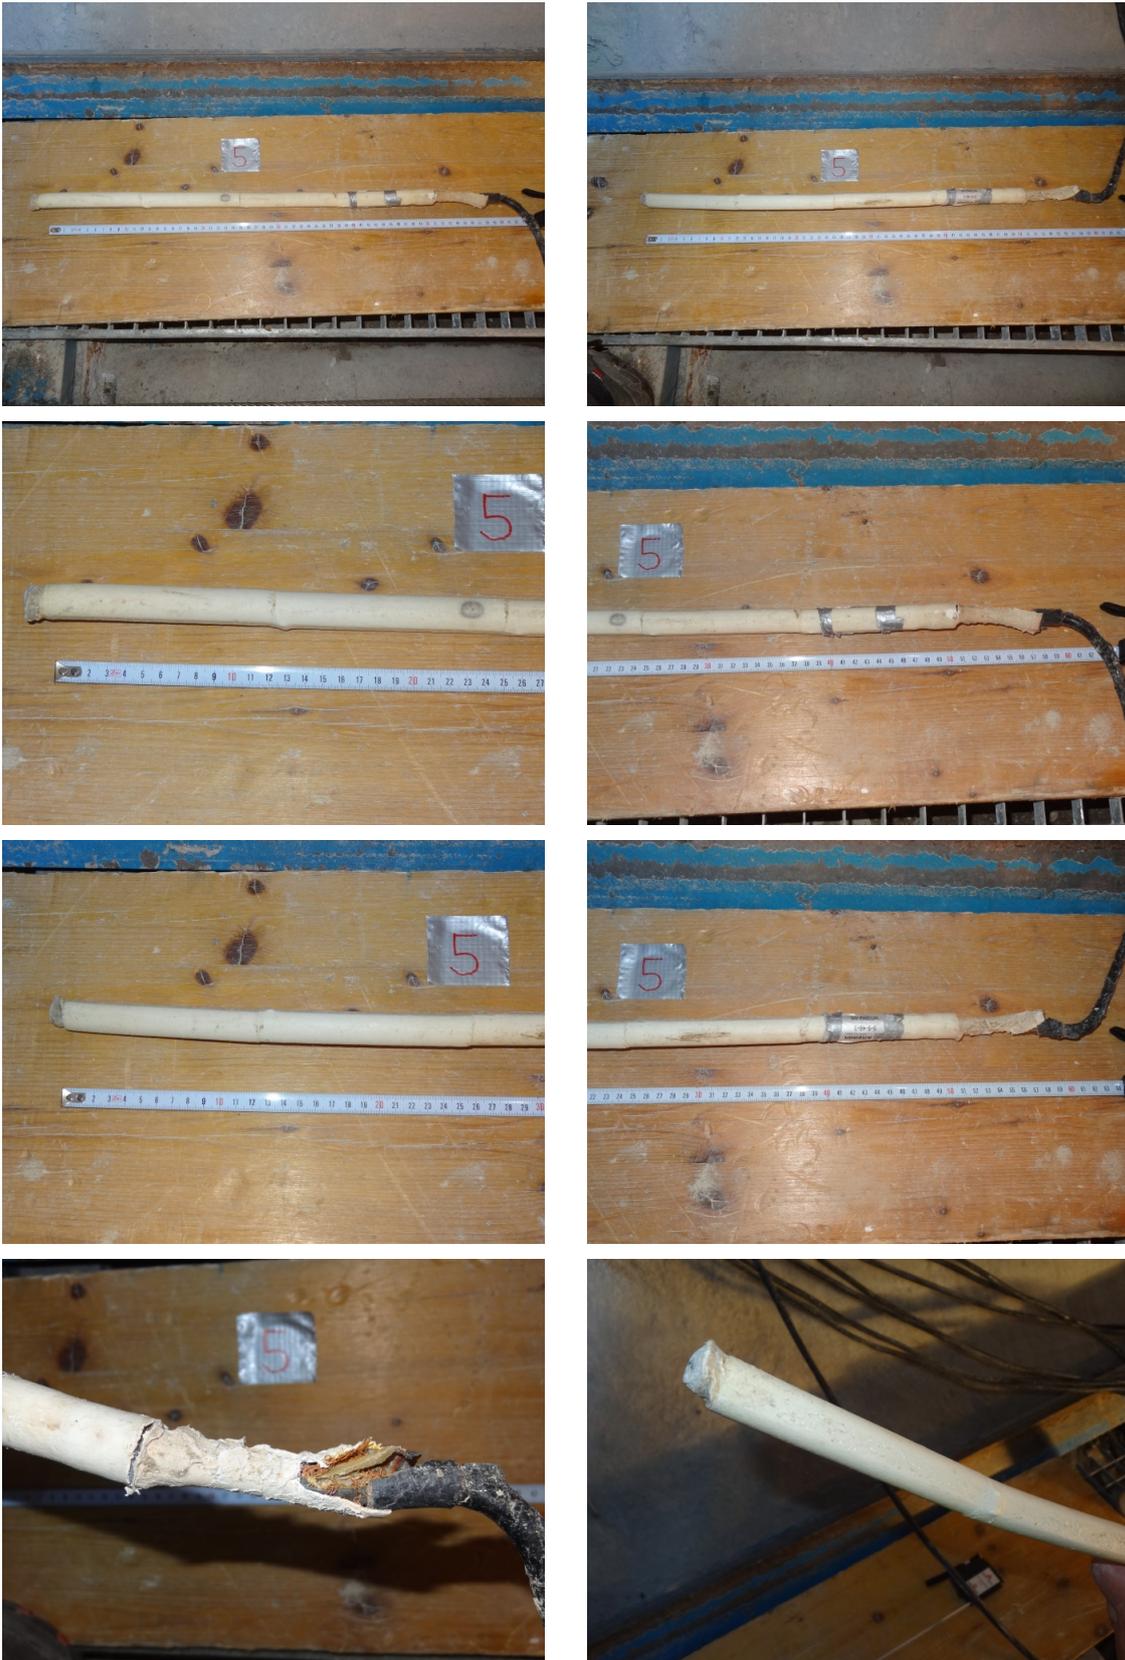
Fig. A-3: State of the bentonite TDR probe WT-M2-05 after retrieval.

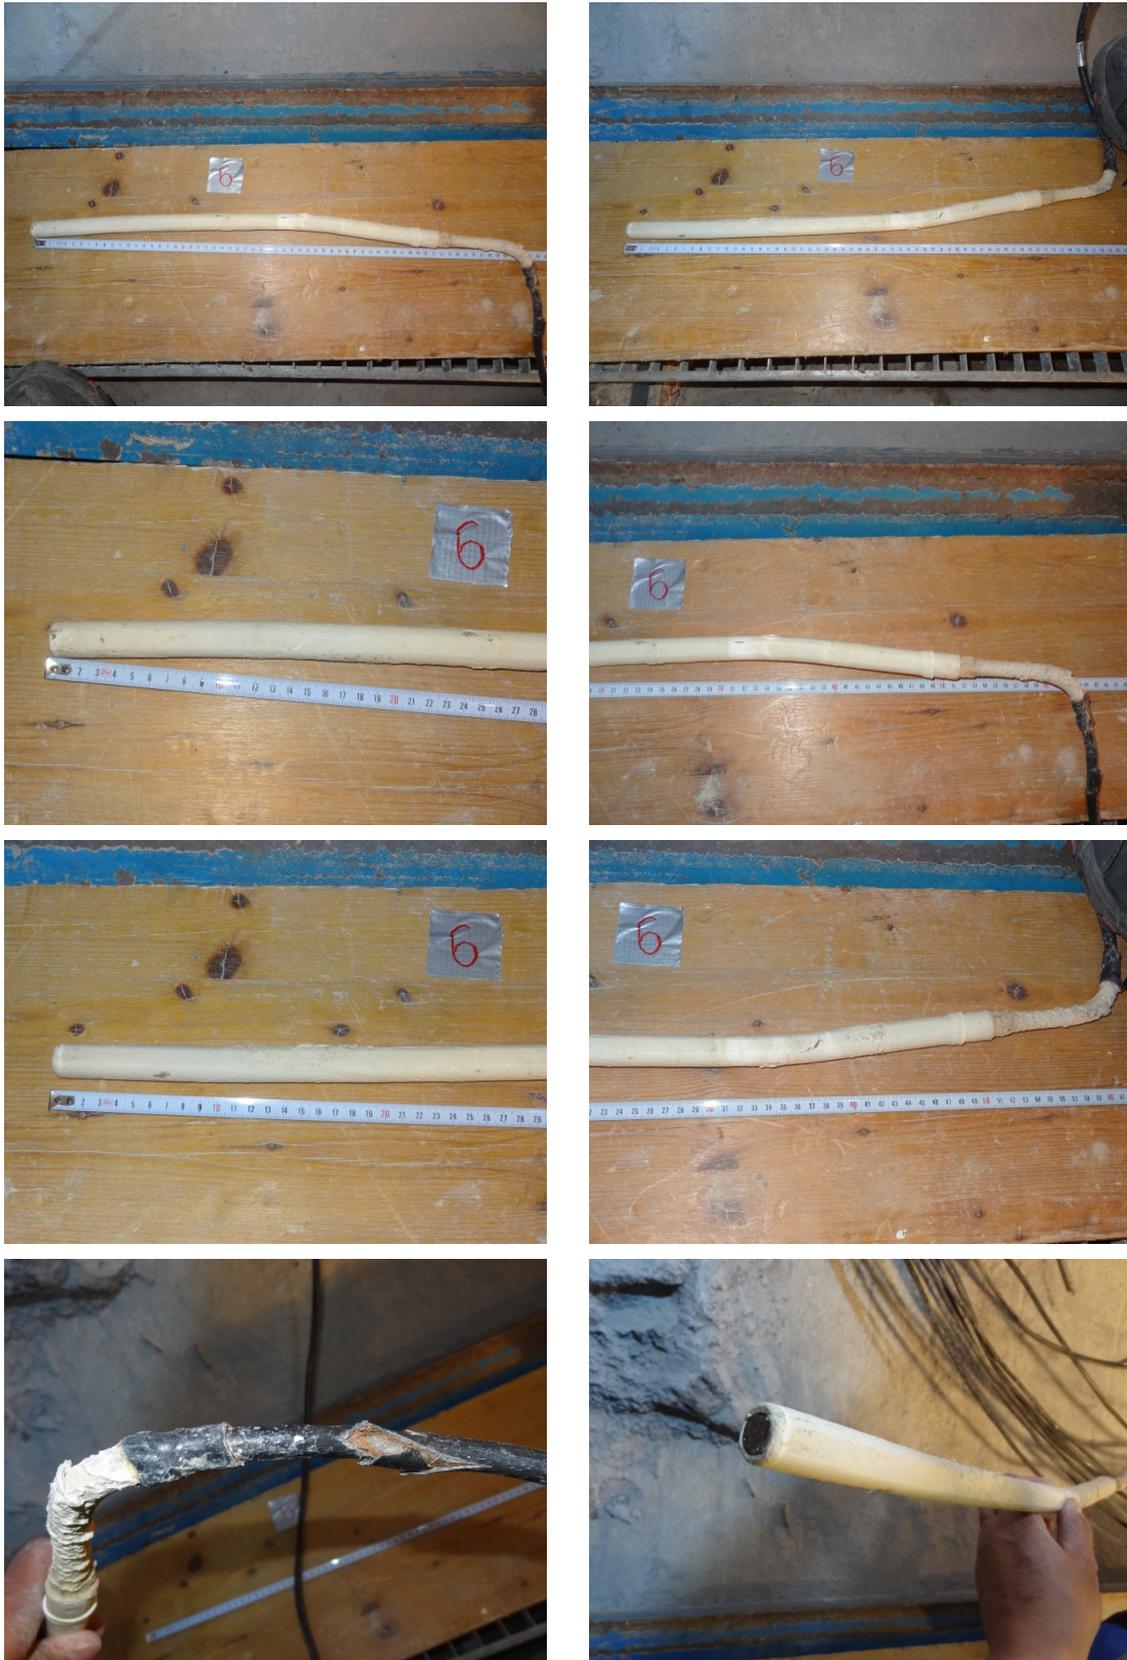
Fig. A-4: State of the bentonite TDR probe WT-M2-06 after retrieval.

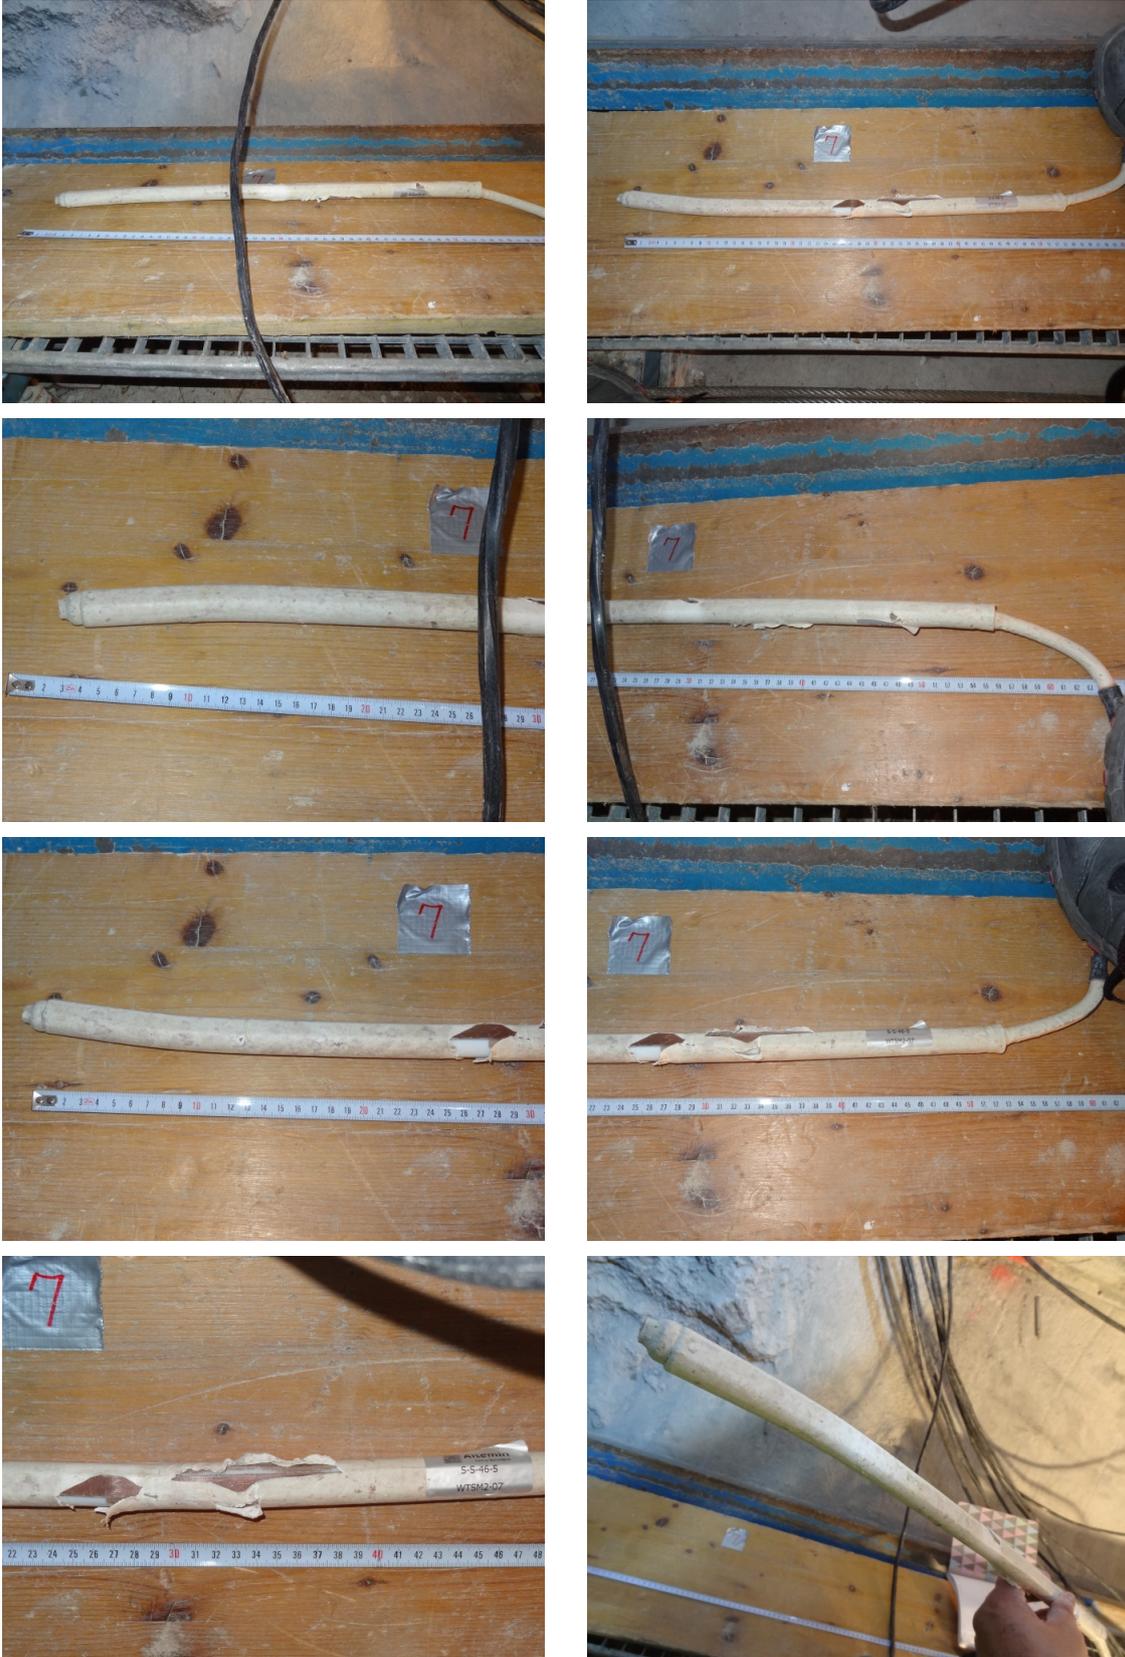
Fig. A-5: State of the bentonite TDR probe WT-M2-07 after retrieval.

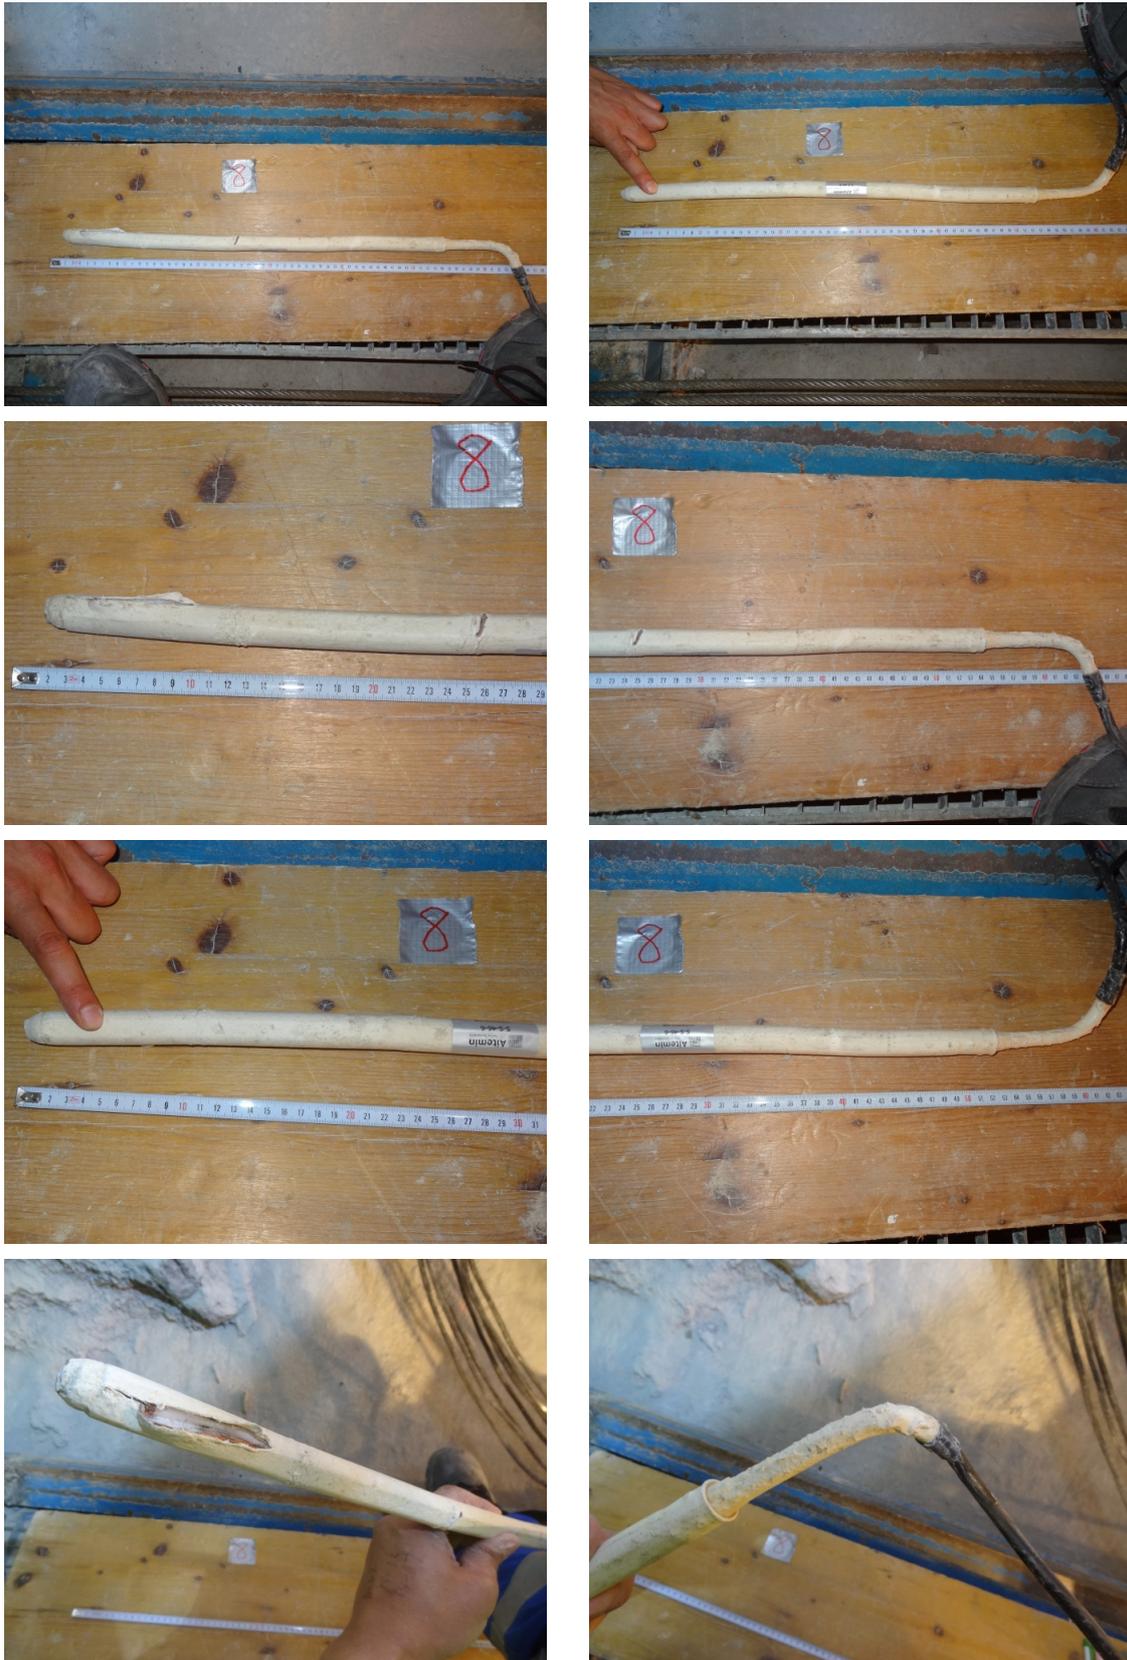
Fig. A-6: State of the bentonite TDR probe WT-M2-08 after retrieval.

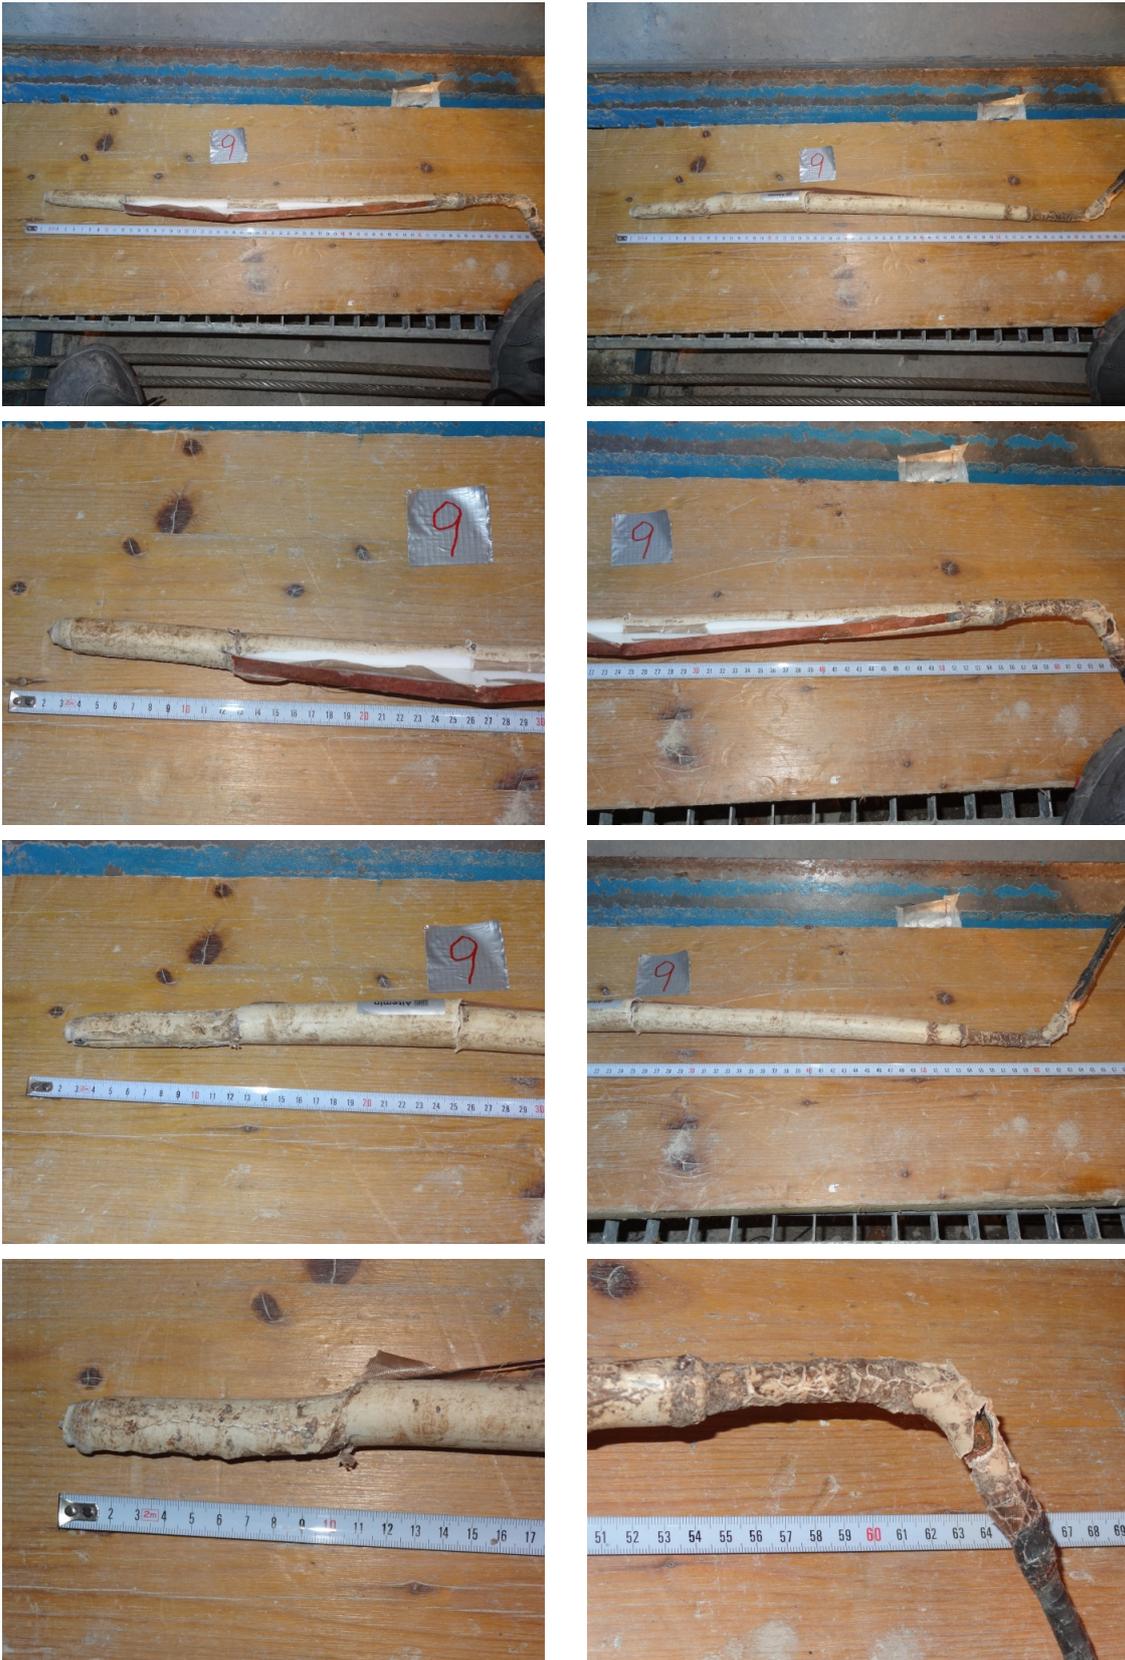
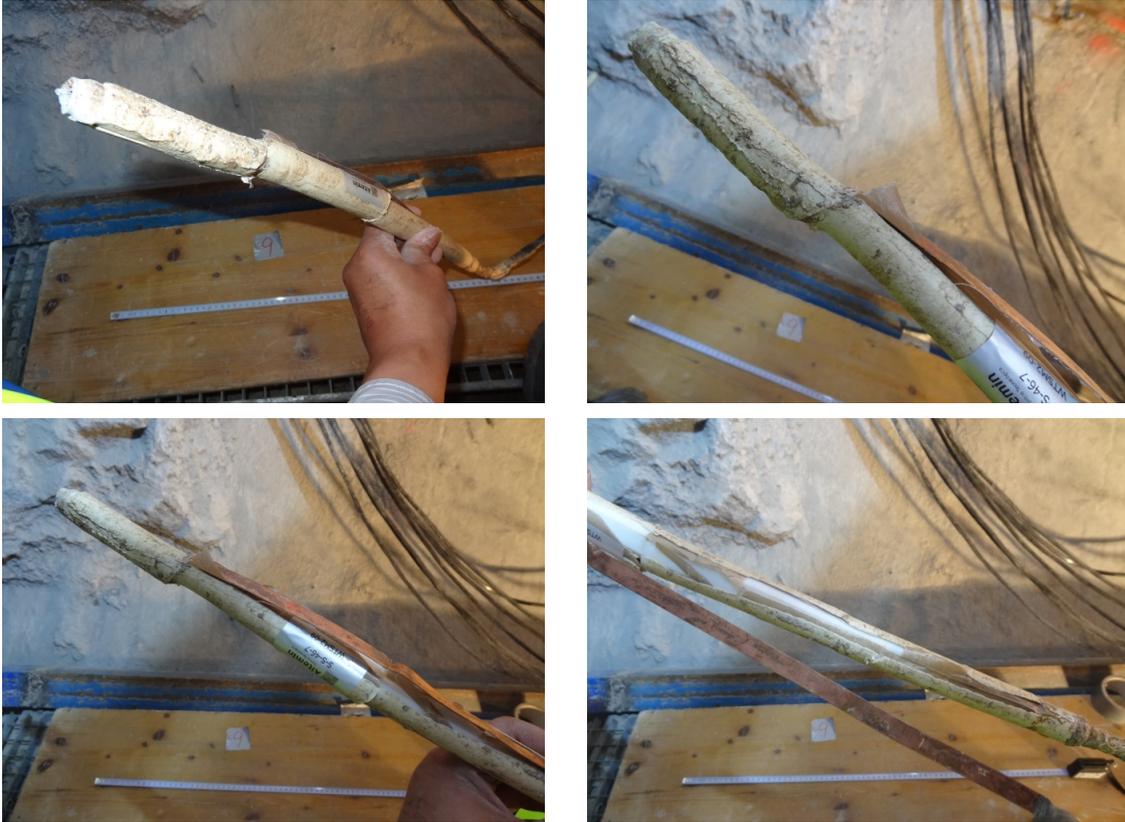
Fig. A-7: State of the bentonite TDR probe WT-M2-09 after retrieval.

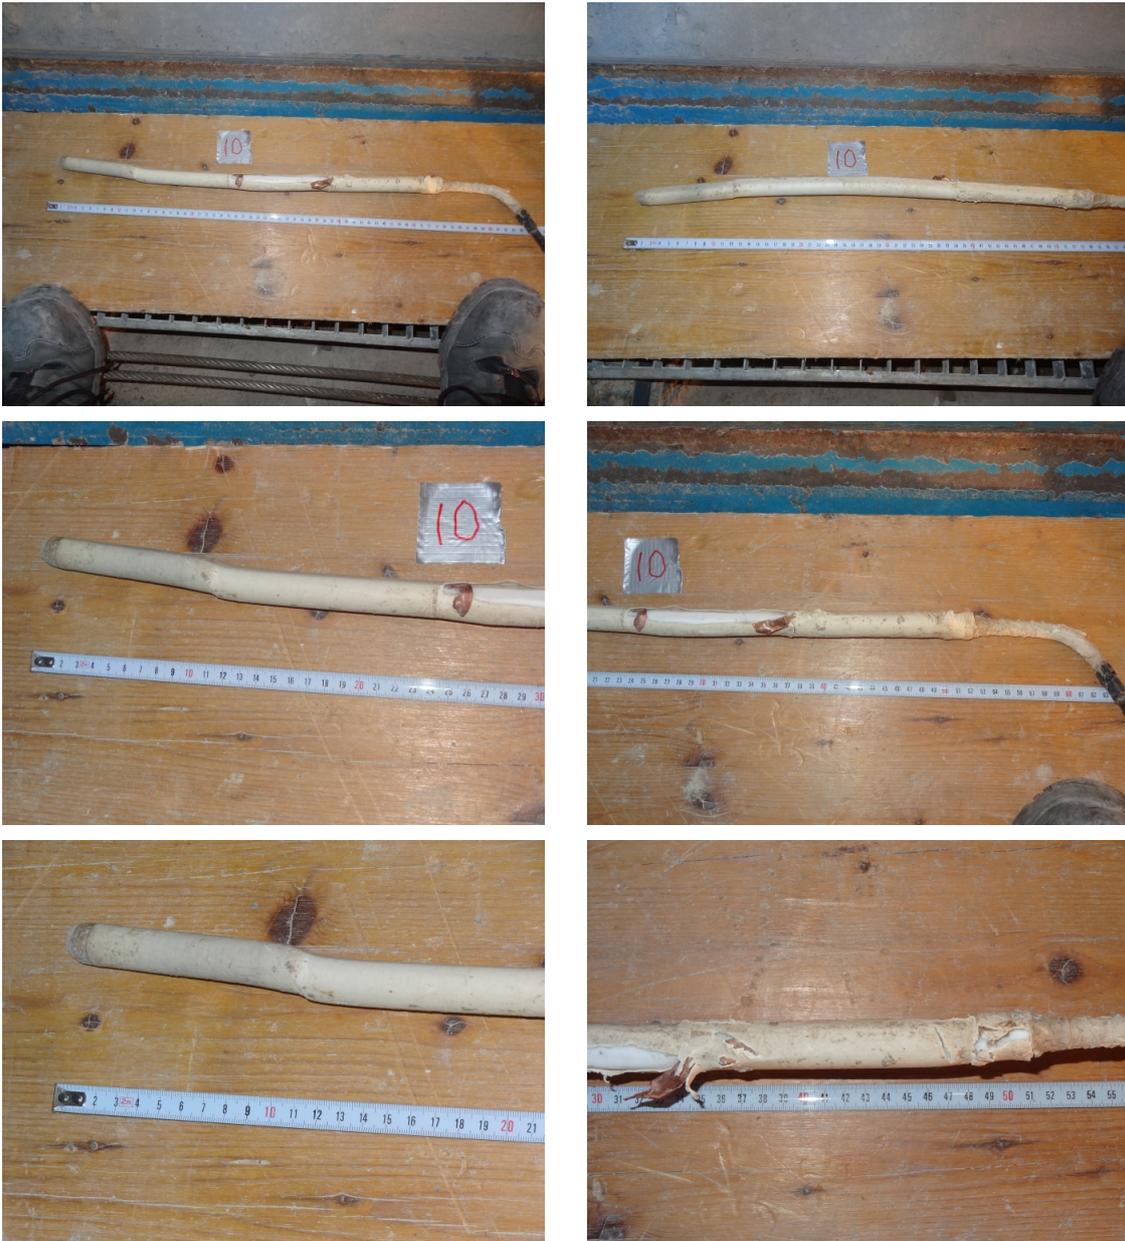
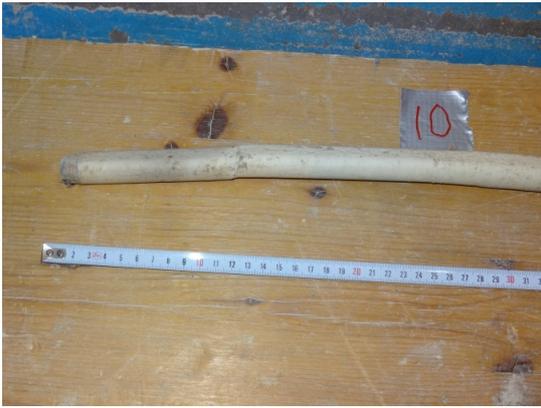
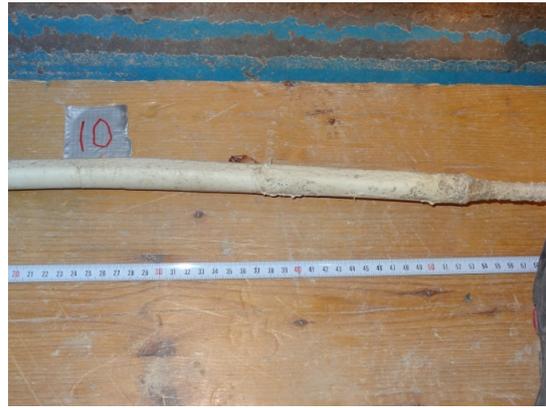
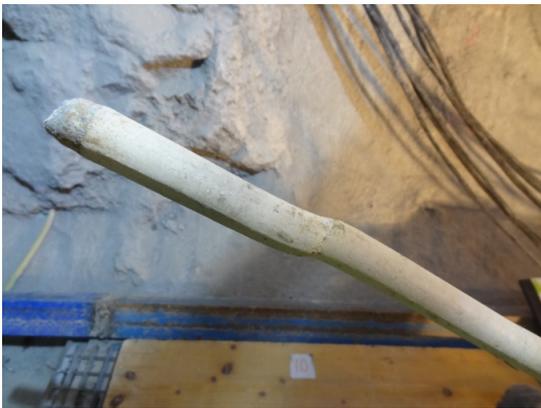
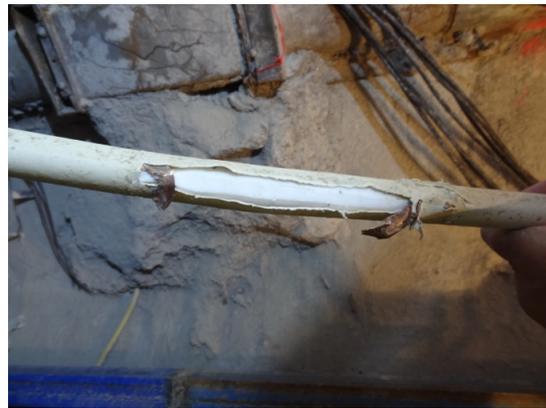
Fig. A-8: State of the bentonite TDR probe WT-M2-10 after retrieval.
