Arbeitsbericht NAB 16-21

**Bentonite TDR probe inspection
and data verification report**

May 2017

**National Cooperative
for the Disposal of
Radioactive Waste**

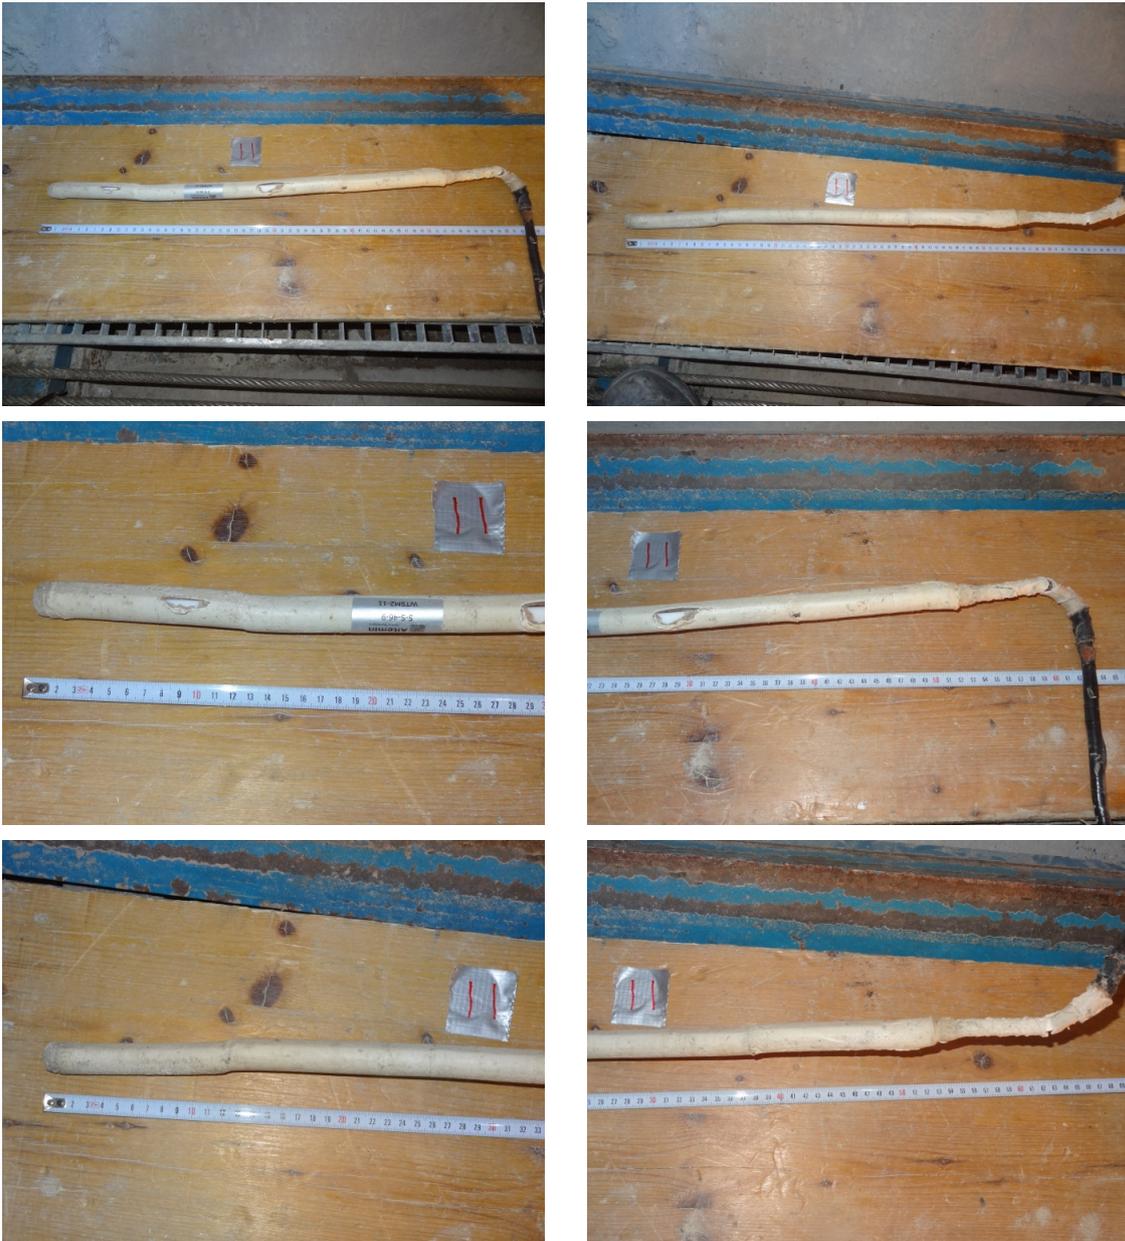
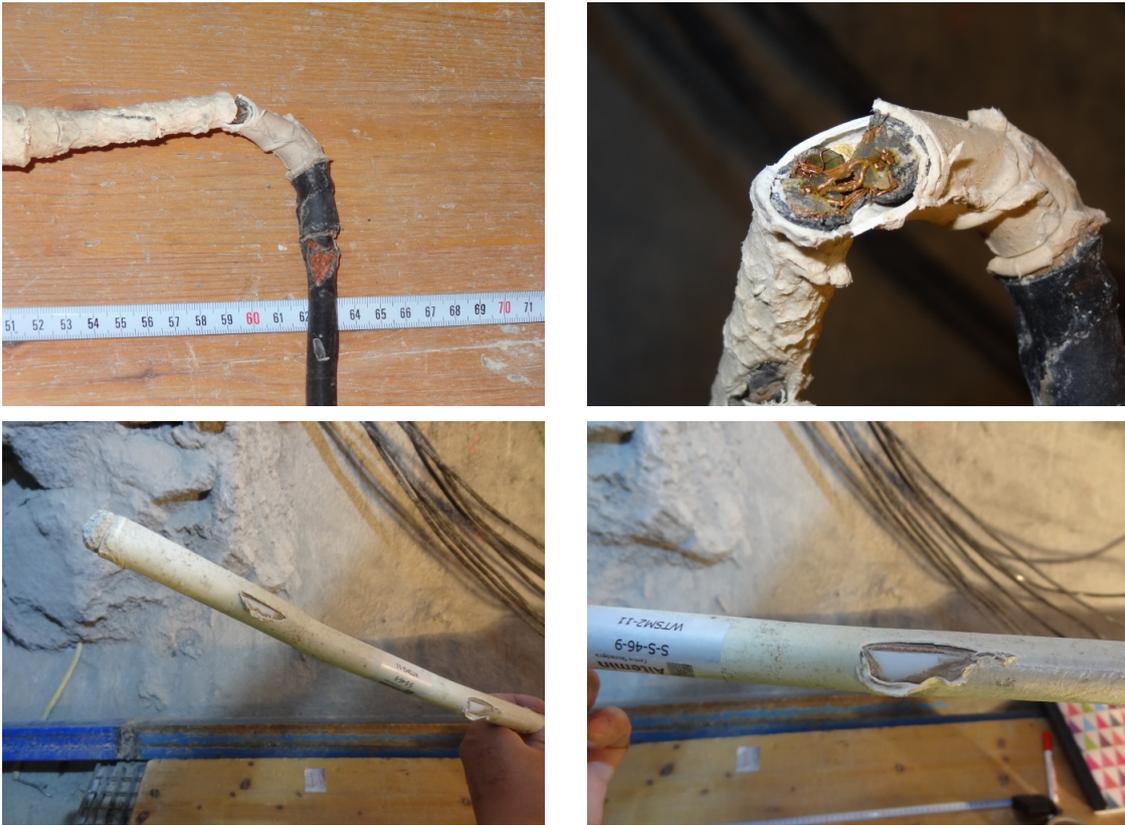
- Some of the probes (WT-M2-04, 05, 06, 09 and 11) had cracks on the cable protection. The cracks looked somewhat old. The conductors were not disconnected. Probe No. 11 showed the most severe damage on the co-axial cable; this probe had failed in 2004 whereas the others survived until June 2015. Little is known about the effect of damage or water intrusion into the outer shield of the co-axial cable to the TDR signal.

- The cable damage (cracks, disconnections) seems less this time for the M2 probes despite the longer monitoring period than the damage observed for the M1 probes. Only Probe No. WT-M2-11 had its cable nearly disconnected whereas, in the previous dismantling, three M1 cables were almost disconnected. The cables in M1 and M2 sections were installed and routed by different teams. The M2 cables were rather loosely installed which could have contributed to a less severe damage.

Fig. A-9: State of the bentonite TDR probe WT-M2-11 after retrieval.

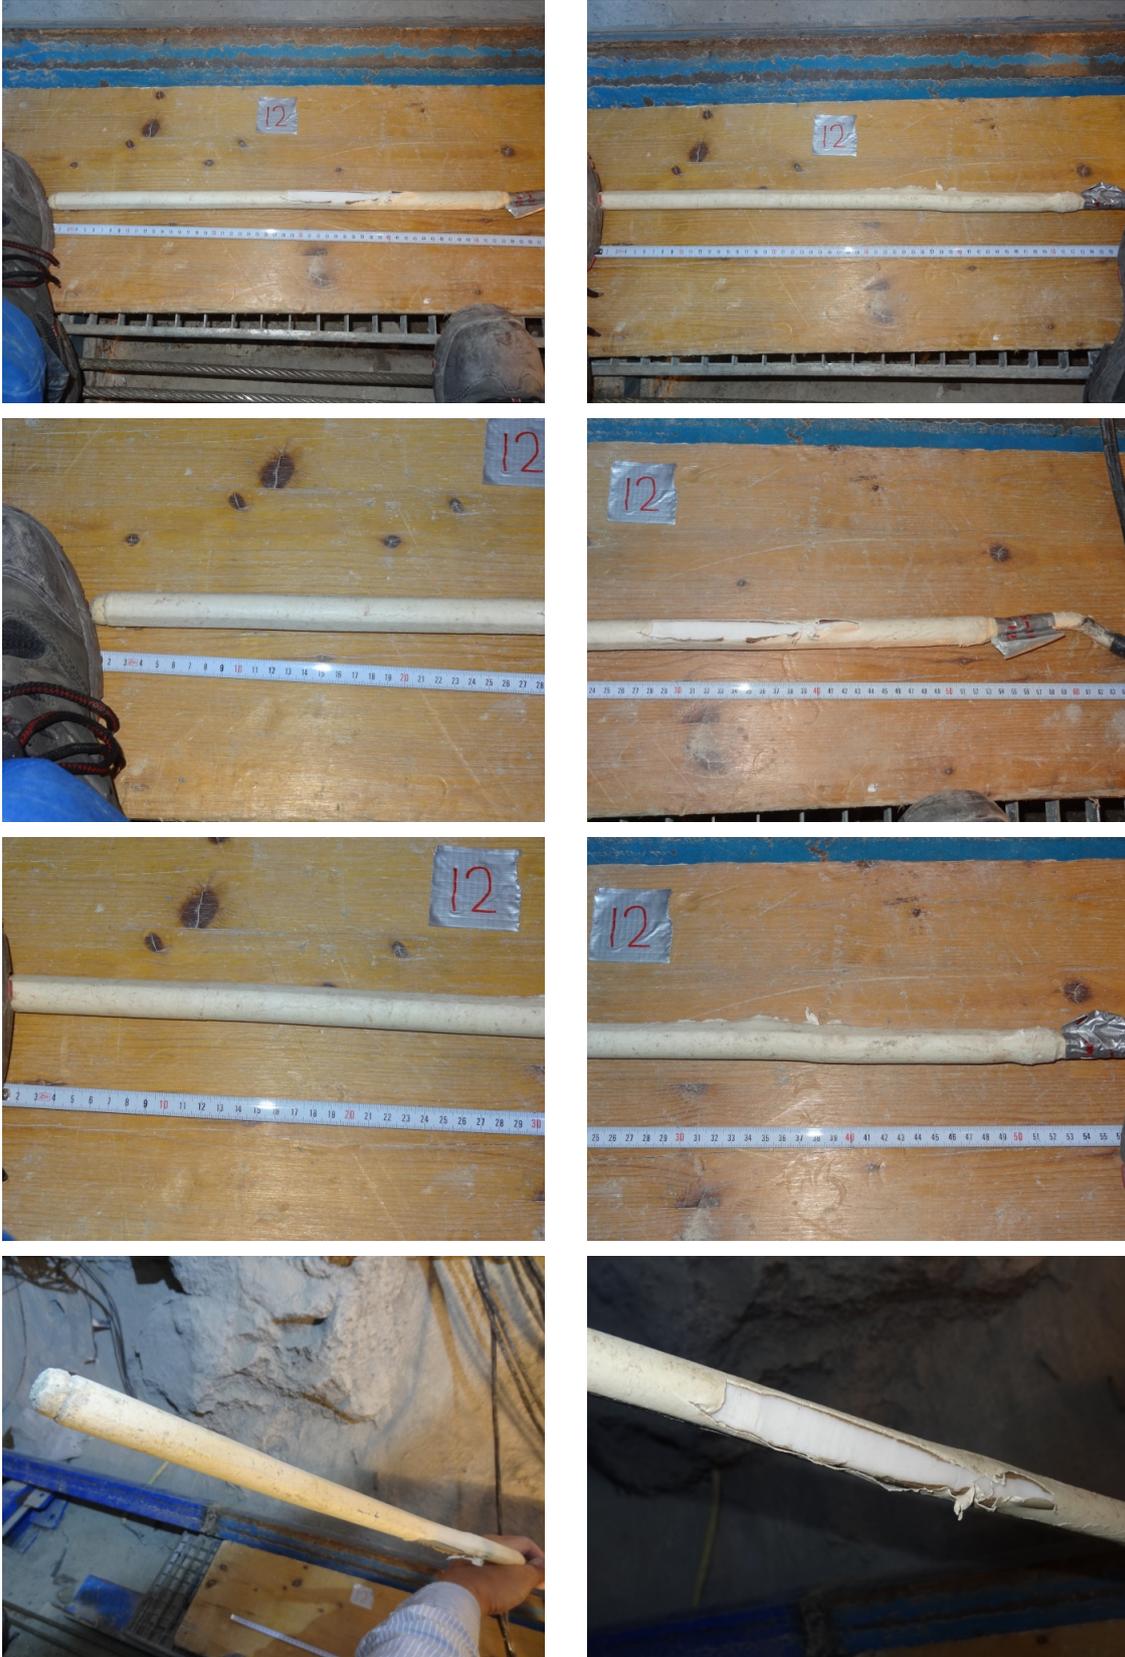
Fig. A-10: State of the bentonite TDR probe WT-M2-12 after retrieval.

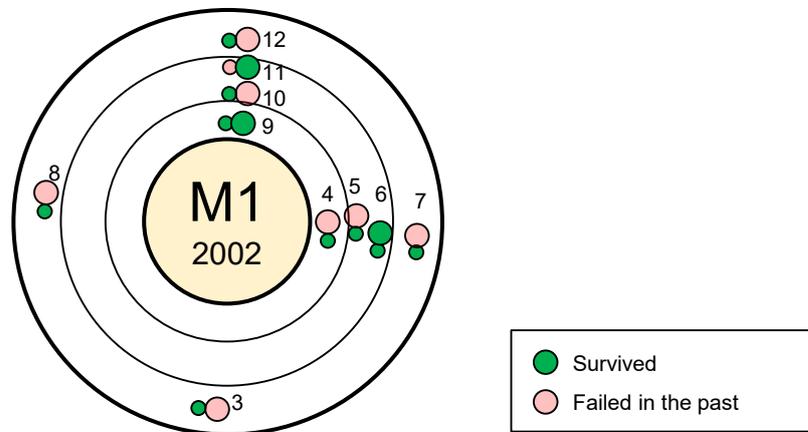
- TDR probes 30% survived
- Temperature 90% survived

Fig. B-1: Status of the TDR probes and temperature sensors at Section M1 at the time of the first dismantling in 2002 (Albert et al. 2003).

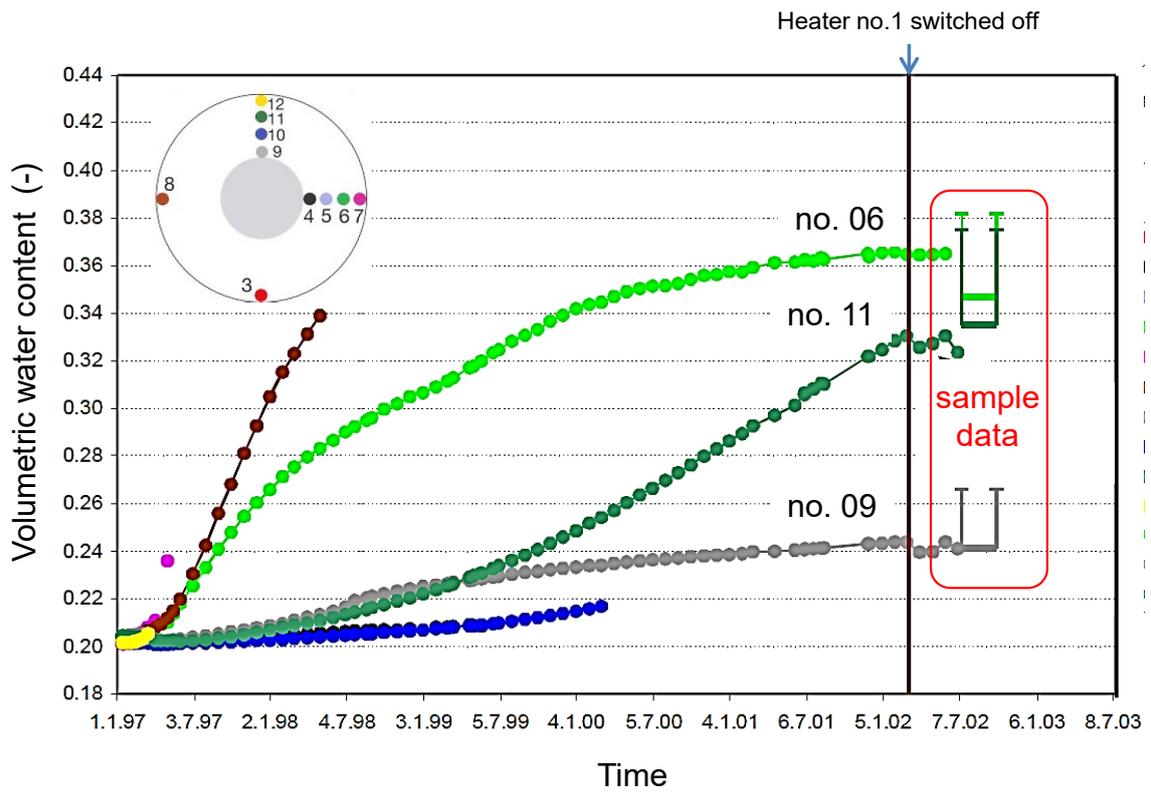
Fig. B-2: Volumetric water content evolution as well as the sample results at the time of the first dismantling in 2002 (figure taken from Albert et al. and revised 2003).

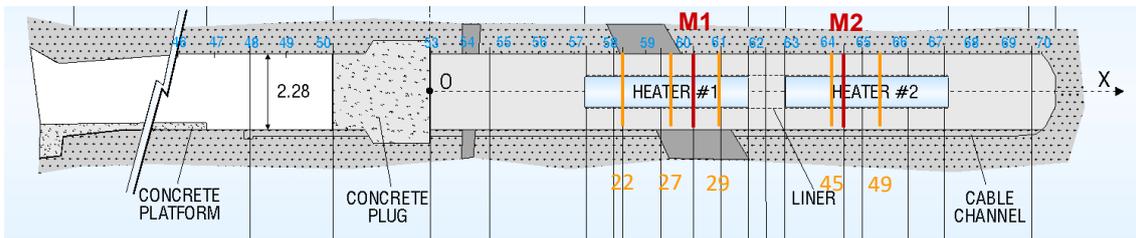
Fig. C-1: Position of sampling sections for the laboratory analyses (Villar 2006, Villar & Iglesias 2016).

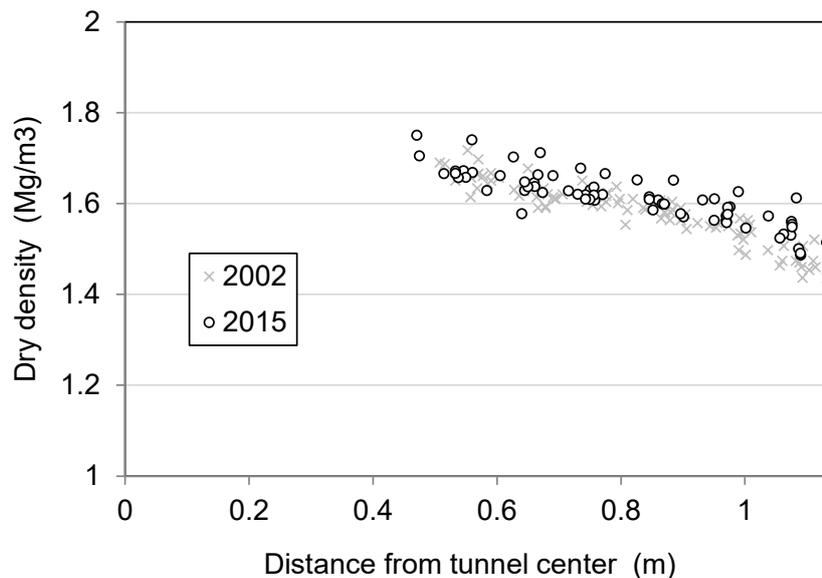
Fig. C-2: Sample analysis results in 2002 and 2015 (dry density).

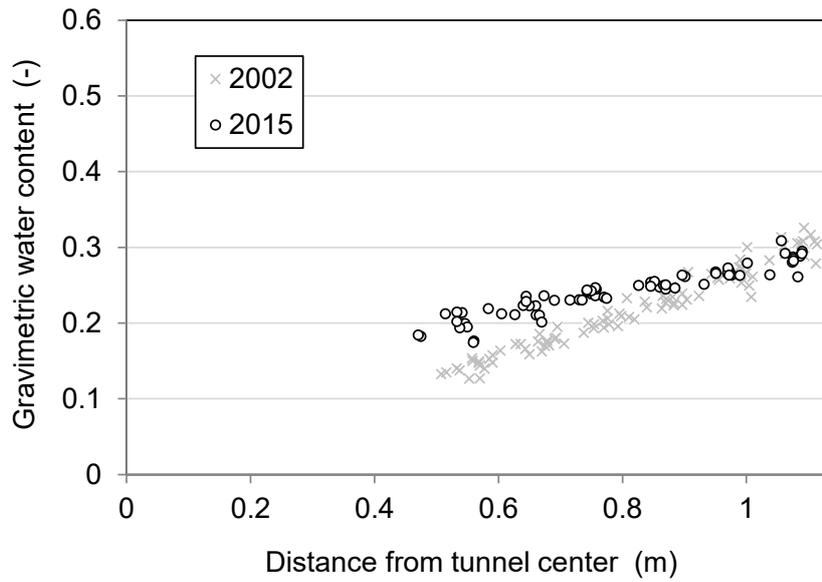
Fig. C-3: Sample analysis results in 2002 and 2015 (gravimetric water content).

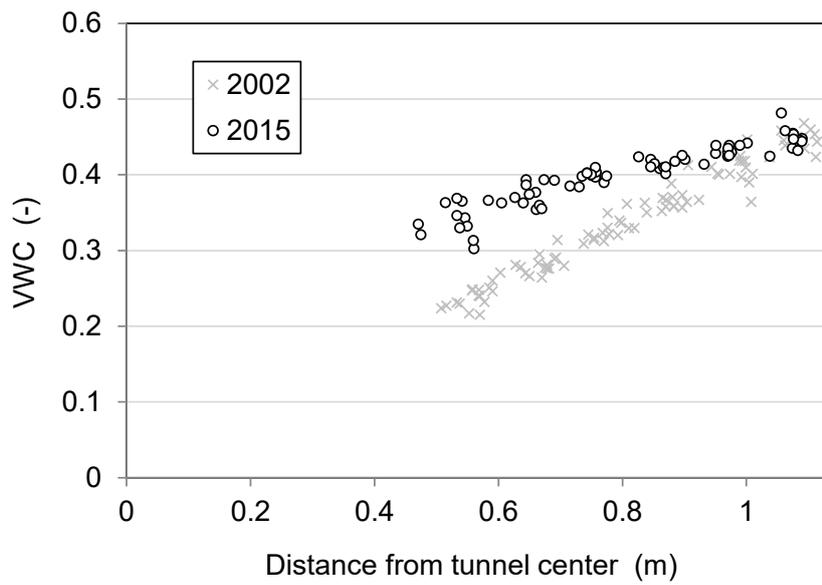
Fig. C-4: Sample analysis results in 2002 and 2015 (VWC).

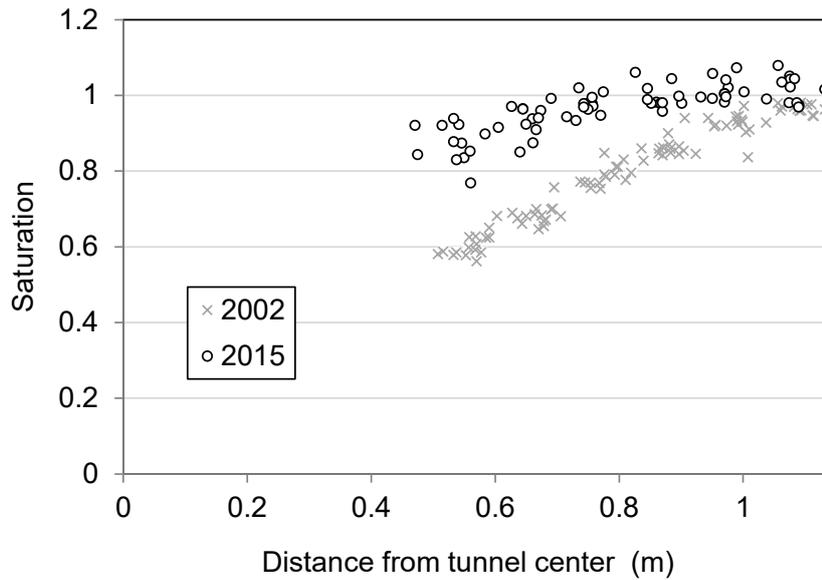
Fig. C-5: Sample analysis results in 2002 and 2015 (saturation).

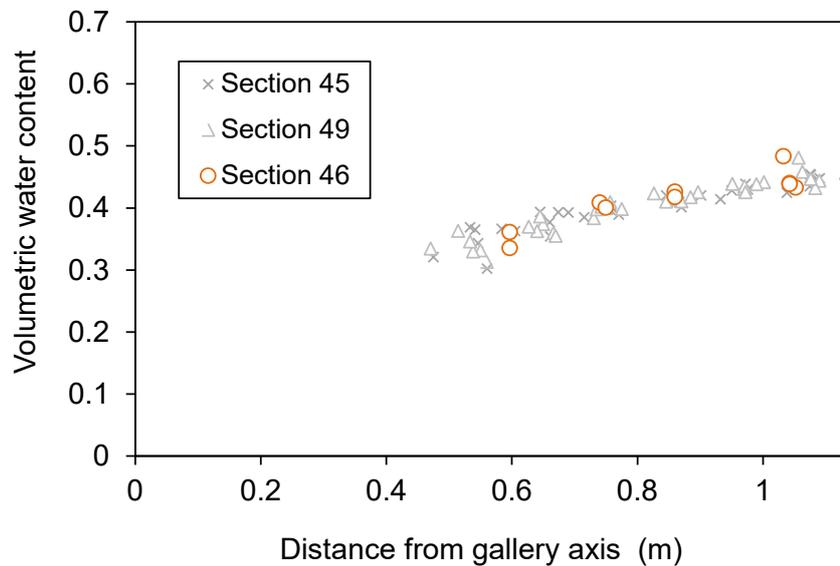
Fig. C-6: Sample analysis results in 2015 (VWC).
