Arbeitsbericht NAB 16-68

FEBEX-DP – Dismantling related supplementary documents

March 2017

National Cooperative
for the Disposal of
Radioactive Waste

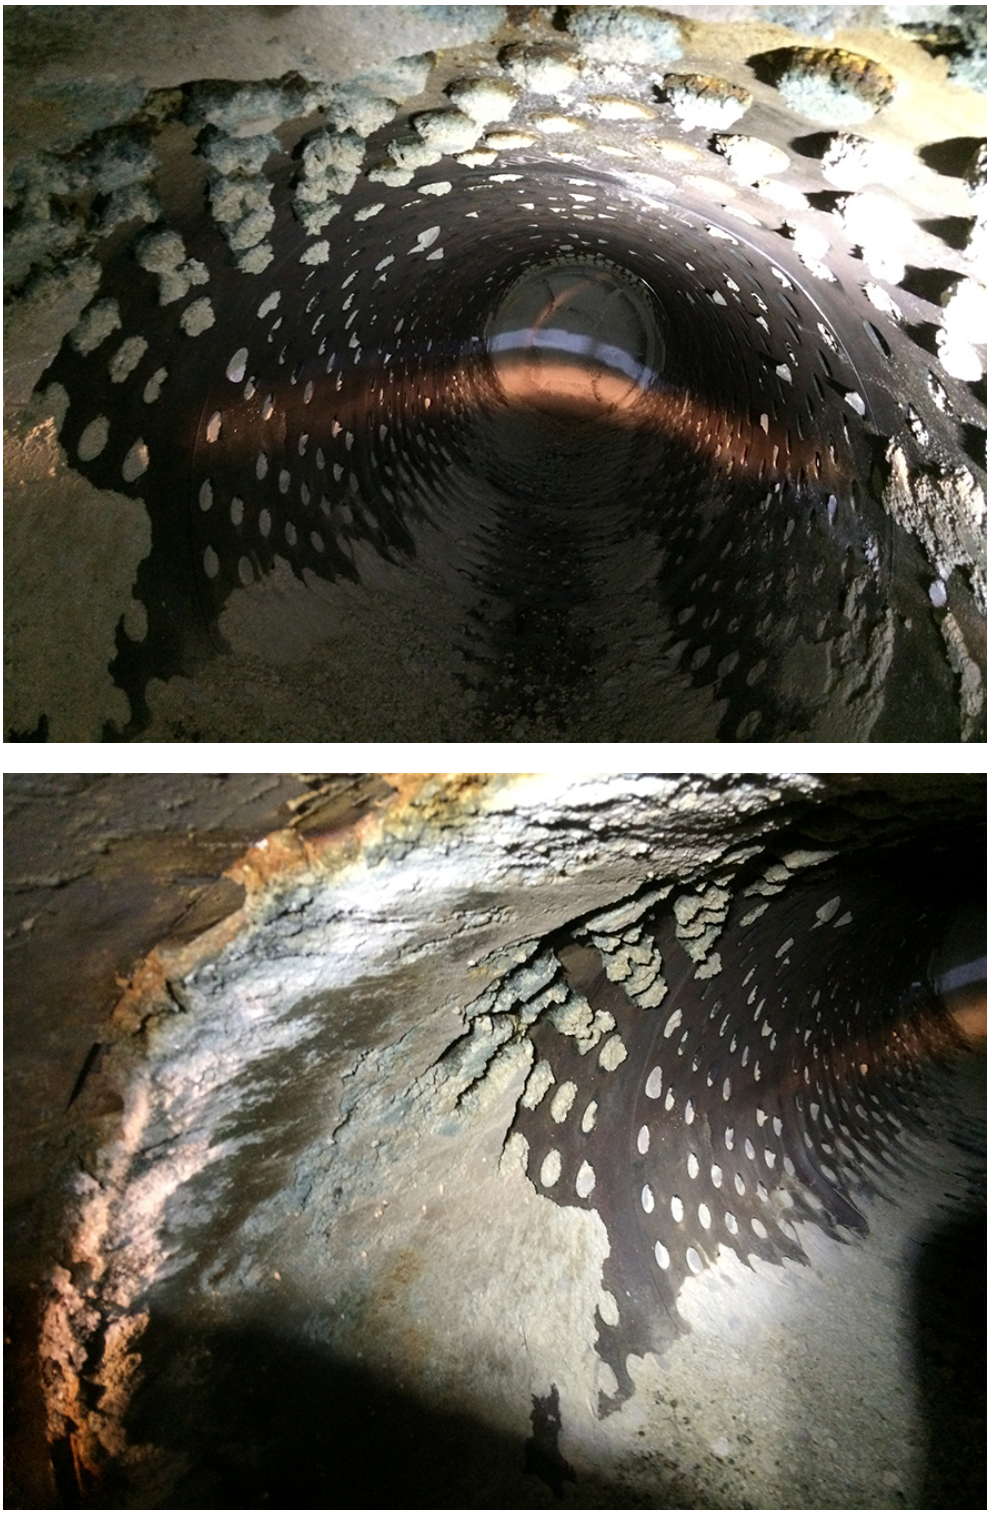
Fig. E-24: The first view into the now empty liner, showing bentonite protruded through the liner holes especially in the front and back part.

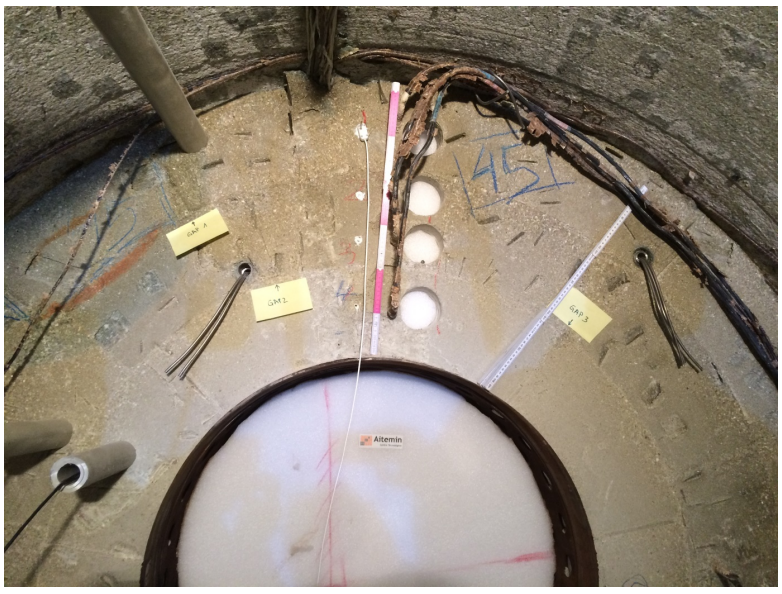
Fig. E-36: bentonite Layer 45 on 25.06.2015.

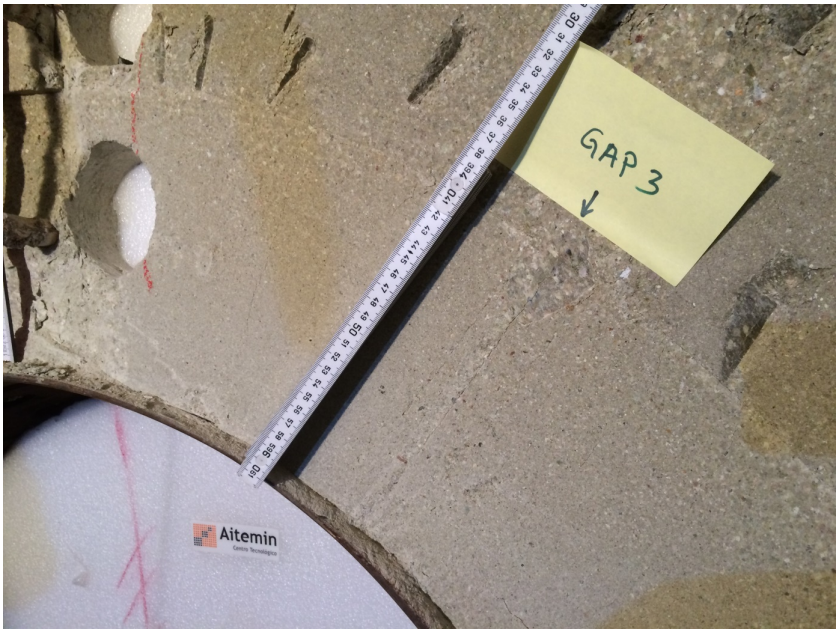
Fig. E-40: Gap 3.

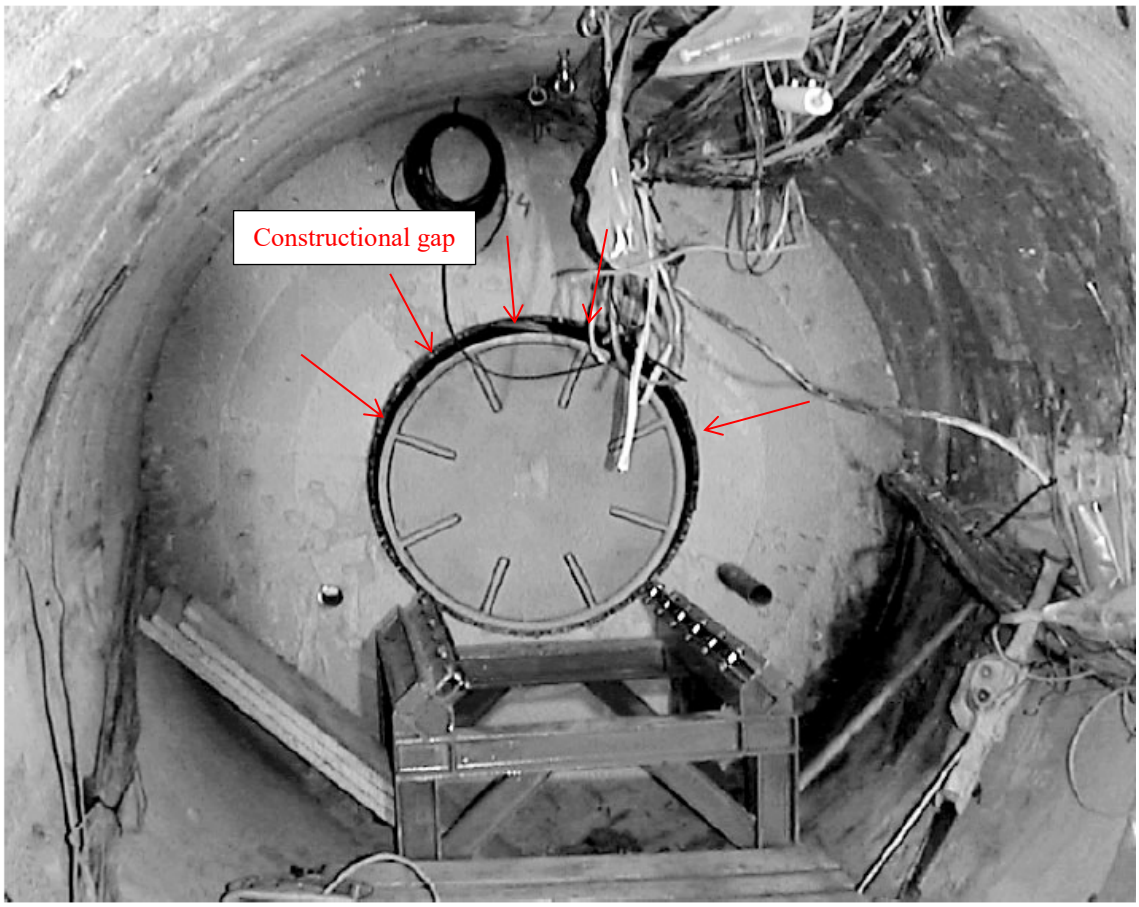
Fig. E-118: The constructional gap between the liner and the dummy (image: The FEBEX-DP experiment with dummy (void of the first FEBEX heater) and the second heater – Fig. 39: ENRESA2003-PT 09-2003-Dismantling of the heater 1 at the FEBEX in-situ test).

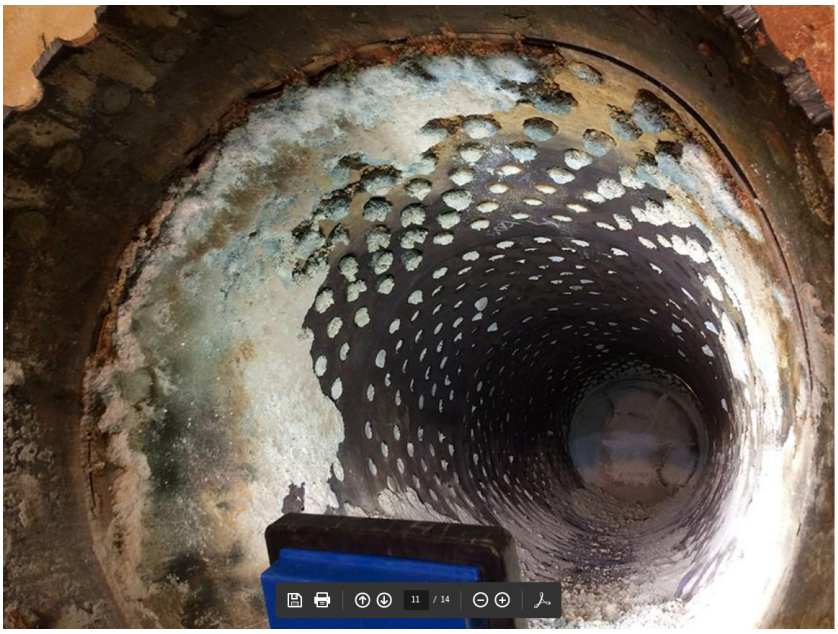
Fig. E-119: The liner after removal of heater 2 for comparison.

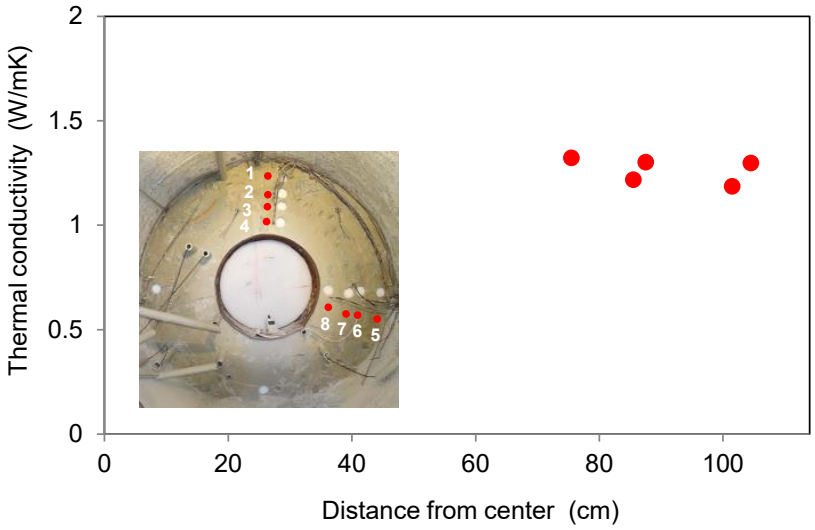
Fig. G-7: In-situ thermal conductivity as a function of radial distance (Section 46).
Measurements at No. 4, 7 and 8 failed.

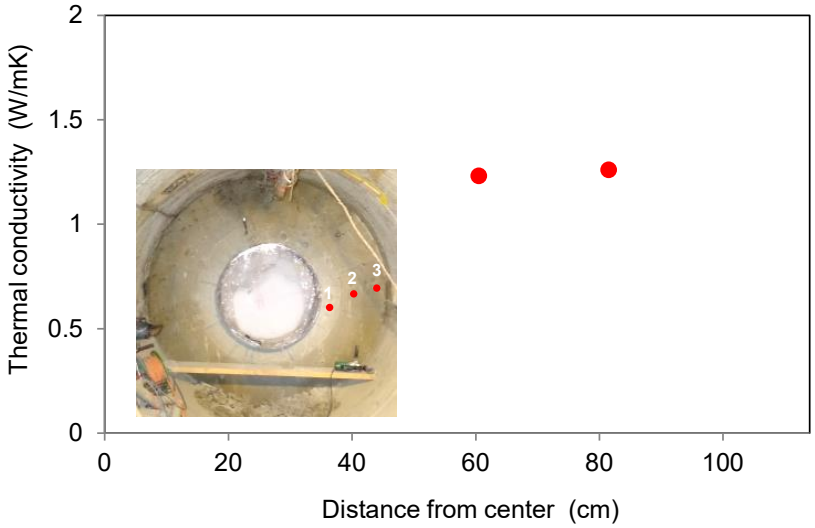
Fig. G-8: In-situ thermal conductivity as a function of radial distance (Section 53).
Measurement at No. 3 failed.

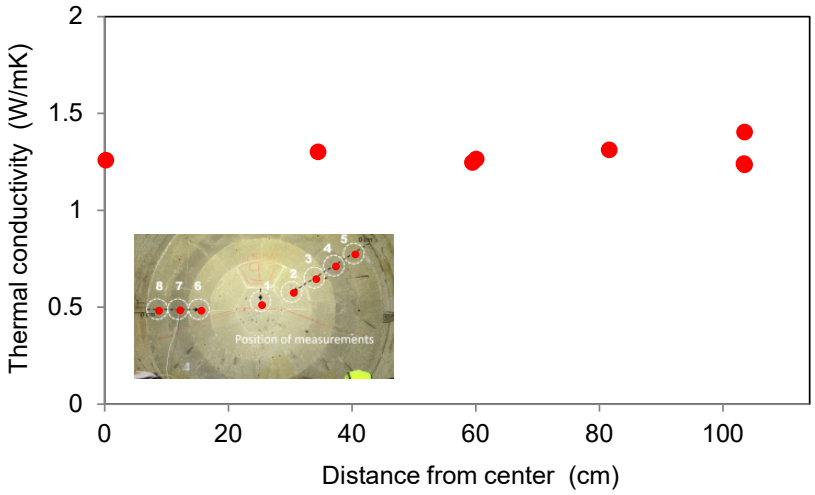
Fig. G-10: In-situ thermal conductivity as a function of radial distance (Section 58, Layer 9).
Measurement at No. 4 failed.
