# Arbeitsbericht NAB 16-20

## FEBEX-DP Post-mortem analysis: Sensors

M. Rey, F-J. Sanz, J-L. García-Siñeriz

AITEMIN

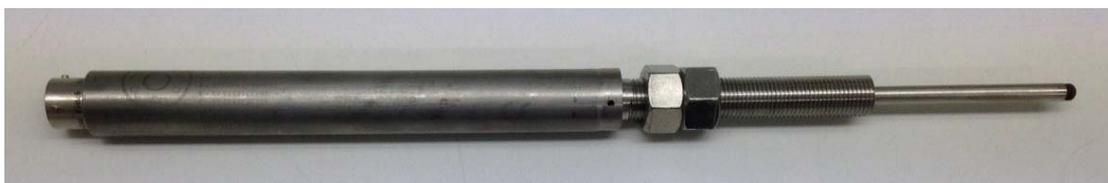
These sensors were operative at the moment of dismantling; they had good external appearance due to the favourable environmental conditions in the gallery. However, the internal springs had lost their elasticity due to rusting as a consequence of humidity; their functioning did not seem significantly affected by this as proven by the verification analysis (see chapter 5.1.1).

**Figure 6. Detail of retrieved displacement sensor**

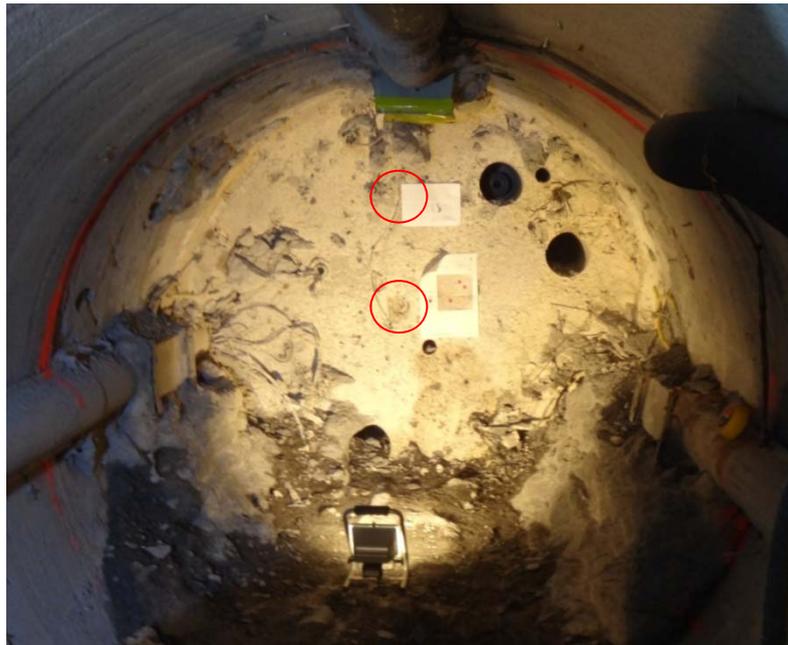
**Figure 9. Overall view of sampling section 34 during dismantling (red circles indicate the expected location of total pressure cells)**

Two total pressure cells were recovered, PSO-01 and PSO-02, which were out of order (see Table 3) well before dismantling on the 14<sup>th</sup> April 2015. The technical characteristics of these sensors are included in section 9.3.2 (KULITE ones).

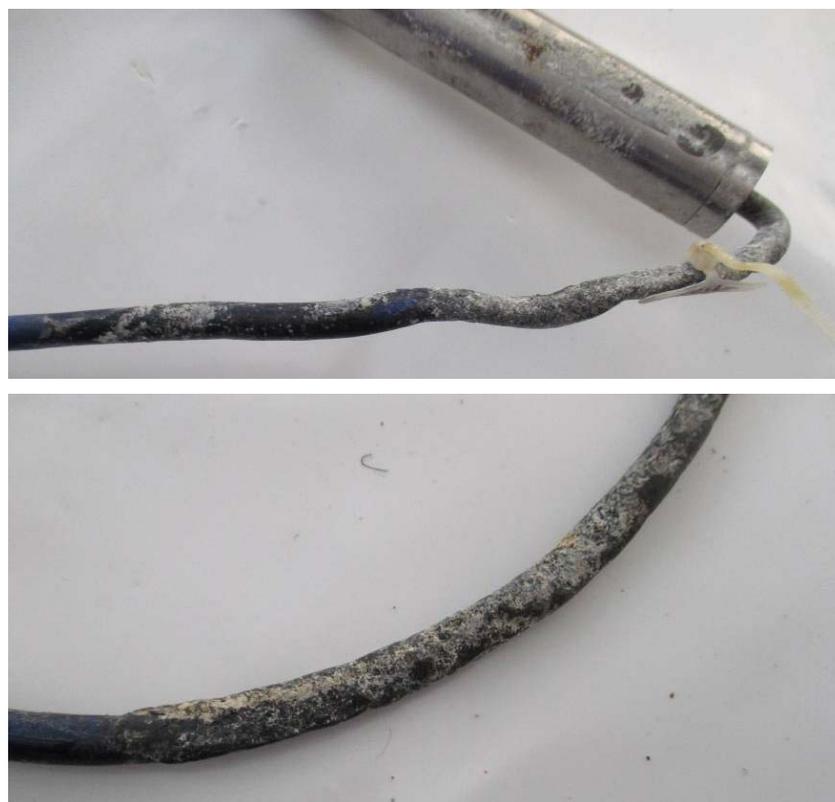
The two total pressure cells were slightly damaged during their extraction, showing some hits of the robot that had dismantled the plug, although their general state of conservation was good; they did not reveal any signs of external corrosion (see Figure 14). The cable was slightly damaged in the vicinity of the sensors, but there was no internal rusting of the wires, indicating they had remained watertight or that the presence of water had not been significant in the section; see Figure 15.

**Figure 15. Detail of final estate of cable, sensors PSP-01 and PSP-02**

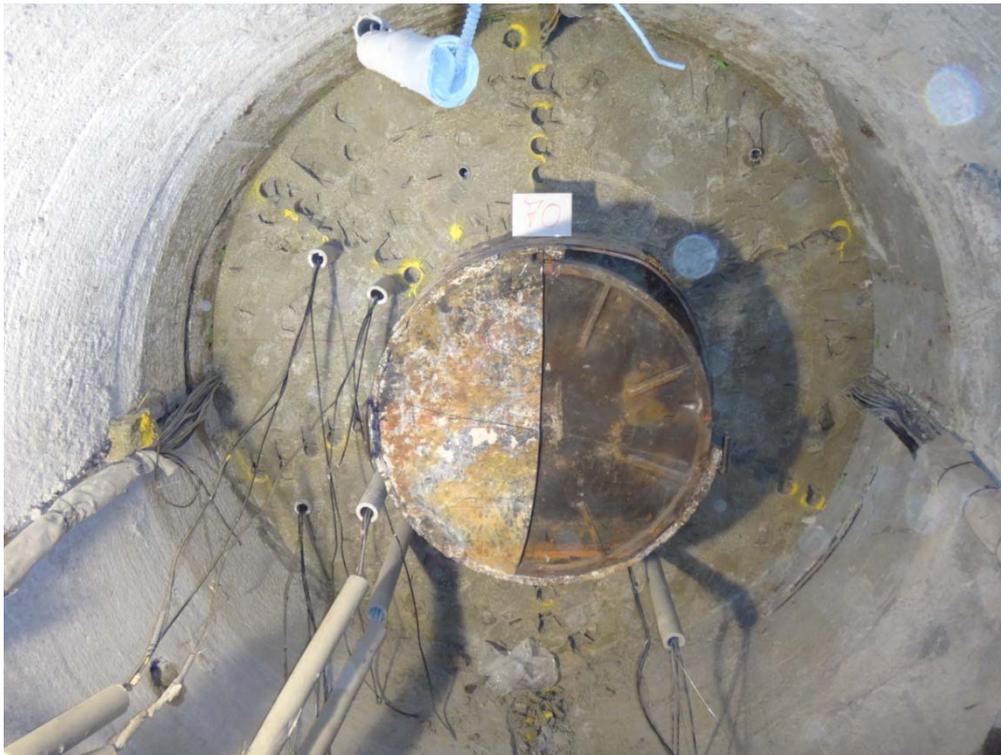
**Figure 18. Sampling section 37 after dismantling**

The three sensors (WCSQ-01, WCSQ-02 and WCSQ-03) were in good conditions; they had not been significantly damaged by bentonite during the operation.

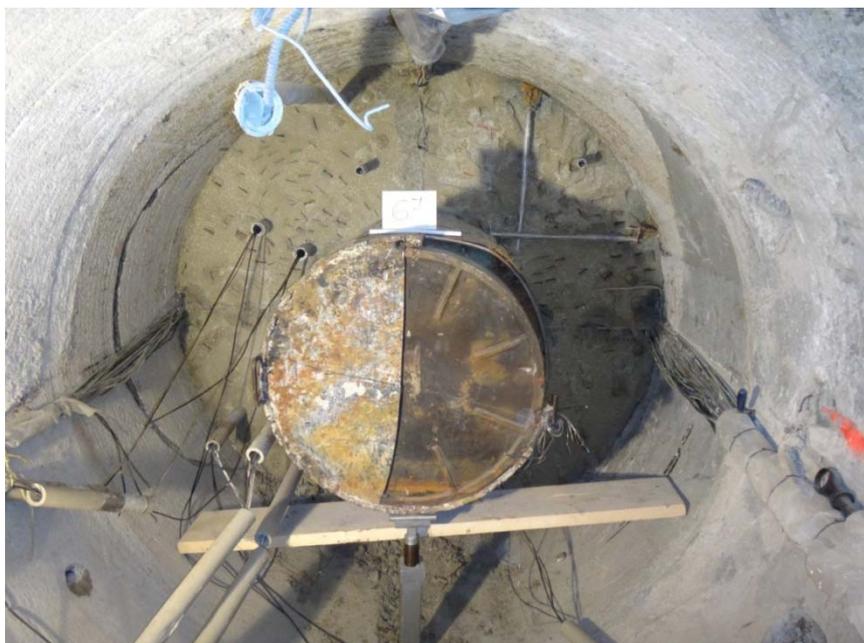
The two extensometers (SH-SG-01 and 02) were found blocked<sup>2</sup>, showed some external scratches from the dismantling operation and were slightly deformed as a consequence of the bentonite's swelling. The technical data of these sensors is given in section 9.3.4.

**Figure 24. Sampling section 38 during dismantling**

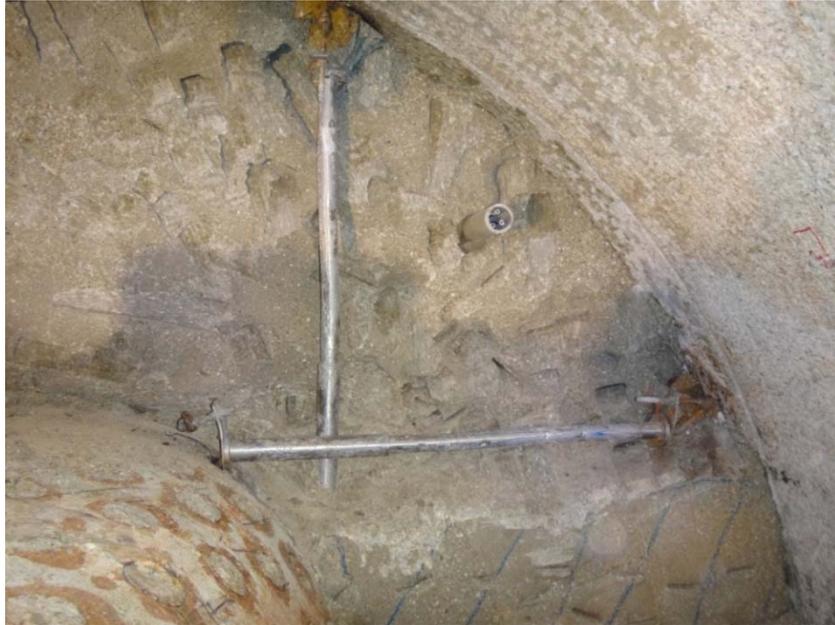
**Figure 25. Detail of extensometers in sampling section 38 during dismantling**

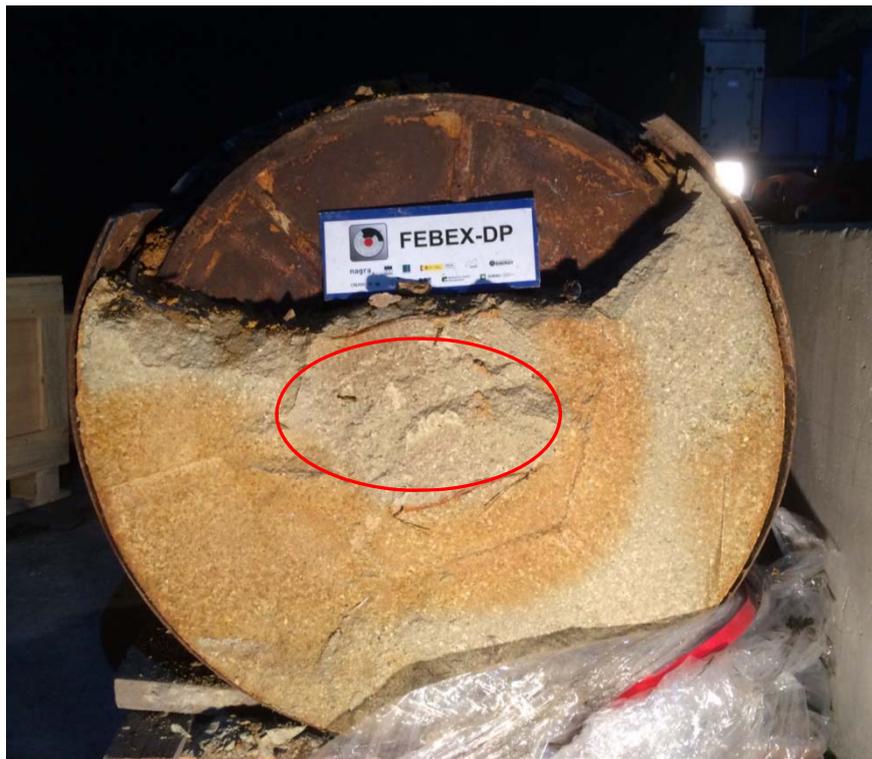
The total pressure cell P-SG-01 was not retrieved as expected. The “dummy canister” and the surrounding liner section were extracted together with the bentonite layer at the rear part (see Garcia-Siñeriz J.L. et al. 2016), which was inside the liner section too (see photo below); therefore, it remained hidden and included in the complete sample package that was left at the Grimsel Test Site. The technical data of the total pressure cell are given in section 9.3.2 (GEOKON 4580-2-6MPa NATM type).

**Figure 29. View of the back part of the dummy canister inside the liner section showing the layer of bentonite that covers the total pressure cell P-SG-01 (approximate location is indicated by the red circle)**

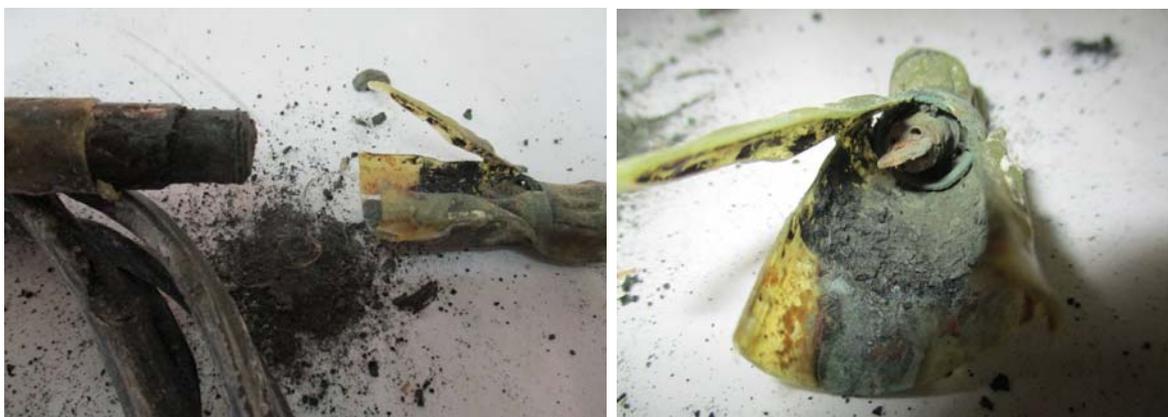
Evidence of the presence of water/humidity inside the sensors was seen, affecting both the filter and sensing element inside the measuring chamber. This was especially the case of thermohygrometers in the central and lower part of the section (WC-SH-01 to WC-SH-06 and WC-SH-11), where the sensing elements (capacitive film and temperature sensor) appeared corroded and/or destroyed, see Figure 36 and Figure 37.

**Figure 37. Detail state of sensor WC-SH-11, close to the liner**

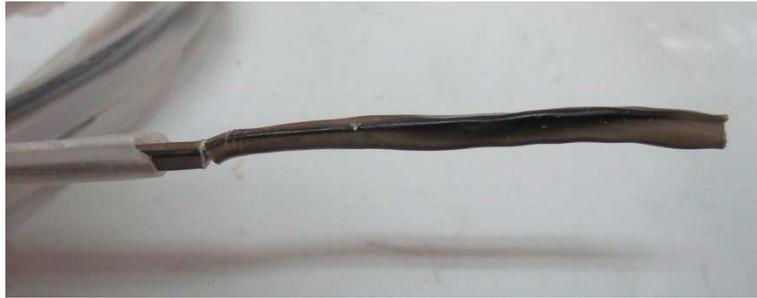
The cables and their protection tubes appeared quite damaged, squashed and broken. The cable was degraded and a change of colour was also noticed; see Figure 39 and Figure 40.

**Figure 40. Detail of cable with colour changes, psychrometers section 41**

It can be stated that all the sensors located in the lower part of the section were in direct contact with free water<sup>3</sup>. They did not suffer significant mechanical damages but the sensitive parts –sensing element– were seriously damaged by corrosion.

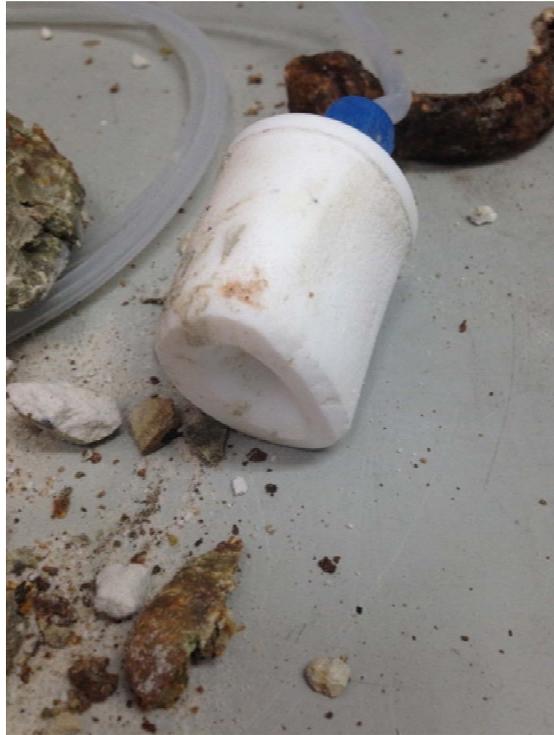
The gas pressure sensor (GP-SH-01) was found complete but clearly deformed due to the bentonite swelling, see Figure 41.

**Figure 41. Gas pressure sensor GP-SH-01 after dismantling**

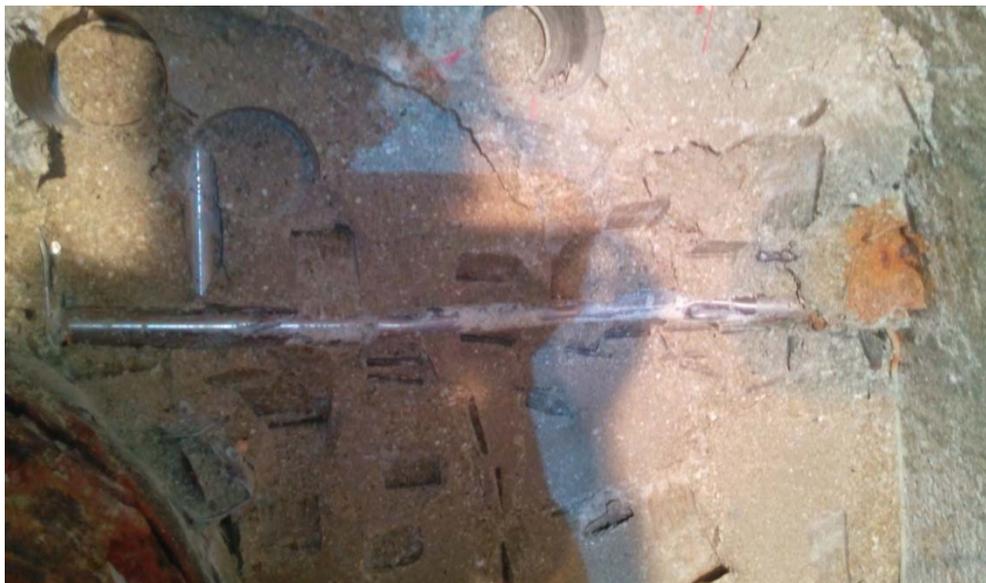
**Figure 45. Sensors in sampling section 42 during dismantling**

The heater displacement sensors (SHSI-01 and SHSI-02, see characteristic at section 9.3.4.) were found slightly deformed as a consequence of bentonite swelling. The body of the sensor was in good condition, but this was not the case of the coupling parts, screws..., which were quite rusty. The cable was not externally damaged but it seemed to have lost some of its properties and was very rigid, as it had previously happened with the same type of sensors in other sections (Geokon ones). There were no signs of water presence inside of the cable or the wires.

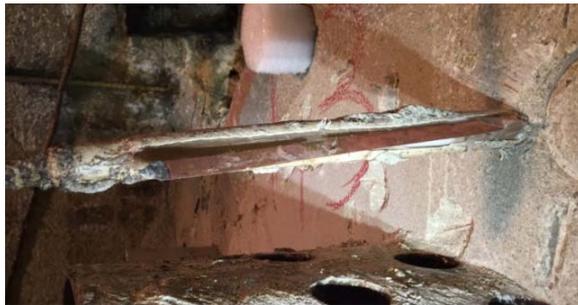
**Cracked coating near heater (WT-M2-09)**

A change in colour from white to brown was seen on the coating film of the probes near the heater (WT-M2-04 and 09). The cable protection showed old cracks in half of the probes (WT-M2-04, 05, 06, 09 and 11), sensor no. 11 –that had failed in 2008– was the most damaged. Most of the probes showed shear deformation at the bentonite block interfaces, although it didn't seem to disturb the volumetric water content estimated with the TDRs that was in close agreement with the sample results, except for WT-M2-09 that had major cracks on the probe coating.

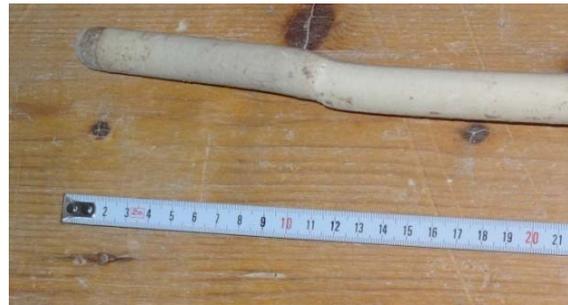
**Large shear at block joints (WT-M2-10)**

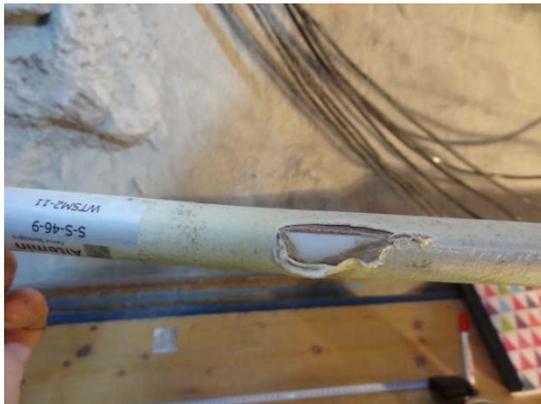
**Typical damage during extraction (WT-M2-11)**

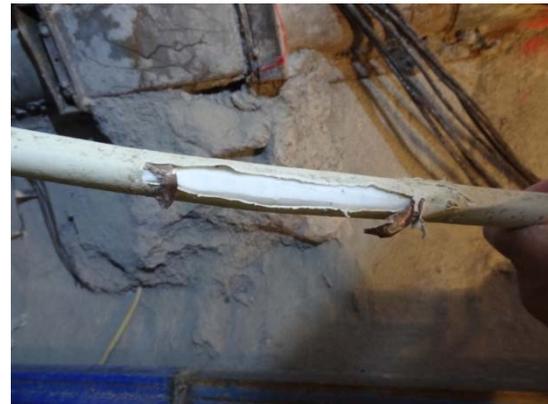
**Typical damage during extraction (WT-M2-10)**

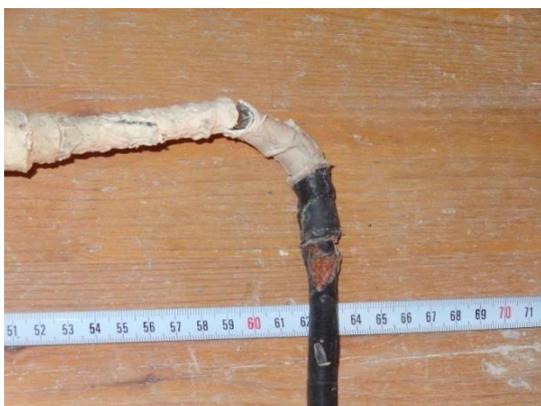
**Typical damage during extraction (WT-M2-11)**

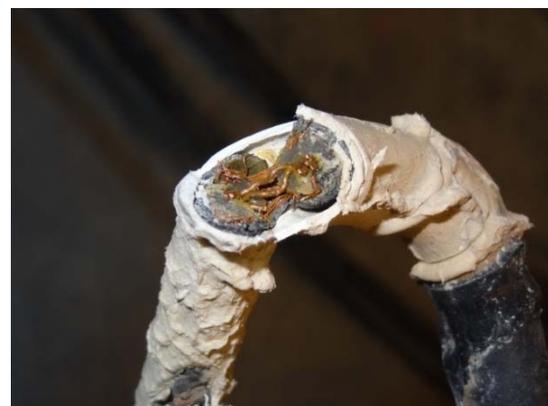
**Nearly disconnected cable (WT-M2-11)**

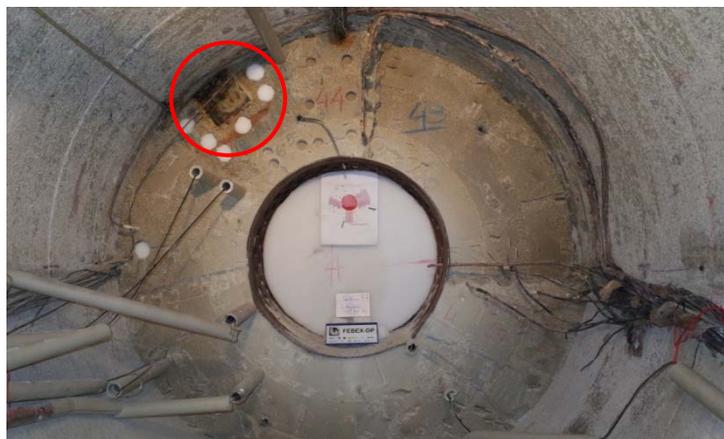
The crackmeter, which had three sensors to measure the displacement in three spatial directions, was out of order from the early part of the operational phase, see Table 11. The majority of sensors of measuring section F2 were located in next sampling section.

Figure 50. Sampling section 47 during dismantling  
The crackmeter is shown inside the red circle

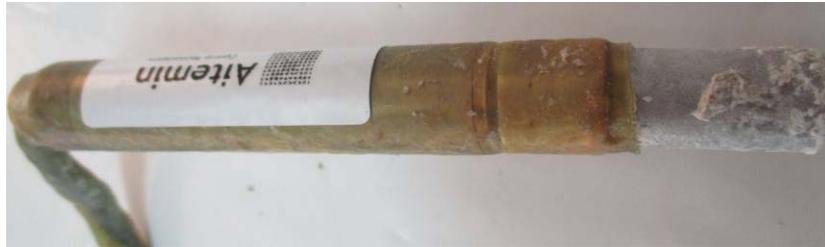
Those sensors installed in the central ring showed important signs of squashing of the cable and of the thermo-retractile that covers the metal body (WC-SF2-03 and 04), especially in the sensor installed on the right (WC-SF2-04); see Figure 56 and Figure 57.

**Figure 56. Detail state of sensor WC-SF2-03**

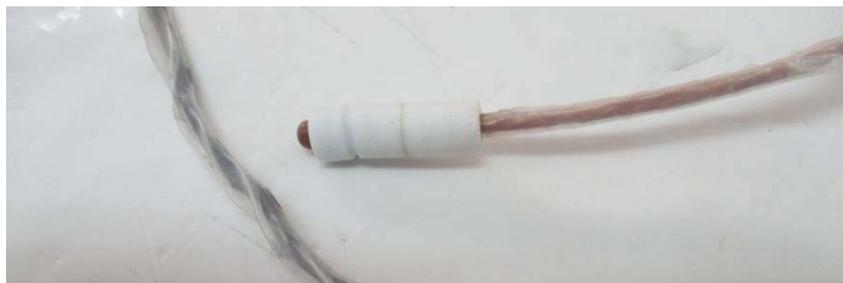
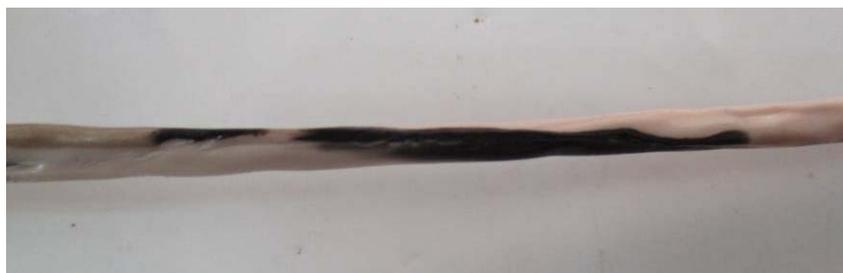
The filter was damaged and had even disappeared in some cases (WP-SF2-01, 03, 05 and 06). The cable and the protection tube were in a bad state, very damaged, with evident signs of degradation (black colour in some points). The sensors with the most significant signs of damage were those installed in the lower part and left part of the section.

**Figure 62. Detail of the state of cable sensor WP-SF2-07**

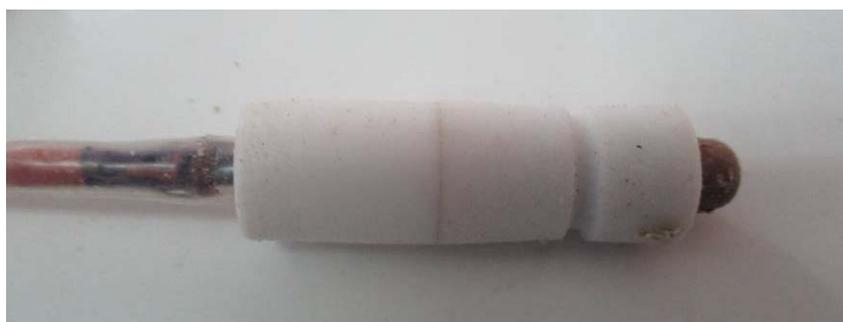
The cable and the cable plastic jacket were quite degraded and sometimes broken, as in sensor WC-SF2-02 (Figure 58).

**Figure 63. Detail of cable stretching of WC-SF2-02 due to swelling of bentonite**

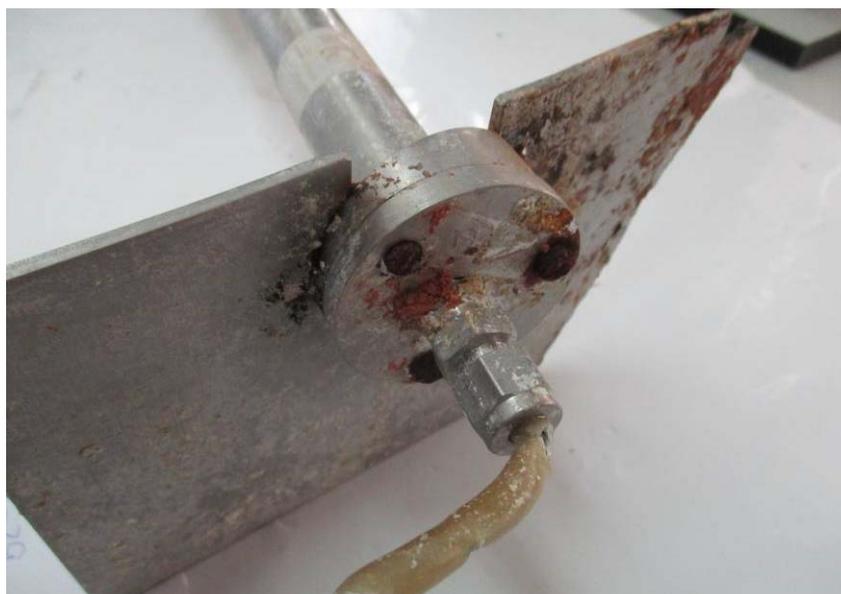
The cable was brown at the sensor output, probably as a consequence of corrosion. Some traces of humidity/water were found in the inner part of the cable of SBF2-01.

**Figure 65. Detail of cable output from sensor SBF2-01**

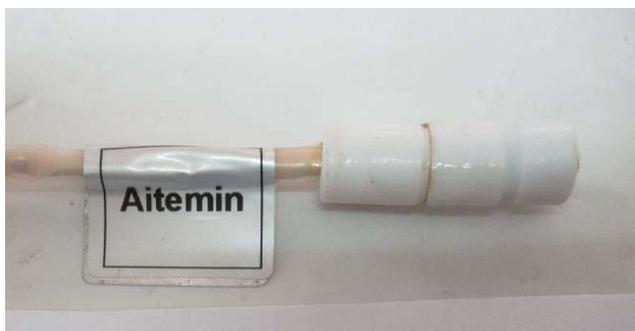
The case of the psychrometers (WPSE2-01 to 08, see technical data in section 9.3.8.) was similar to previous sections. In general, they were slightly deformed (see Figure 77), with the filters appearing broken in the case of sensors 01, 03, 04, 05, 06 and 07. The cable and the protection tube were both quite damaged; the colour of the cable had turned black; see Figure 78.

**Figure 77. Detail of psychrometers' protection slightly deformed by bentonite's swelling (left S-S-51-19 / WPSE2-01; right S-S-51-23 / WPSE2-05)**

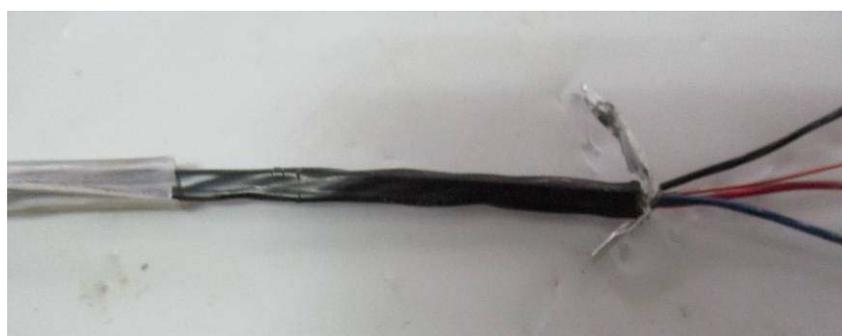
**Figure 78. Detail of cable sensor WP-SE2-07**

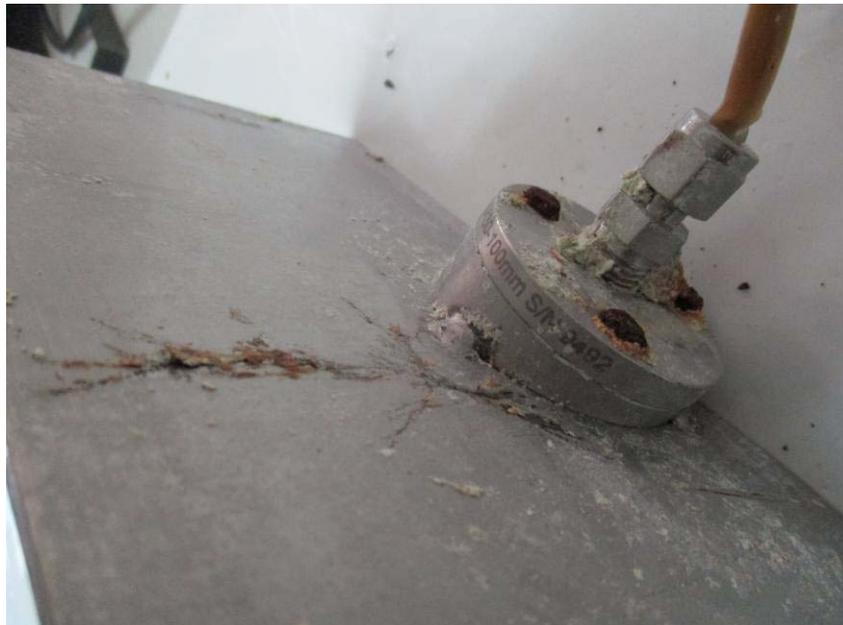
The extensometers (SB-E2-01 and SB-E2-02, see technical data in section 9.3.5.), were slightly deformed as a consequence of bentonite swelling; see Figure 81. There were traces of rust in the vicinity of the sensor's body. Sensor SB-E2-02 was blocked.

**Figure 82. Detail of the state of the cable (sensor SB-E2-02)**

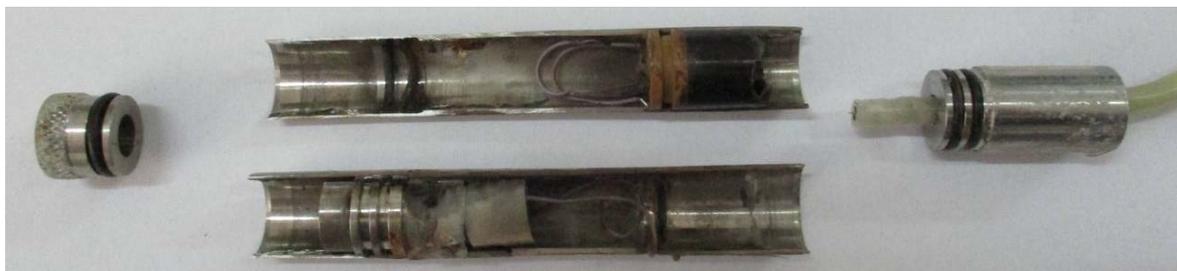
Sensor QSH-02 was disassembled –the body was cut longitudinally to observe the interior part– and the presence of rust inside the chamber was observed (see Figure 88), originating in the measuring membrane. However, the quantity of rust was negligible considering the duration of the experiment and the fact that there was no effect on the sensor's electronics. It can be therefore stated that these sensors were watertight and robust.

**Figure 88. Pore pressure sensor QSH-02 after being cut longitudinally, close-up of disassembled parts**

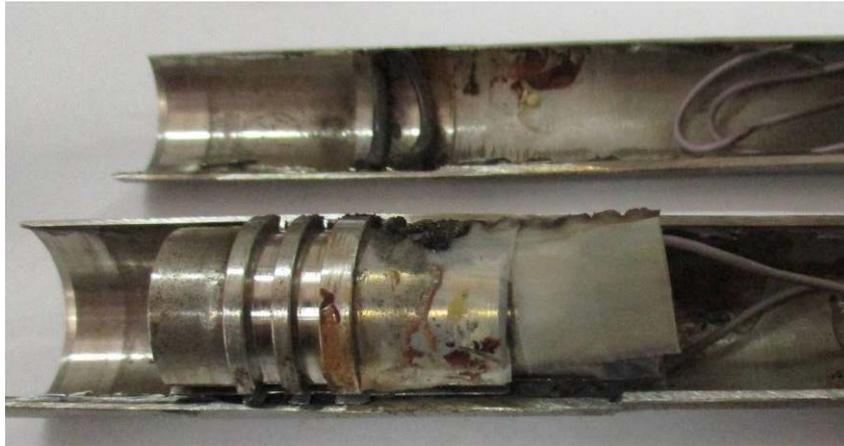
**Figure 89. Detail of pore pressure sensor QSH-02 close-up**

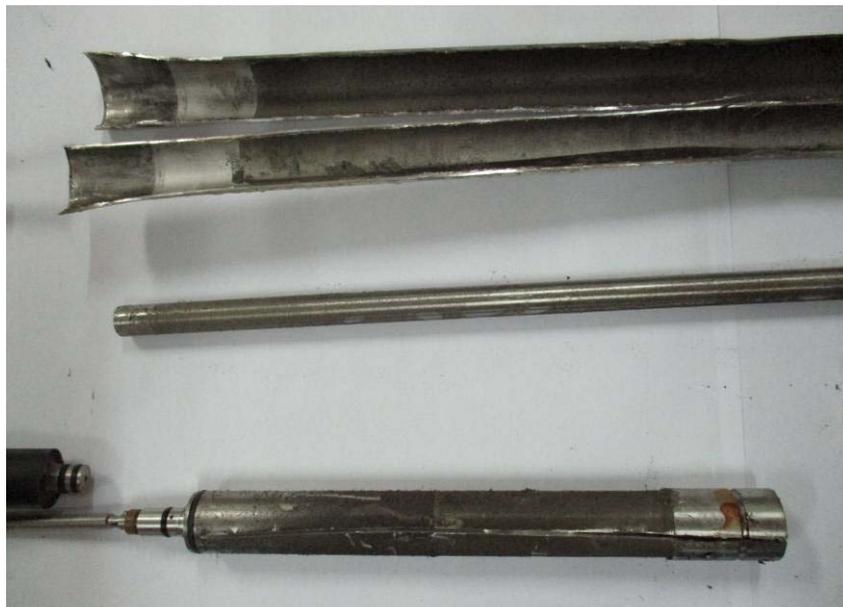
These sensors are made of a cylinder that houses the sensing element, and which moves along another cylinder that acts as protection as well, preserving water tightness by means of several O-rings. The transition sensor's electronics-vibrating wire was encapsulated with resin. Again, the body of one sensor (SHSG-02) was cut longitudinally to inspect the interior (Figure 90).

**Figure 90. Extensometer close-up of disassembled parts**

From the visual inspection, it can be concluded that the main problem for these sensors was the deformation caused by bentonite swelling. When the tubes were slightly bent the movement was limited and finally blocked. As a consequence of this deformation the O-rings may lose their seal, allowing water or bentonite to enter although in small amounts only.

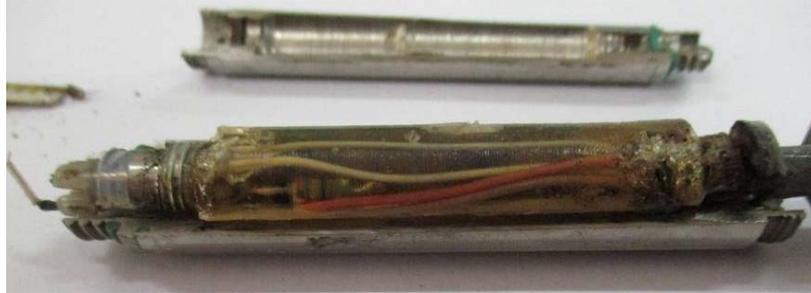
The body of the capacitive relative humidity sensor WCSH-09 was cut longitudinally to examine the inner part (Figure 91). As a result, it can be stated that these sensors lost their water tightness during the operation. The water reached the sensing element entering by the filter or by the connecting point of filter and capsule. This connection was protected by thermo-shrinkage tubing but the protection did not prove effective enough.

Figure 91. Capacitive relative humidity sensor WCSH-09 exploded view

The transition from electronics to wire was made inside the metallic capsule, which was encapsulated with resin. However, as the transition was directly connected to the sensing element, the water entered through the conductors/wires, causing the corrosion of the metallic wires.

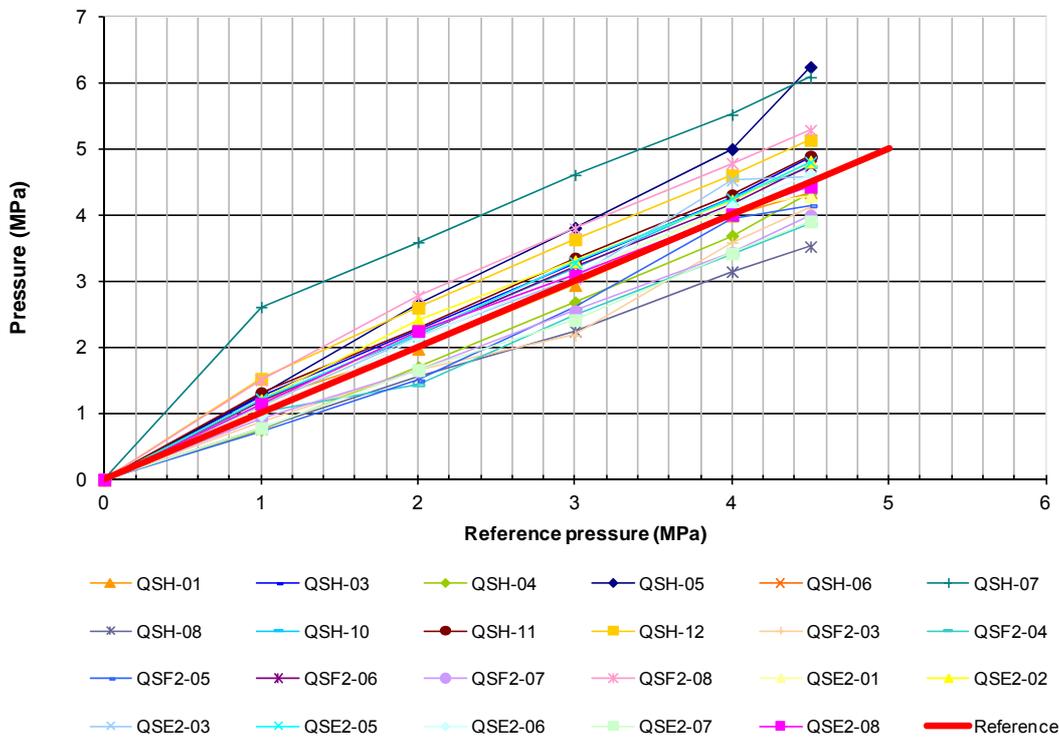
The results are also plotted in Figure 97; a reference curve of the ideal response is added in red, to compare with the recorded verification reading. As can be seen, they showed an average deviation below 10% except for QSH-07, which had a higher error. Sensor QSH-05 also had a larger deviation, but only above 4 MPa. These results, after 18 years of operation, can be considered as excellent. Temperature sensors of QSH-01 and QSH-10 were broken.

**Figure 97. Results of the verification of pore pressure sensors**

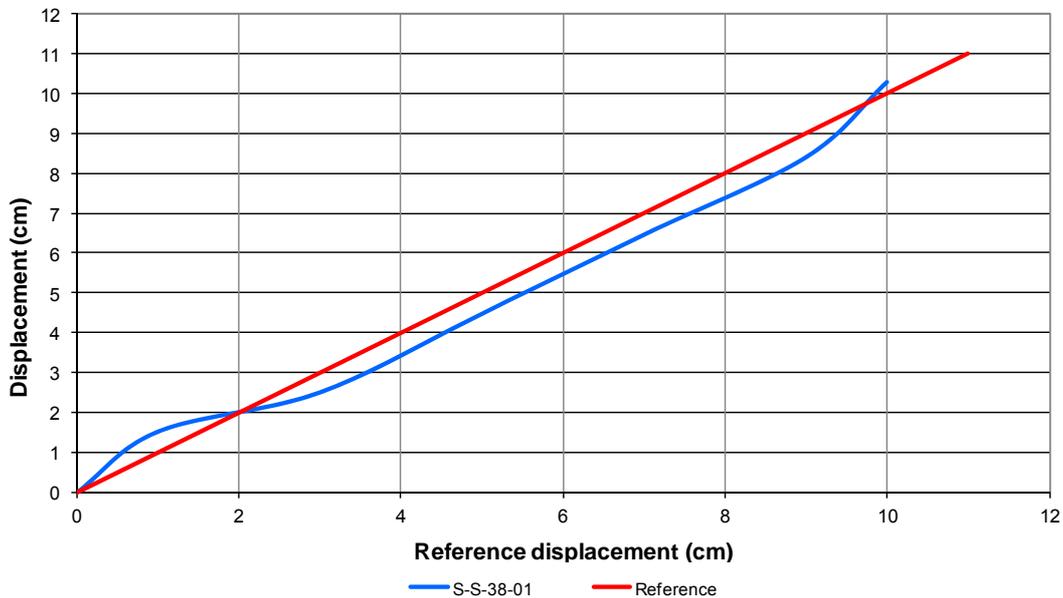
**Figure 98. Results of the verification of displacement sensor S-S-38-01 / SHSG-01**

A maximum deviation of 0.59 cm was recorded for sensor S-S-38-01 / SHSG-01 see Figure 98.

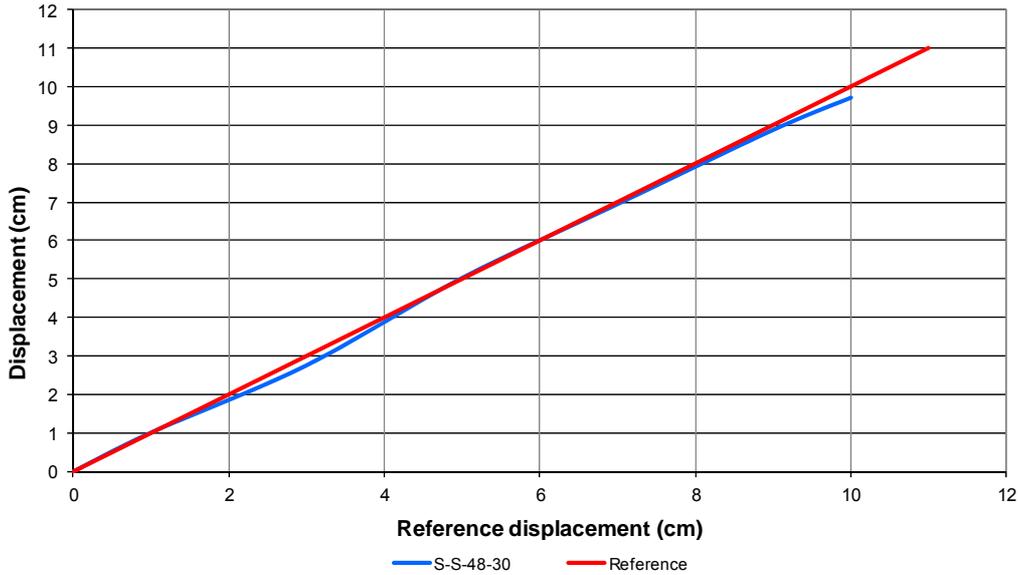
**Figure 99. Results of the verification of displacement sensor S-S-48-30 / SBSF2-02**

A maximum deviation for sensor of 0.29 cm was recorded for S-S-48-30 / SBSF2-02, see Figure 99.

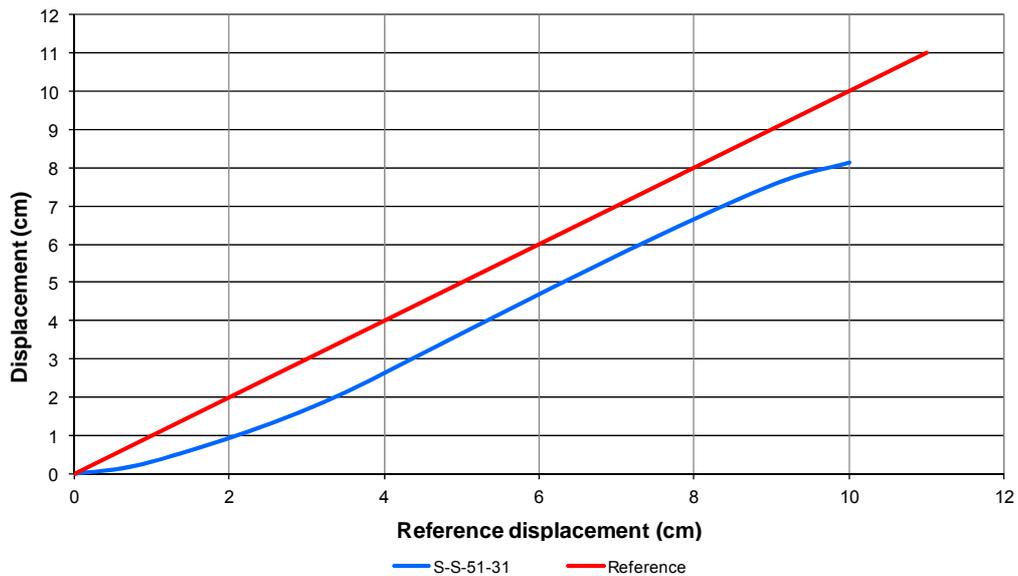
**Figure 100. Results of the verification of displacement sensor S-S-51-31 / SBSE2-01**

Finally, a maximum deviation of 1.88 cm is seen for sensor S-S-51-31 / SBSE2-01 (Figure 100).

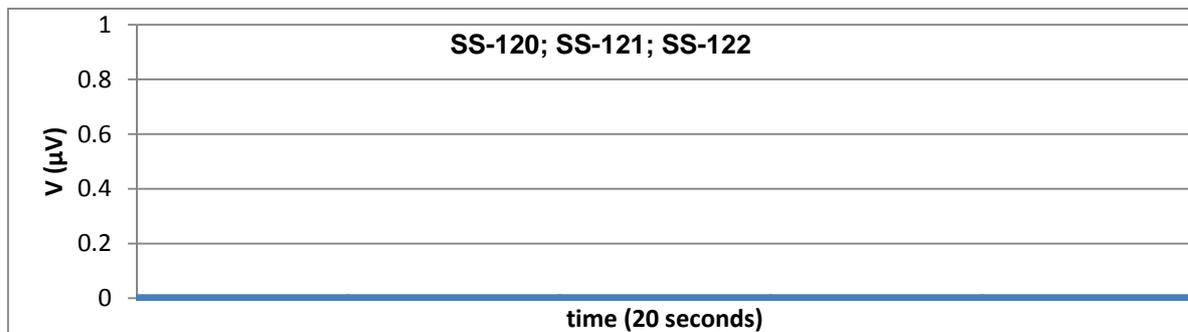
**Figure 101. Verification curve for psychrometer WC-SF02-03**

Sensor WP-SF2-03 (faulty during the test):

The graphs are coincident for the three standard solutions, i.e. it is not functioning:

The obtained results show that none of the checked sensors can be considered as reliable. As it had already been observed in the previous dismantling operation (García-Siñeriz et al. 2006), the heating-cooling cycles of the sensing elements of the sensors, to which they are subject for the continuous reading, may have damaged the sensor, causing its failure and accelerating the contamination of the chamber with salts coming from the bentonite. The signal of a contaminated sensor looks like the graph at the right hand of Figure 109.

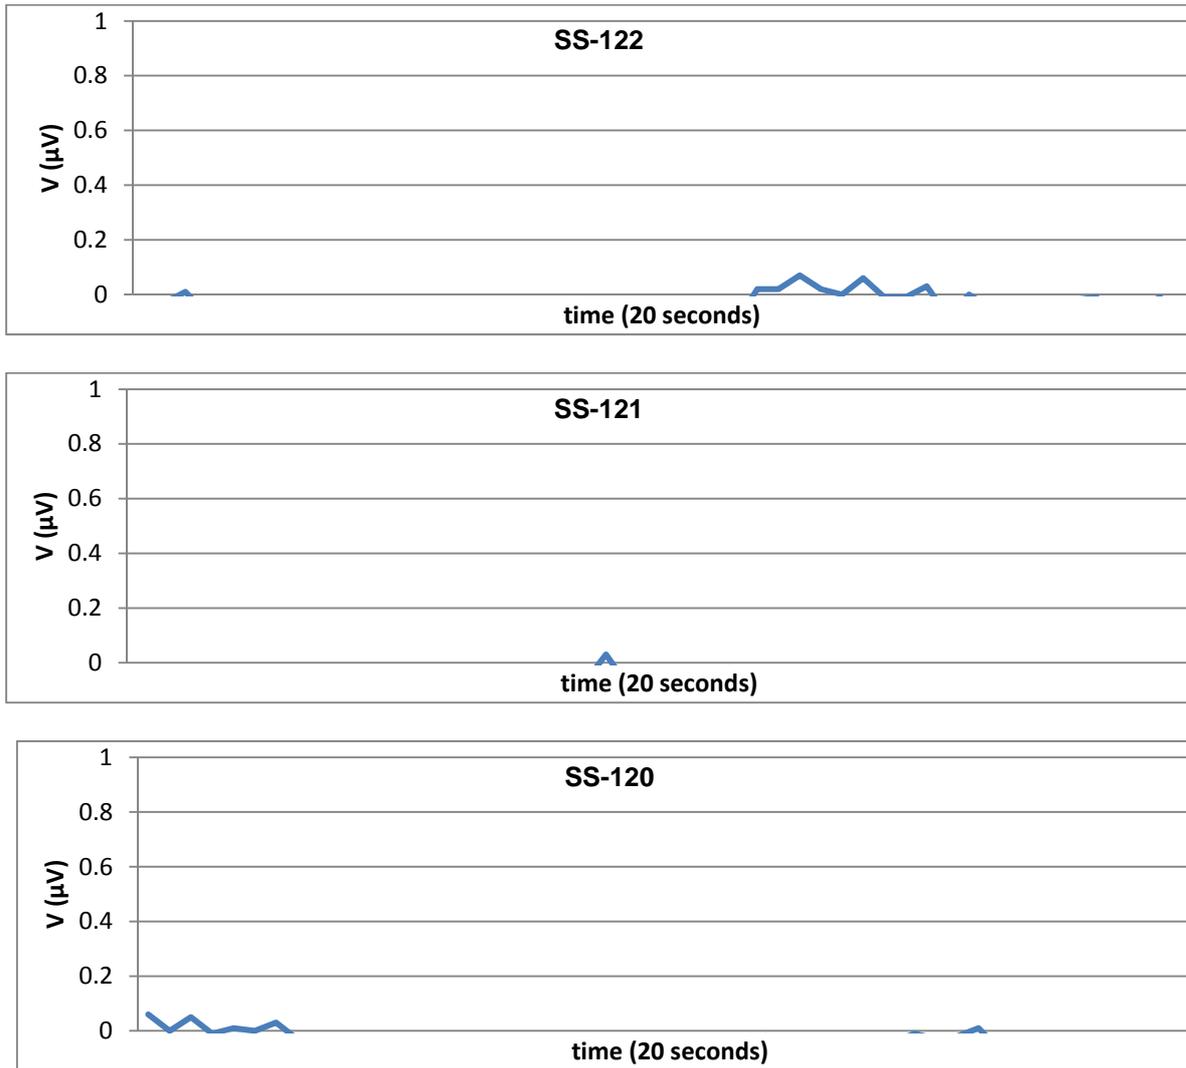
Figure 102. Verification curves for psychrometer WP-SF2-04

Sensor WP-SF2-04 (faulty during the test):

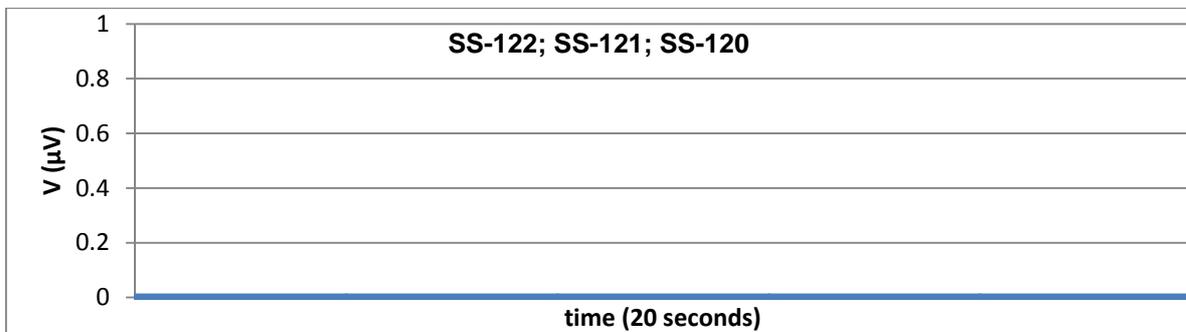
Figure 103. Verification curves for psychrometer WP-SF2-05

Sensor WP-SF2-05 (faulty during the test):

The graphs are coincident for the three standard solutions:

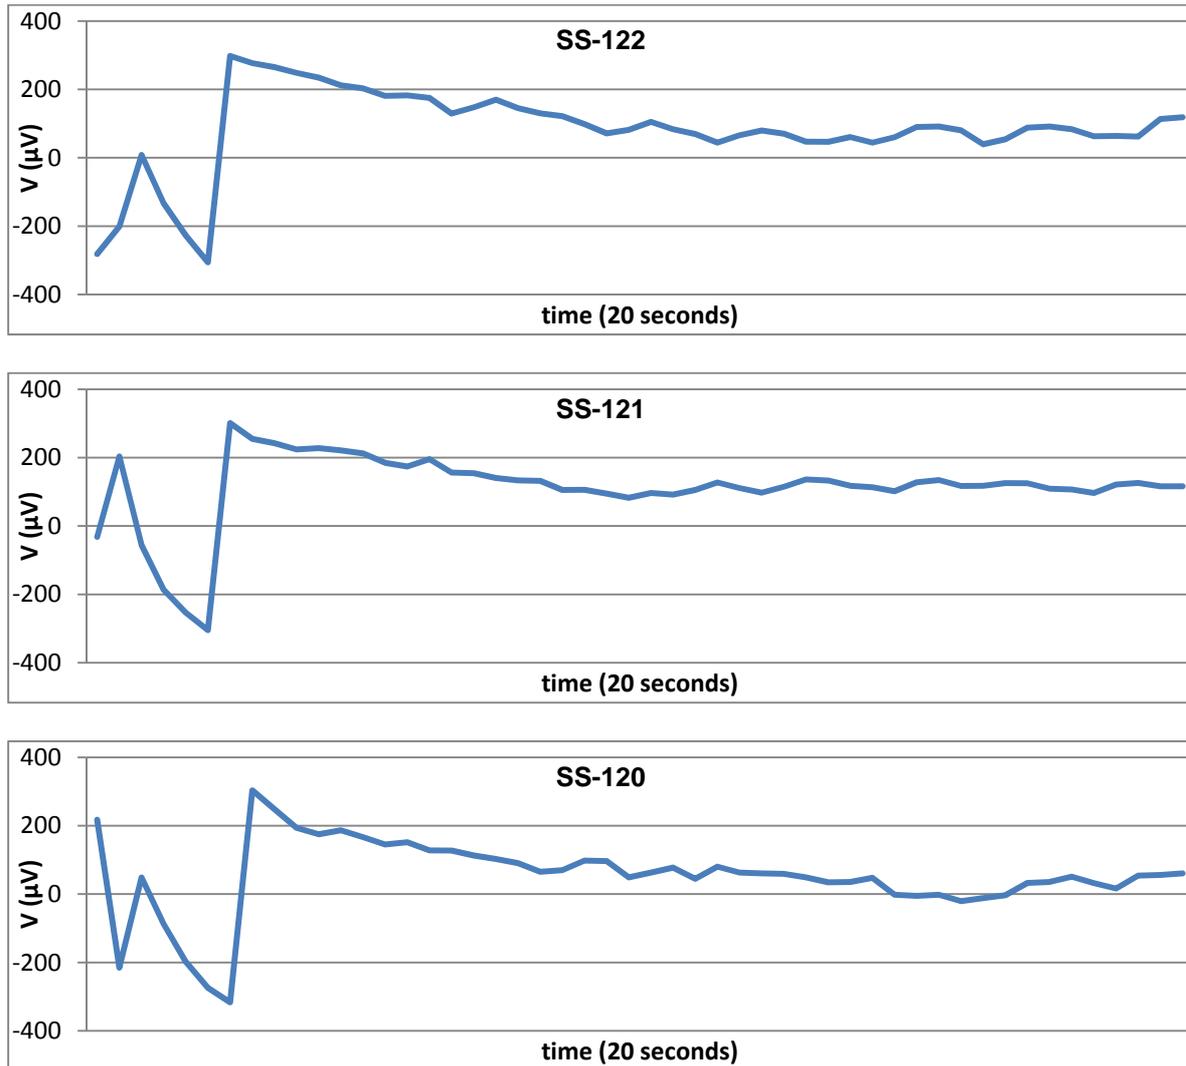
Figure 104. Verification curves for psychrometer WP-SF2-07

Sensor WP-SF2-07 (faulty during the test):

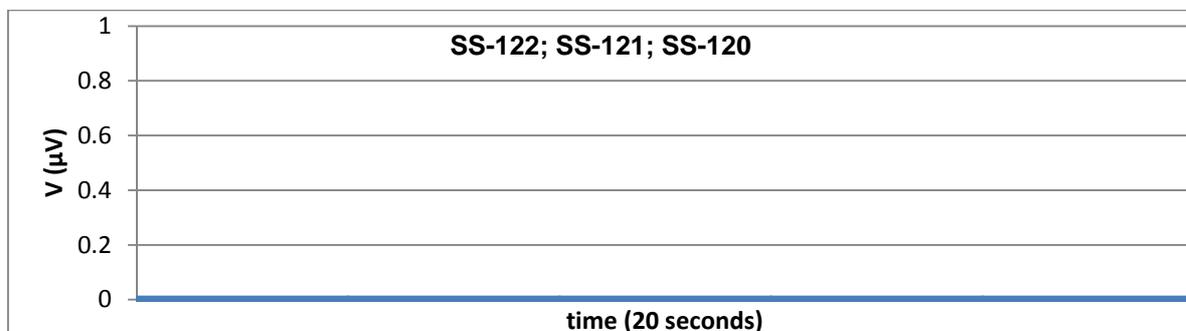
Figure 105. Verification curves for psychrometer WP-SE2-02

Sensor WP-SE2-02 (faulty during the test):

The graphs are coincident for the three standard solutions:

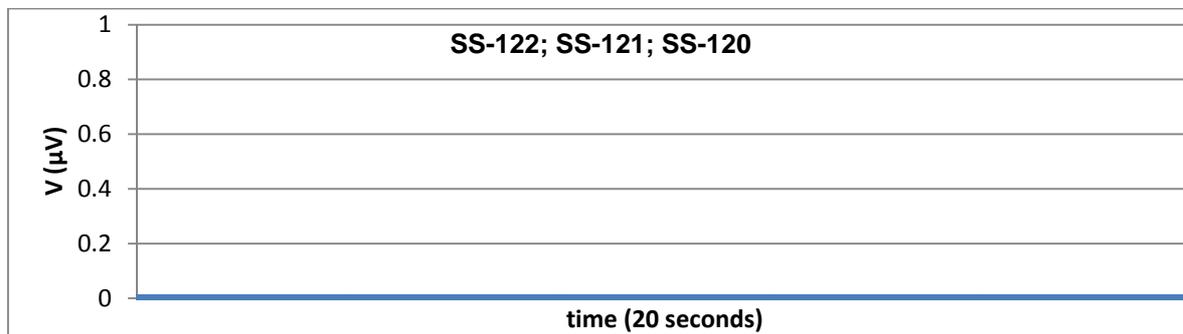
Figure 106. Verification curves for psychrometer WP-SE2-04

Sensor WP-SE2-04 (faulty during the test):

The graphs are coincident for the three standard solutions:

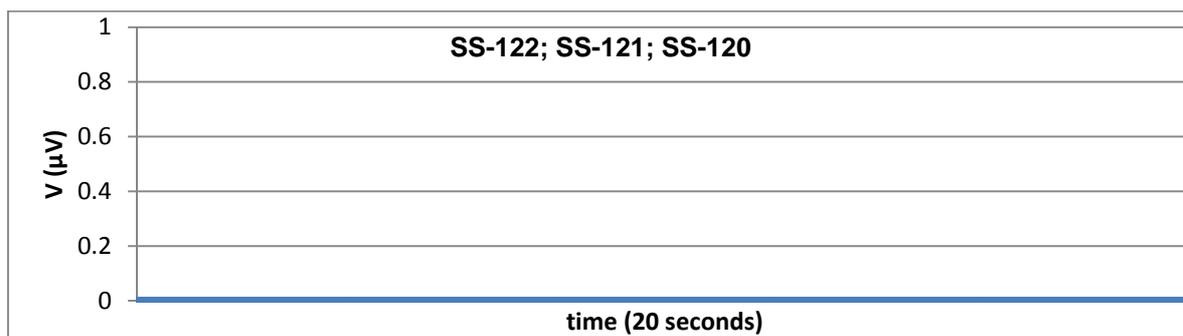
Figure 107. Verification curves for psychrometer WP-SE2-05

Sensor WP-SE2-05 (faulty during the test):

The graphs are coincident for the three standard solutions:
