# Arbeitsbericht NAB 16-20

## FEBEX-DP Post-mortem analysis: Sensors

M. Rey, F-J. Sanz, J-L. García-Siñeriz

AITEMIN

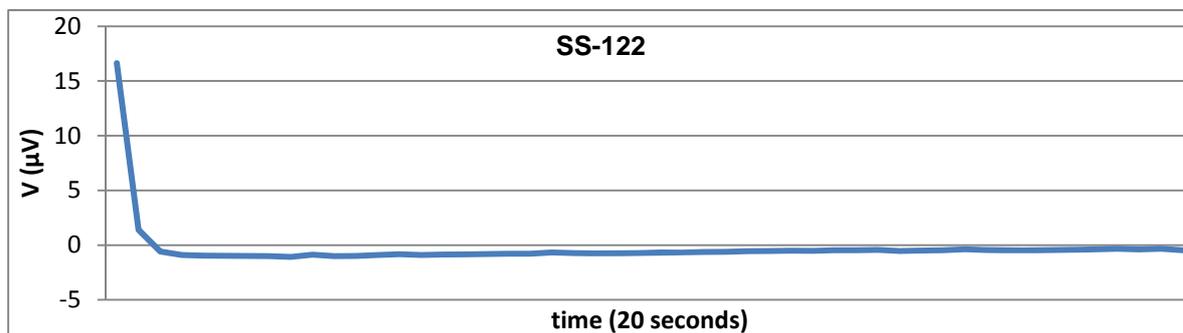
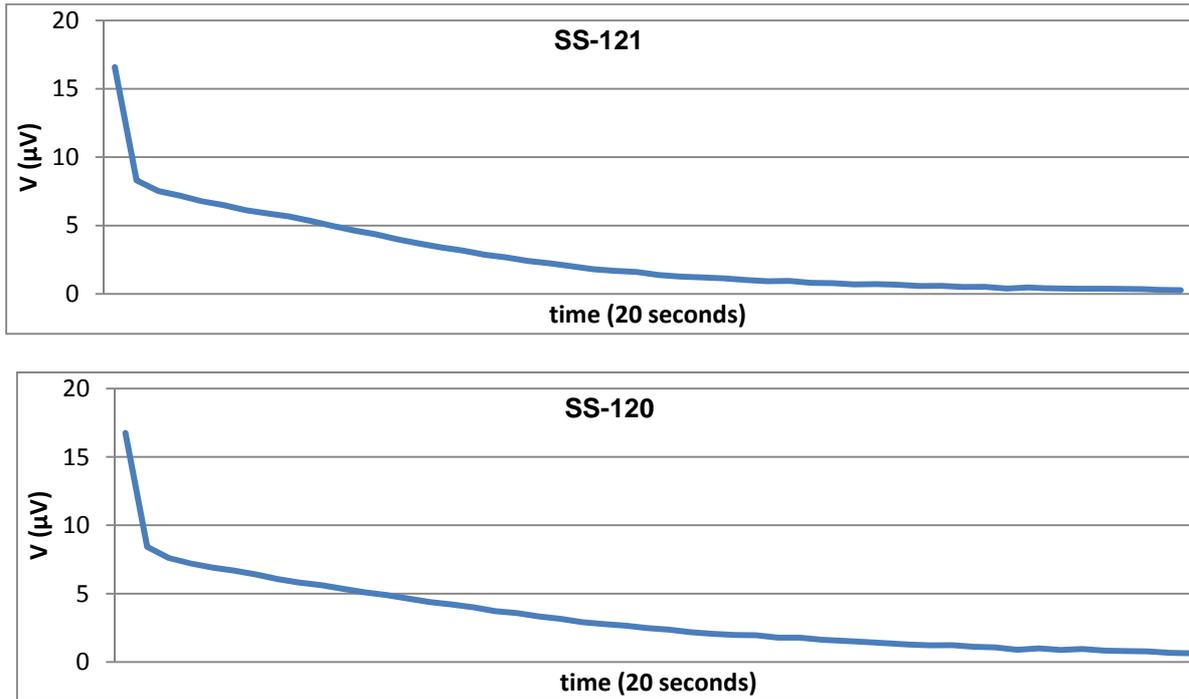
**Figure 108. Verification curves for psychrometer WP-SE2-08**

Sensor WP-SE2-08 (faulty during the test):

The obtained results show that none of the checked sensors can be considered as reliable. As it had already been observed in the previous dismantling operation (García-Siñeriz et al. 2006), the heating-cooling cycles of the sensing elements of the sensors, to which they are subject for the continuous reading, may have damaged the sensor, causing its failure and accelerating the contamination of the chamber with salts coming from the bentonite. The signal of a contaminated sensor looks like the graph at the right hand of Figure 109.

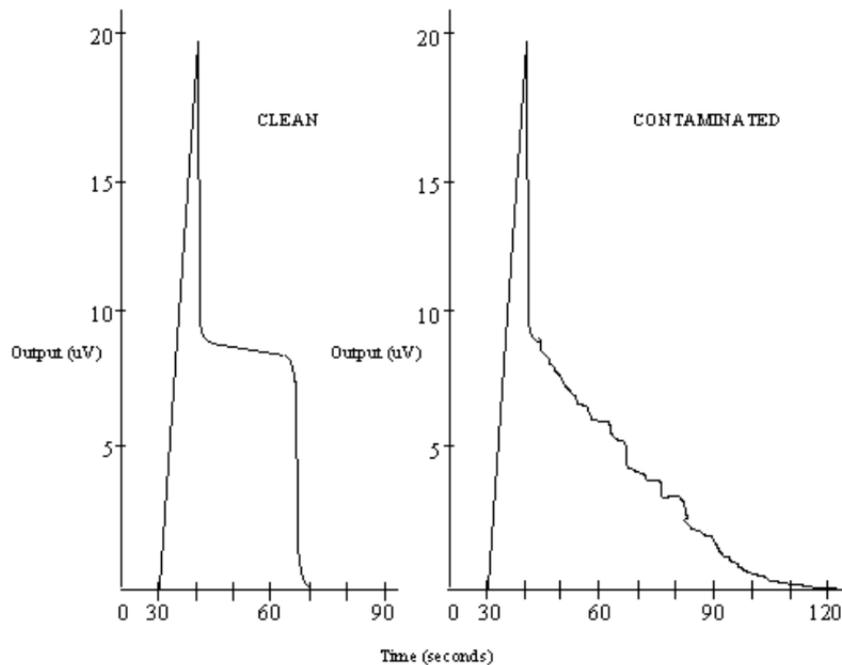
**Figure 109. Output signal for clean and contaminated psychrometer (from sensor’s manual)**

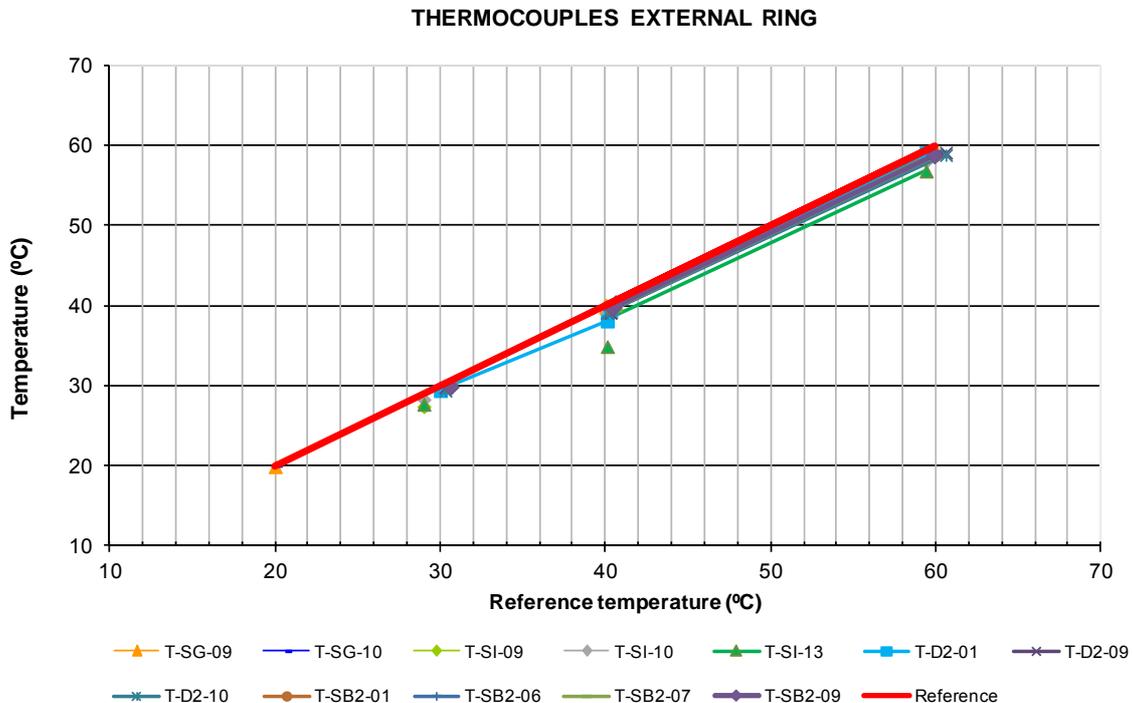
Figure 111 shows the calibration results of sensors installed in external ring giving a valid signal after dismantling.

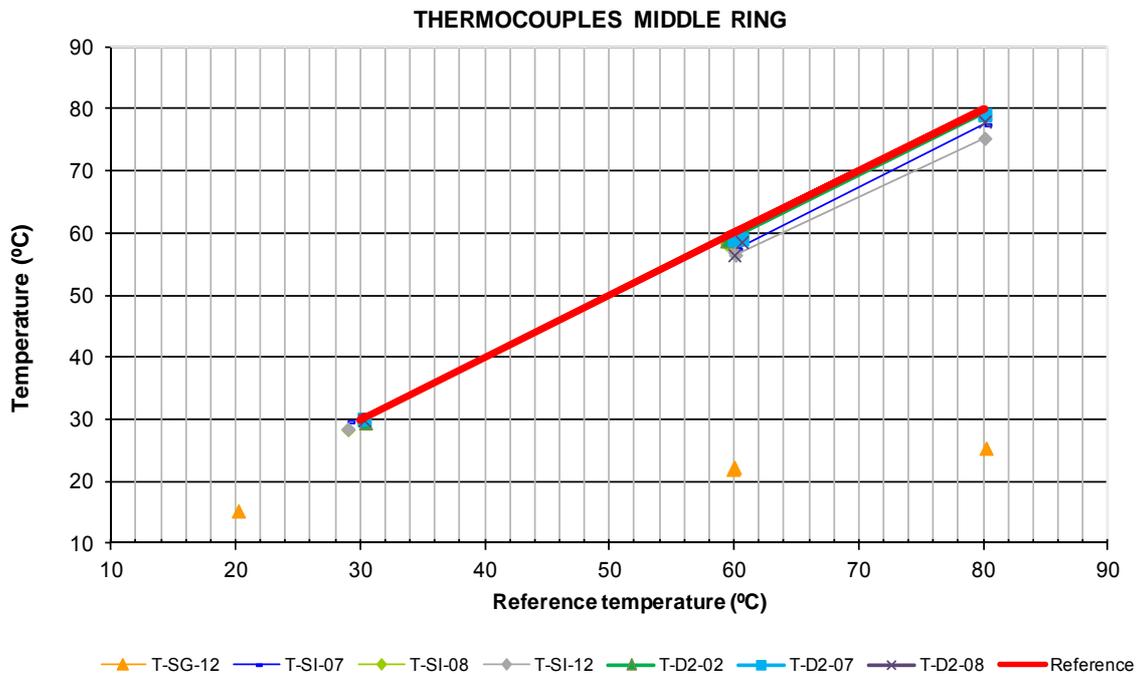
**Figure 112. Results calibration thermocouples middle ring**

Figure 112 shows the calibration results of sensors installed in middle ring giving a valid signal after dismantling.

<sup>5</sup> N.R. No response. probably damaged during dismantling

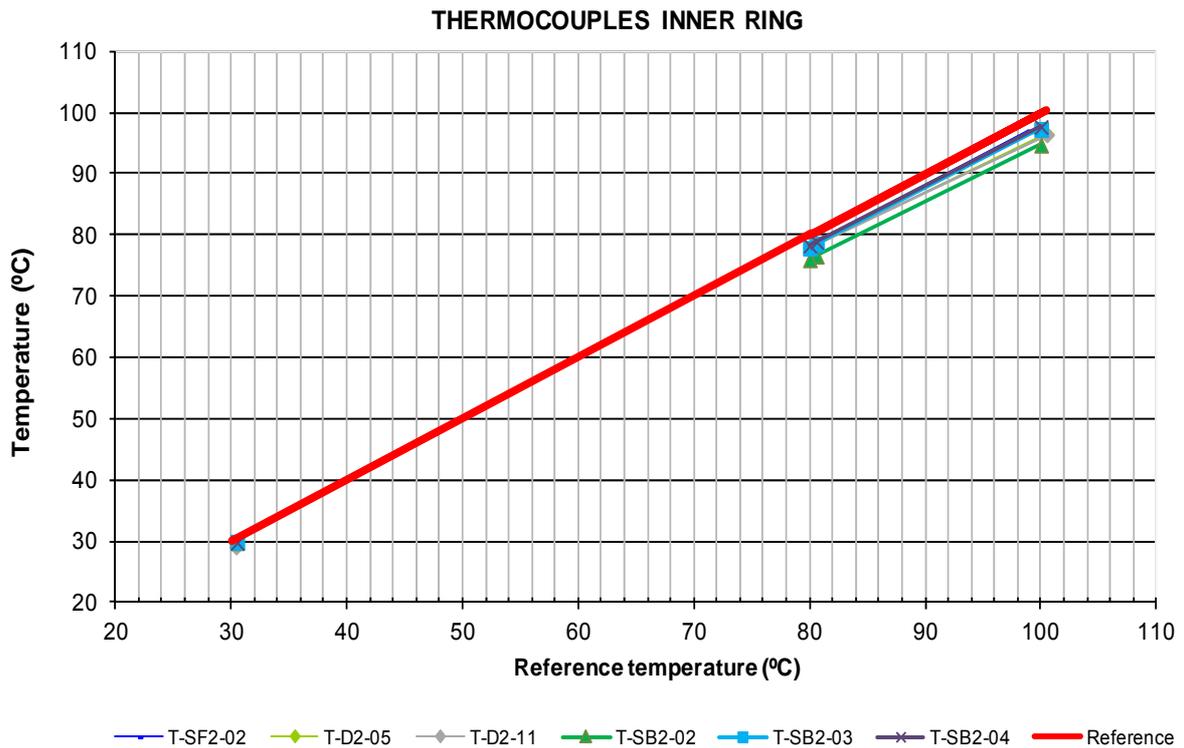
**Figure 113. Results calibration thermocouples inner ring**

Unfortunately, some thermocouples did not show any response to temperature changes (N.R.) probably these were damaged during the dismantling operations.

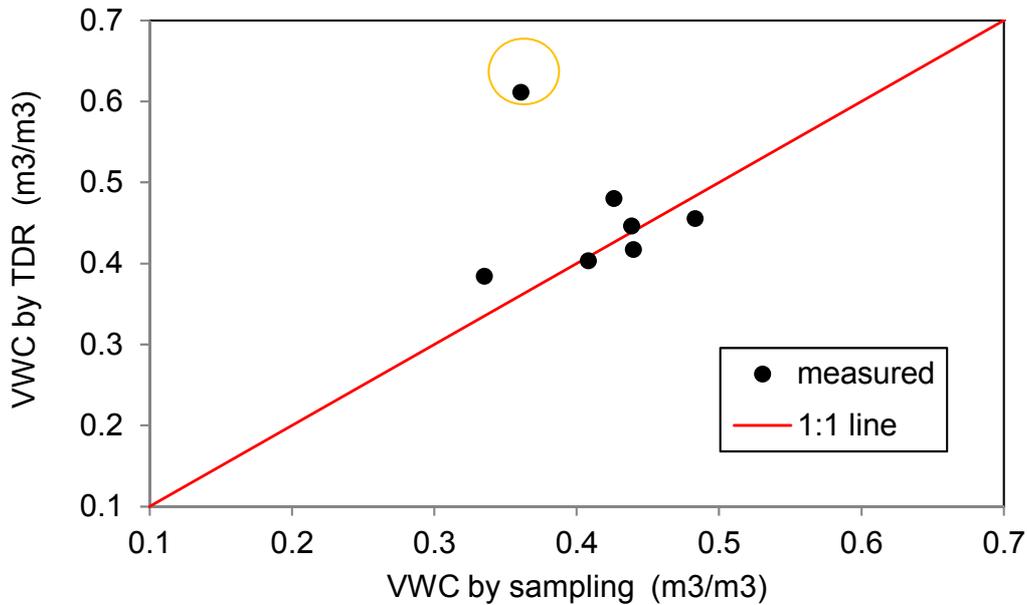
**Figure 114. Comparison of TDR-measured volumetric water content and those from samples**

Figure 114 shows the comparison of the TDR-measured volumetric water content (VWC) and those of the samples taken in the vicinity of the probes. More details of the verification of the data are given in Sakaki et al. 2016. Although the circled TDR-measured VWC was overestimated possibly due to water intrusion via cracked probe coating, the rest showed a good agreement with the sample results.
