Arbeitsbericht NAB 16-54

Corrosion Study of FEBEX-DP Components

Virginia Madina

TECNALIA

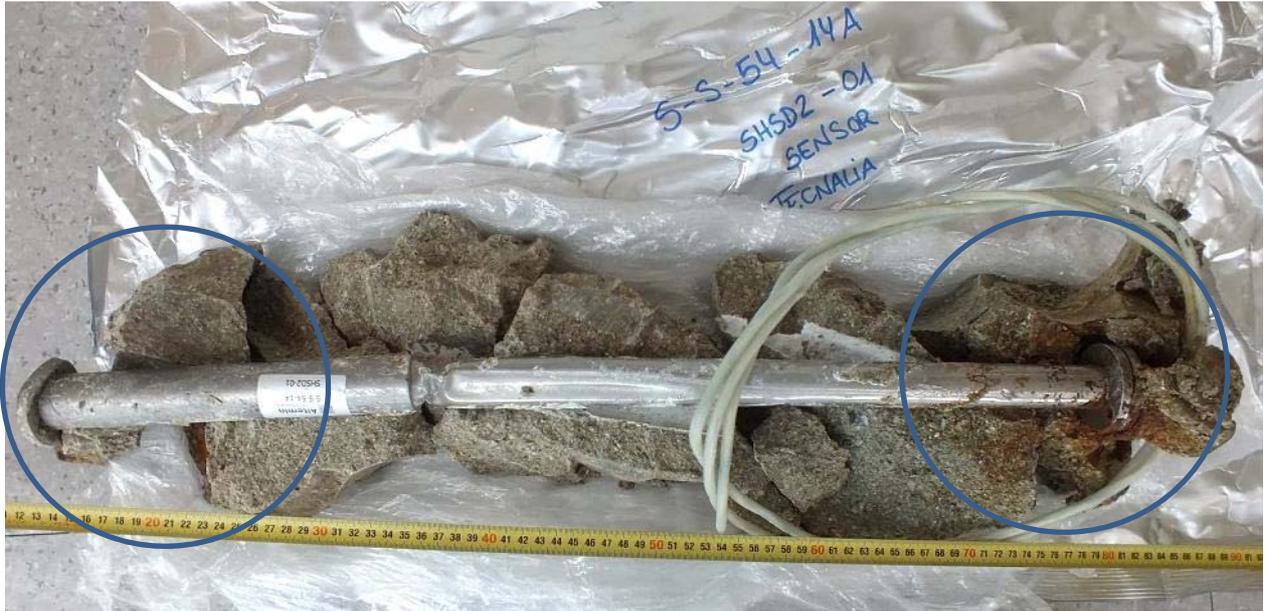
The corrosion damage observed on sensor ref. SHSD2-01 is very similar with that observed for sensors SHSD2-02 and SHSD2-03. The corrosion damage is defined in three zones: R (close to the rock), L (close to the Liner), and C (central zone of the extensometer). Zones R and L coincide with the zones of greatest corrosion and diffusion of corrosion products, as it can be seen in the above mentioned photographs.

Figure 3.2: Macrograph showing general appearance of sensor ref. SHSD2-01 and bentonite surrounding it

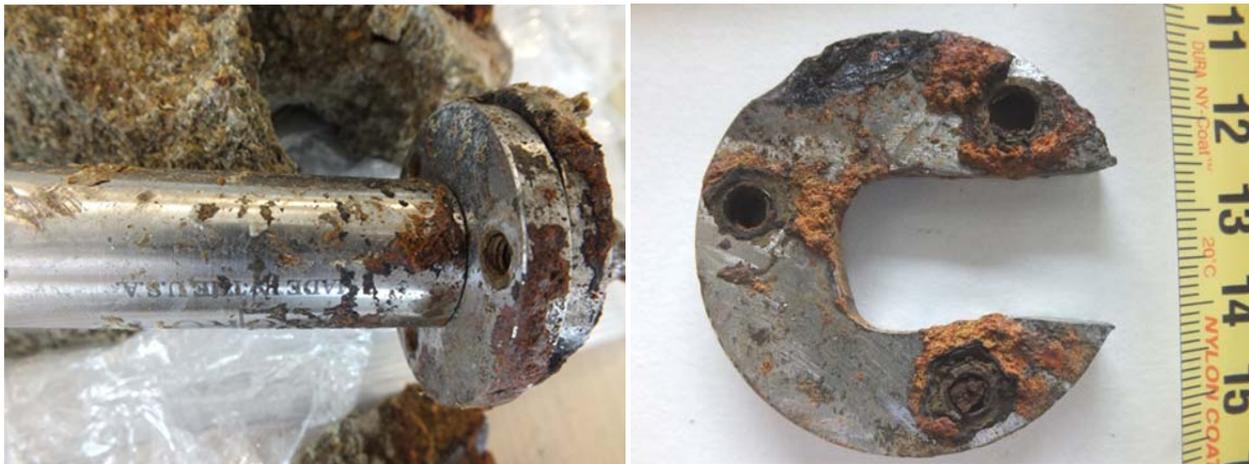
Figure 3.3: Detail of sensor ref. SHSD2-01 close to the rock

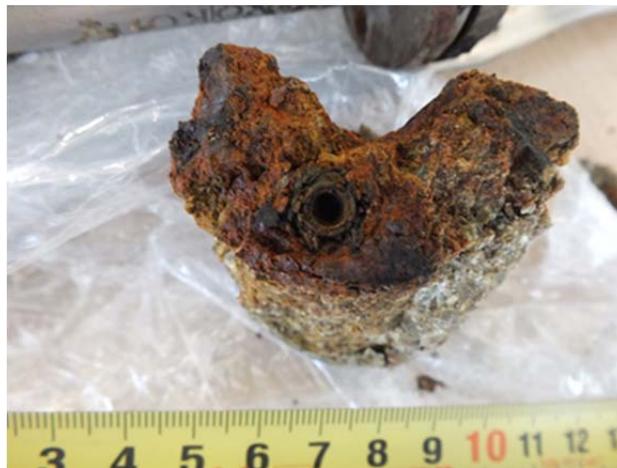
Figure 3.4: Detail of bentonite surrounding sensor ref. SHSD2-01 close to the rock

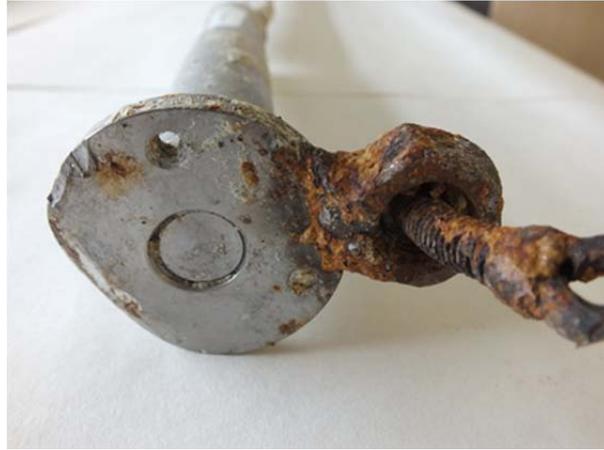
Figure 3.5: Detail of sensor ref. SHSD2-01 close to the liner

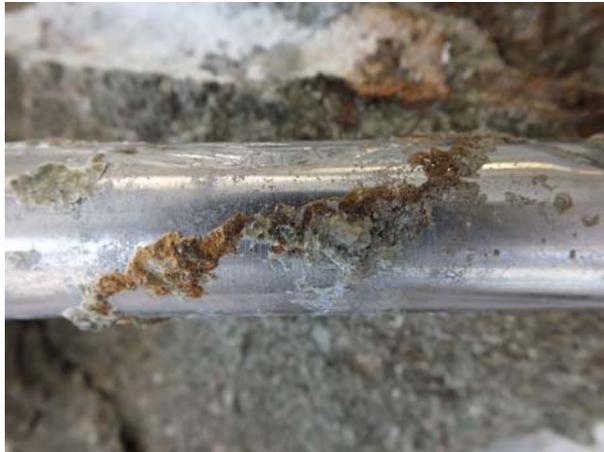
Figure 3.6: Detail of sensor ref. SHSD2-01 close to the rock

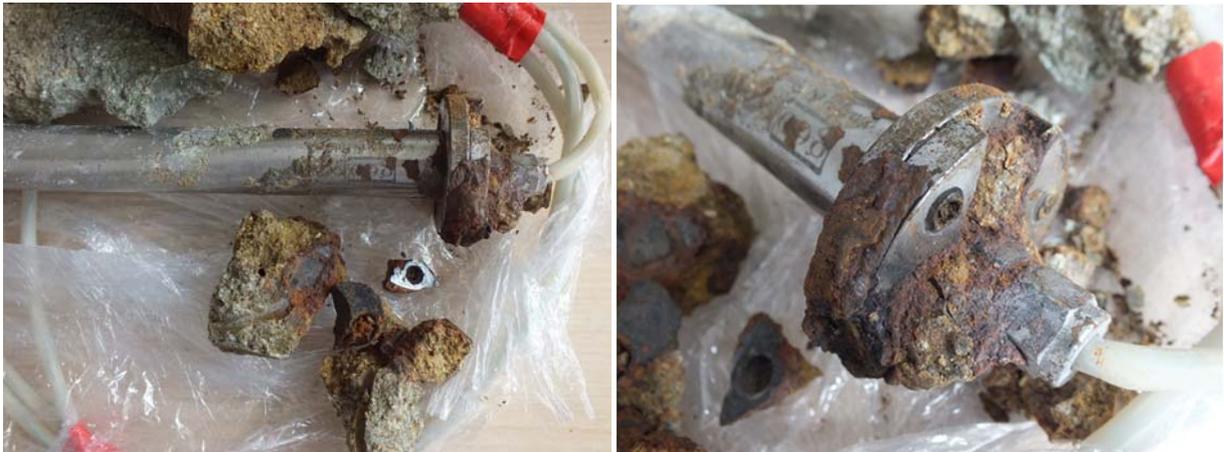
Figure 3.8: Detail of sensor ref. SHSD2-02 close to the rock

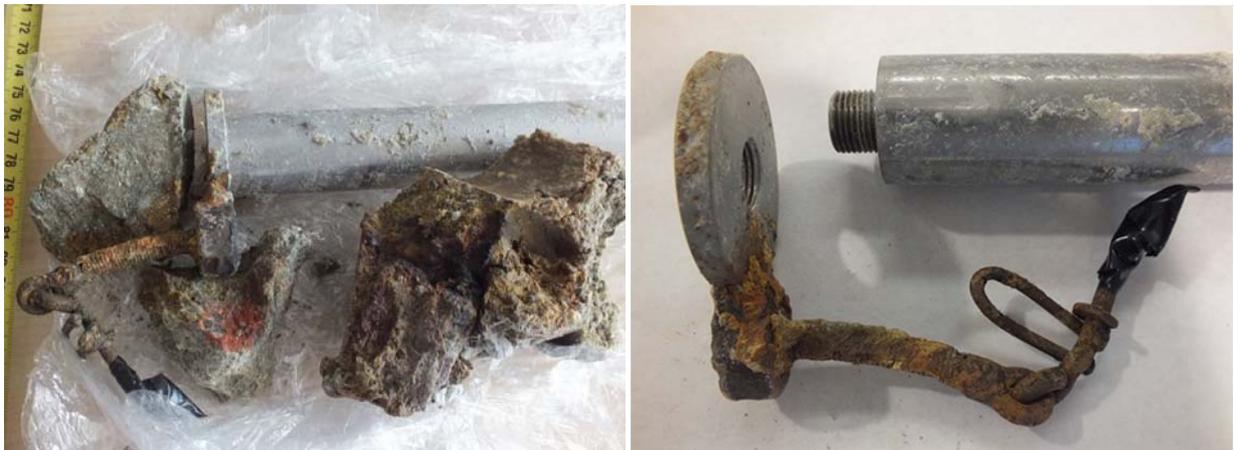
Figure 3.9: Detail of sensor ref. SHSD2-02 close to the liner

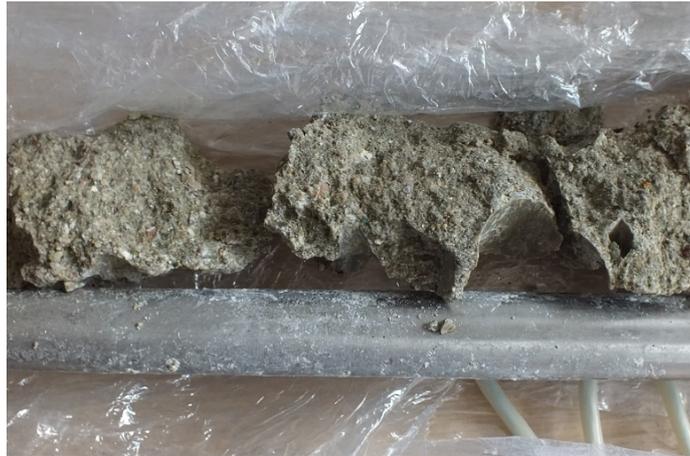
Reddish corrosion products are not observed on the central zone of the extensometers.

Figure 3.10: Detail of central zone in sensor ref. SHSD2-02 and bentonite surrounding it

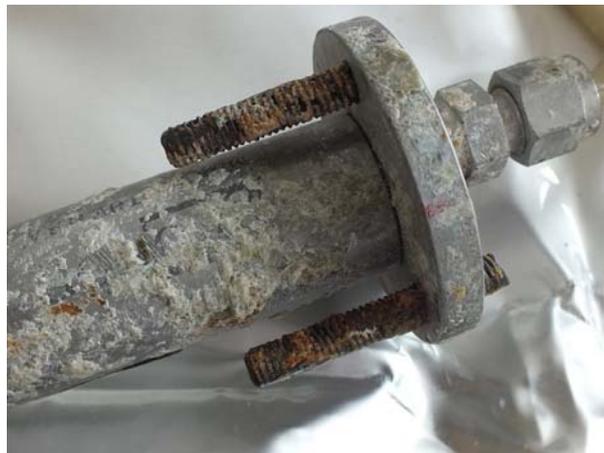
Figure 3.12: Detail of sensor ref. SHSD2-03 close to the rock

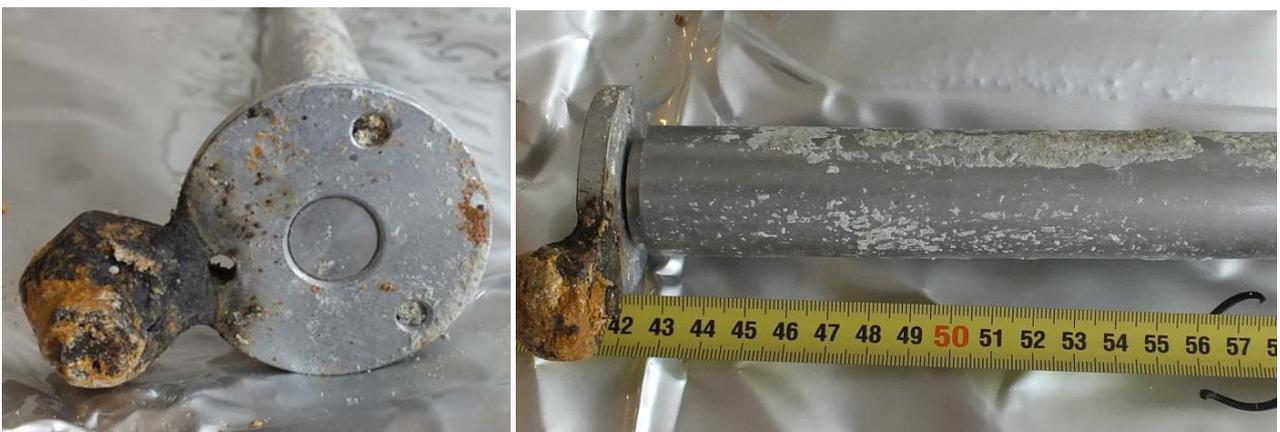
Figure 3.13: Details of sensor ref. SHSD2-03 close to the liner

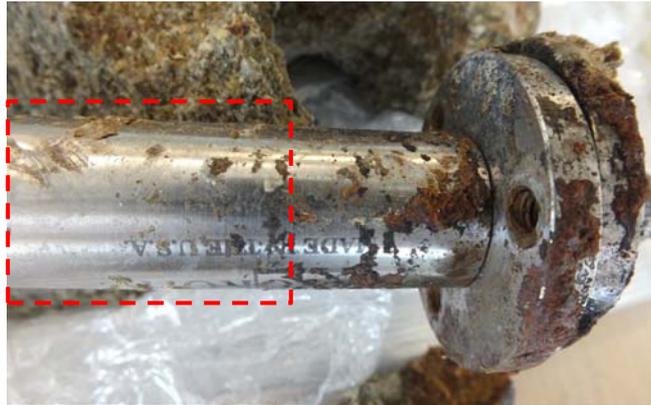
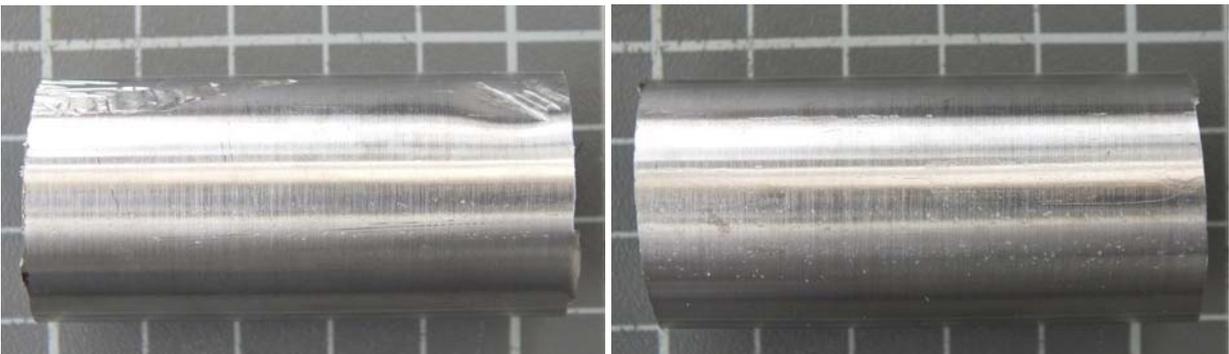
Apparently the brownish-red corrosion products observed on the surface of the extensometer tubes in areas close to the rock and close to the liner, are due to the corrosion of components parts of the anchoring devices made from carbon steel. In order to verify this issue, some sections extracted from the tubes have been chemically cleaned, with the intention of removing the adhered corrosion products. One of the cleaning solutions proposed for stainless steels in ASTM G1¹ standard, has been used. This chemical solution removes all the corrosion products with negligible attack of the underlying metal. Photographs in Figures 3.14 and 3.15 show the aspect of the extensometer tubes, on reception and after removing the tightly adhered corrosion products. Areas of mechanical damage are observed on the surface of the stainless steel tube, but pitting or other kind of localized corrosion is not detected.

Figure 3.14: Sections of sensor ref. SHSD2-02 (close to the rock) before and after removing the adhered corrosion products. One side and the other

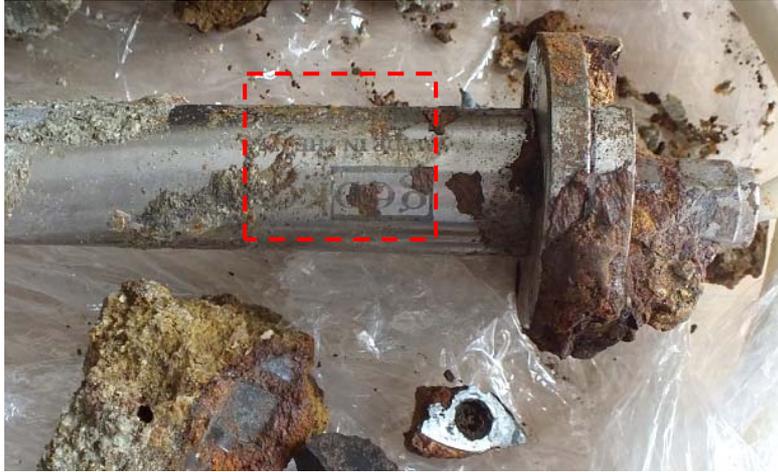
Figure 3.15: Section of sensor ref. SHSD2-01, close to the rock, before and after removing the adhered corrosion products. One side and the other

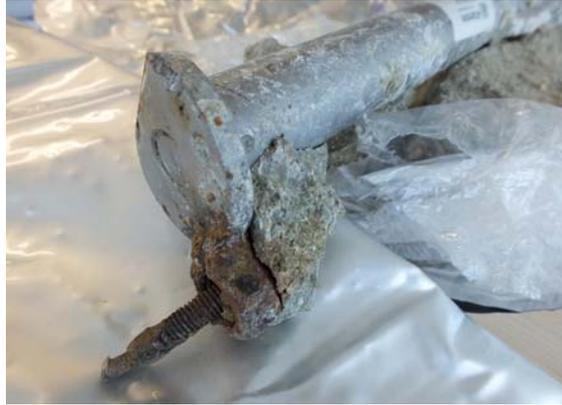
Figure 3.18: Macrograph of sensor ref. SHSD2-01 close to the liner

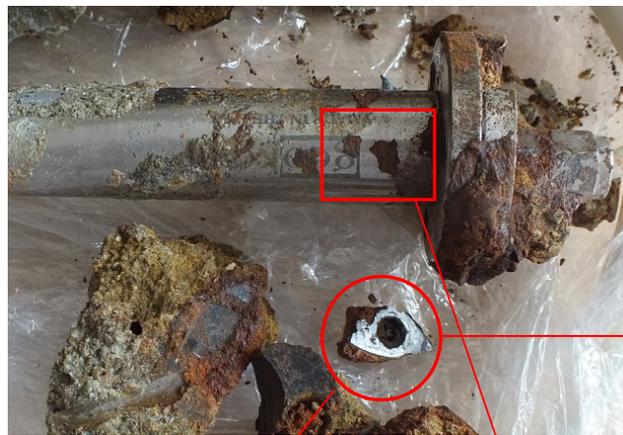
- The black brilliant oxide layer generated in screw from sensor ref. SHSD2-02 close to the rock, shown in Figure 3.19, corresponds principally to magnetite (Fe_3O_4)
- Corrosion products generated in the nut from sensor ref. SHSD2-02 close to the liner, shown in Figure 3.24, correspond principally to magnetite (Fe_3O_4) and siderite (FeCO_3)
- It is important to point out that in the XRD spectrum only the crystalline species (diffracting ones) are shown.

Figure 3.19: Macrograph of sensor ref. SHSD2-02, close to the rock, and corresponding EDS spectra

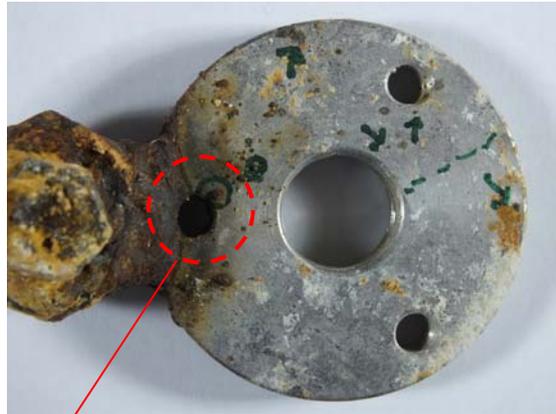
Chloride is only detected in the EDS analyses carried out on the shallow “pits” observed on stainless steel joints close to the liner in sensors ref. SHSD2-02 and SHSD2-03, shown in Figures 3.22, 3.23 and 3.27.

Figure 3.27: Photograph showing corroded zone of joint from sensor ref. SHSD2-03 close to the liner, and electron micrograph and EDS spectrum corresponding to this zone

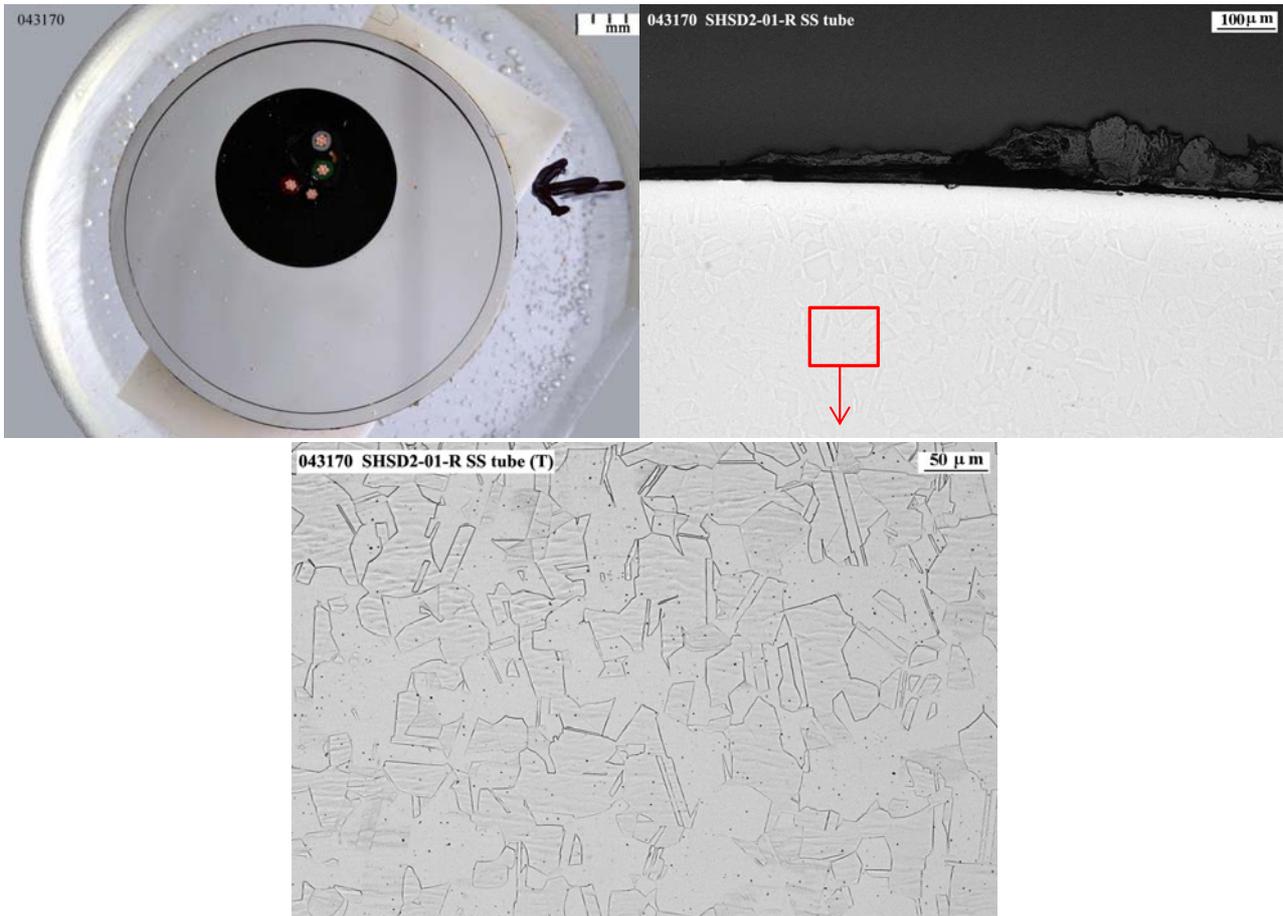
The optical micrographs in Figures 3.36 and 3.37 show no signs of localized or generalized corrosion in the 316 stainless steel tubes from sensors ref. SHSD2-01 and SHSD2-02. Chemical etching reveals a non-sensitized austenitic microstructure.

Figure 3.36: Photograph of metallographic probe and optical micrographs of stainless steel tube from sensor ref. SHSD2-01 close to the rock, with metallographic etching

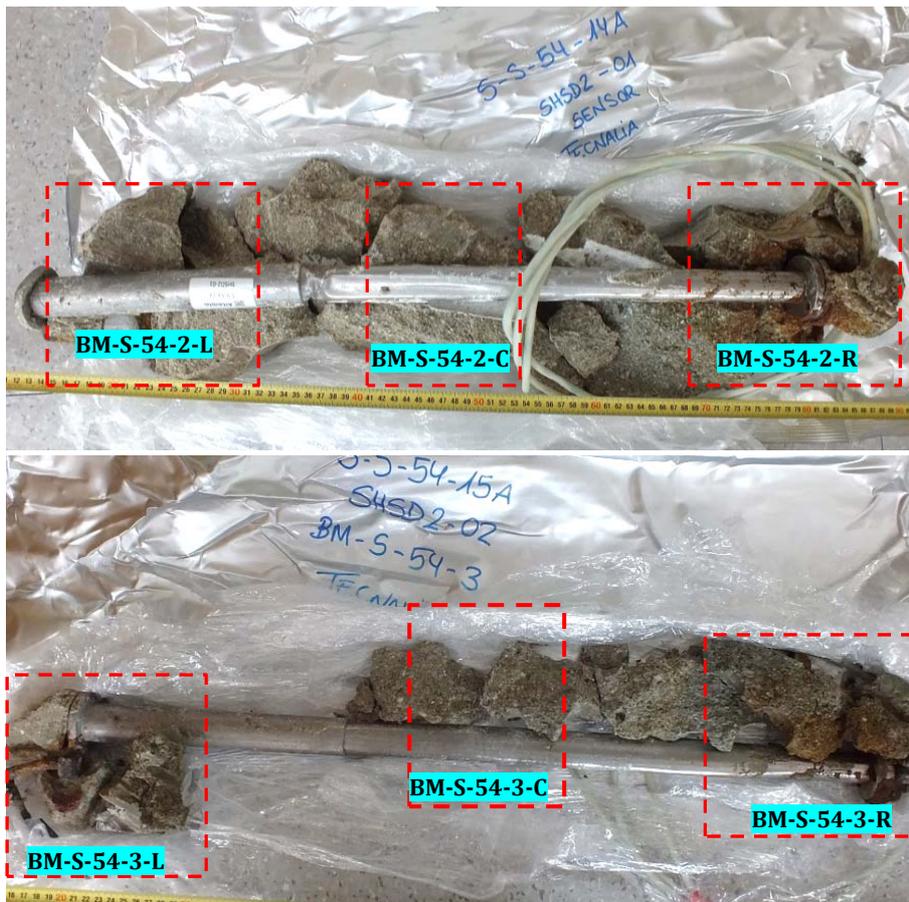
Figure 4.1 shows the appearance of the bentonite samples surrounding sensors SHSD2-01 and SHSD2-02. The bentonite located around the attaching devices of the sensors to the rock and to the liner, shows a brownish-red color, due to the diffusion of corrosion products. There is not detected significant diffusion of corrosion products in the bentonite located around the central part of the extensometers. Bentonite samples are identified with L (liner), R (rock) and C (center) based on their location (see Figure 4.1).

Figure 4.1: Macrographs showing location of the bentonite samples reference BM-S-54-2 (up) and BM-S-54-3 (down)

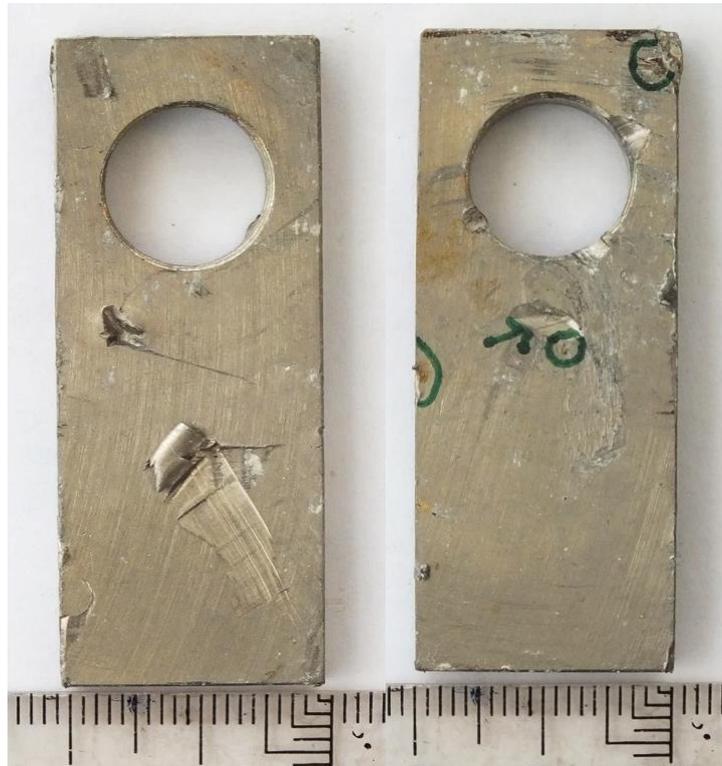
Figures 5.19 to 5.24 show details of the 6 titanium alloys coupons. Visual inspection reveals little or no general corrosion. Reddish spots/particles are observed on the surface of almost all the titanium coupons. This is probably due to the corrosion of enriched iron particles. They appear to have been deposited or stuck on the surface of the samples.

Figure 5.21: Photographs showing corrosion coupon ref. 3A4 (Ti7 base), one side and the other

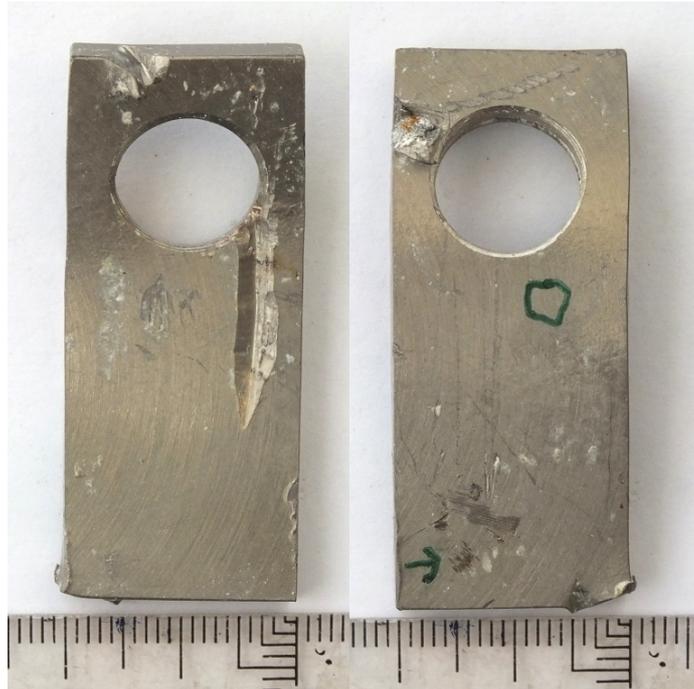
Figure 5.22: Photographs showing corrosion coupon ref. 3A6 (Ti7 PAW), one side and the other

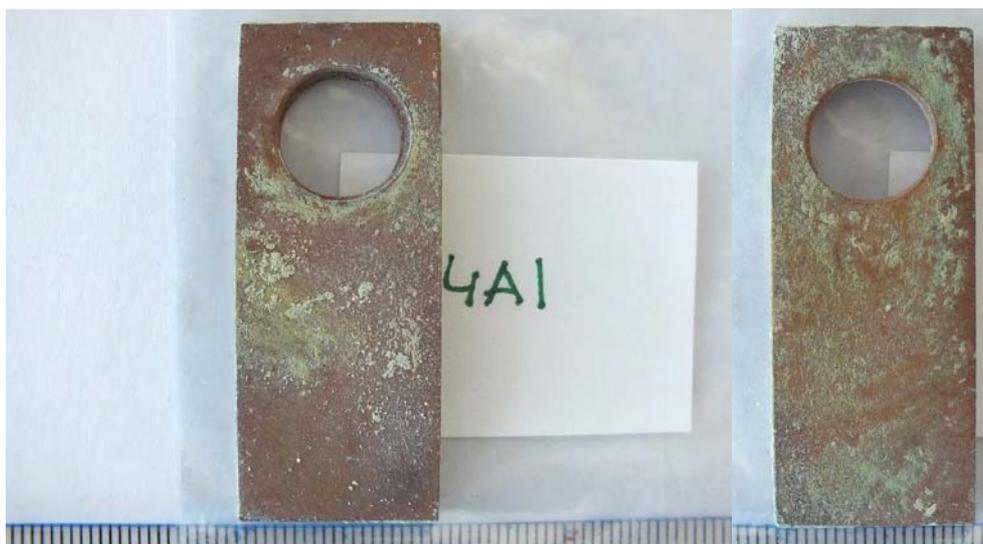
The surface of the Cu-ETP coupons show a brownish-red color, with greenish areas mixed with bentonite, Figures 5.29 and 5.30. Uniform general corrosion appears to be the predominant mechanism observed, with a quite adherent oxide layer. Only when the adhered bentonite in coupon ref. 4A2 is removed with a plastic brush, there are observed small areas of localized corrosion in one edge of the coupon, Figure 5.30.

Figure 5.29: Photographs showing coupon ref. 4A1 (one side and the other)

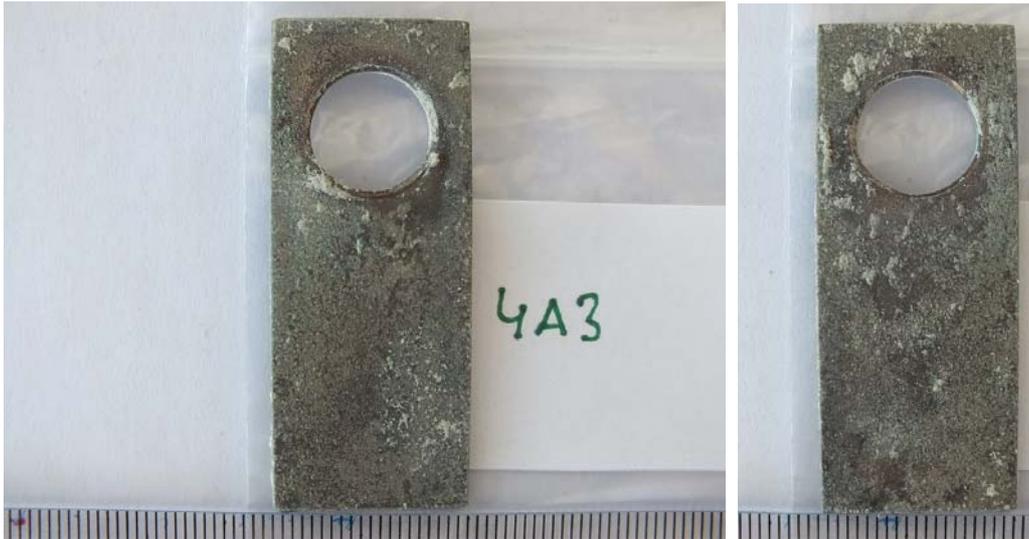
The surface of the Cu-10Ni coupons shows a blackish-grey color, with greenish areas mixed with bentonite, Figures 5.31 and 5.32. Uniform general corrosion appears to be the predominant mechanism observed. There is no visible pitting or other types of localized corrosion.

Figure 5.31: Photographs showing corrosion coupon ref. 4A3 (one side and the other)

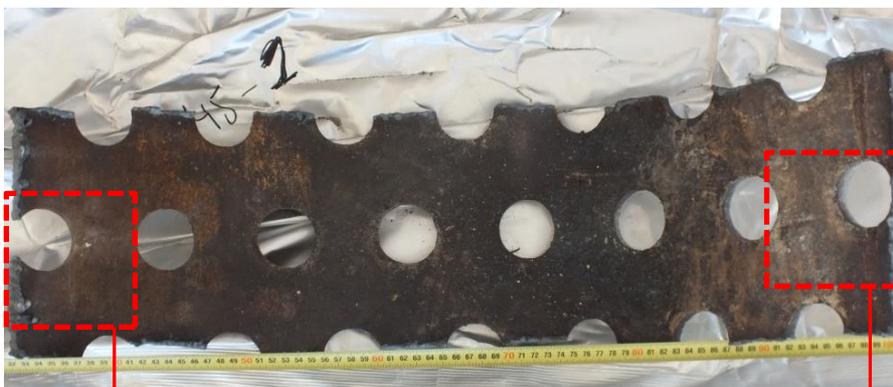
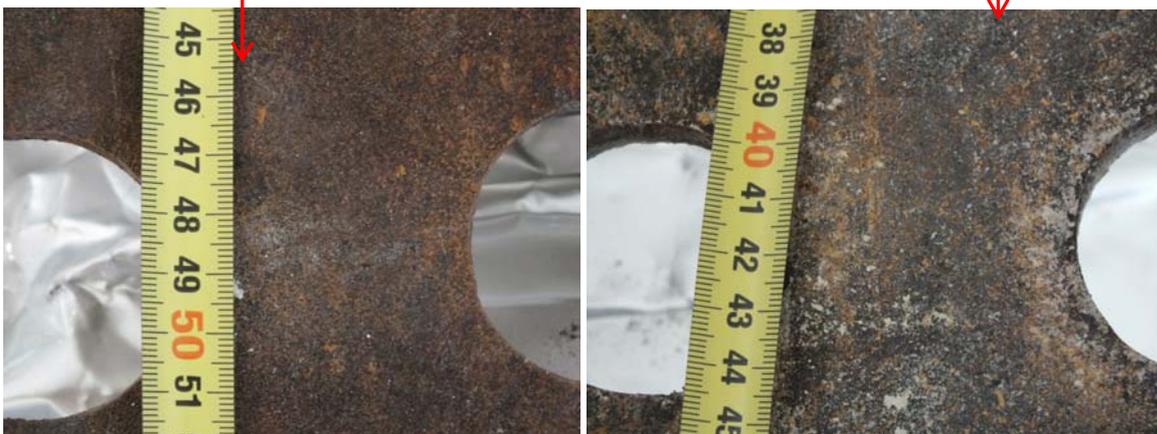
Figures 6.3 to 6.10 show different aspects of the corrosion generated on ML45 liner samples. A bentonite layer, compacted and apparently well adhered is observed in the four quadrants of the liner. A higher extension of the corrosion is detected in areas bordering the holes, or in areas that could correspond to the separations in the bentonite blocks. General corrosion is the predominant mechanism observed in both external and internal (underside) surface of the samples. There is no visible pitting or other types of localized corrosion.

Figure 6.4: Photographs showing general appearance and detail of internal surface of ML45-1 section

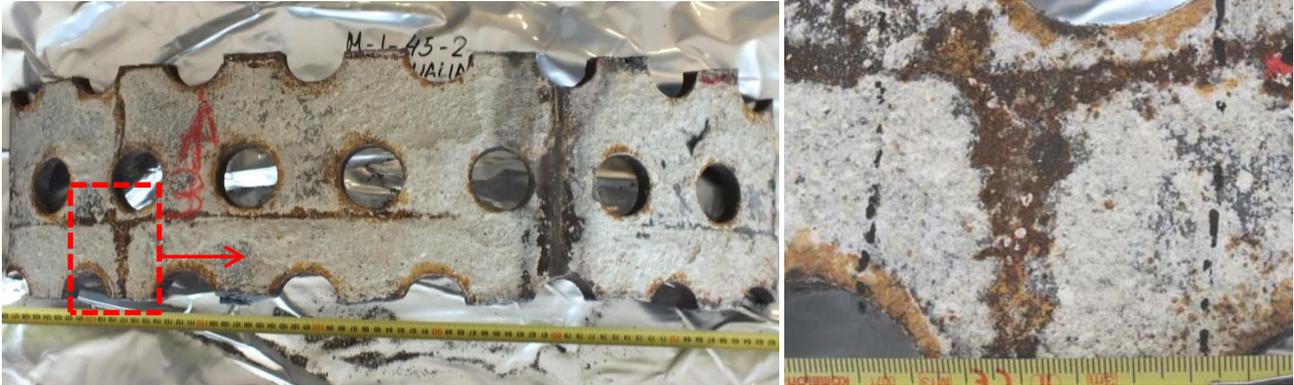
Figure 6.5: Photographs showing general appearance and detail of external surface of ML45-2 section

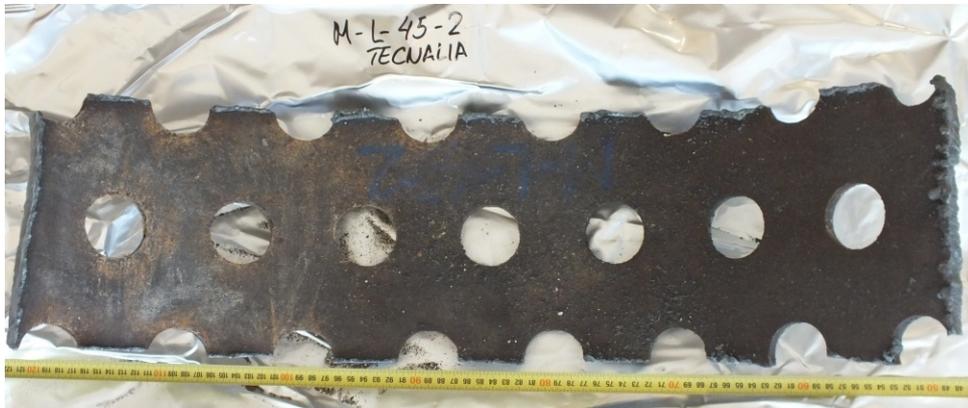
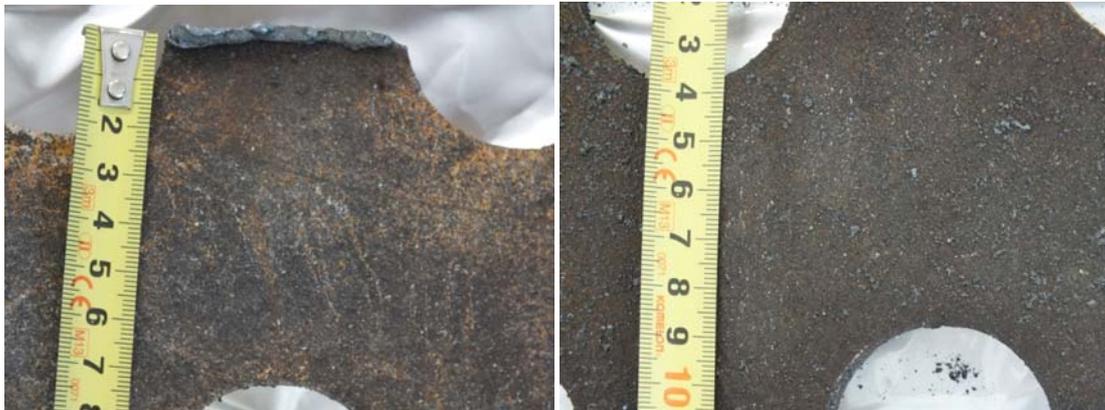
Figure 6.6: Photographs showing general appearance and detail of internal surface of ML45-1 section

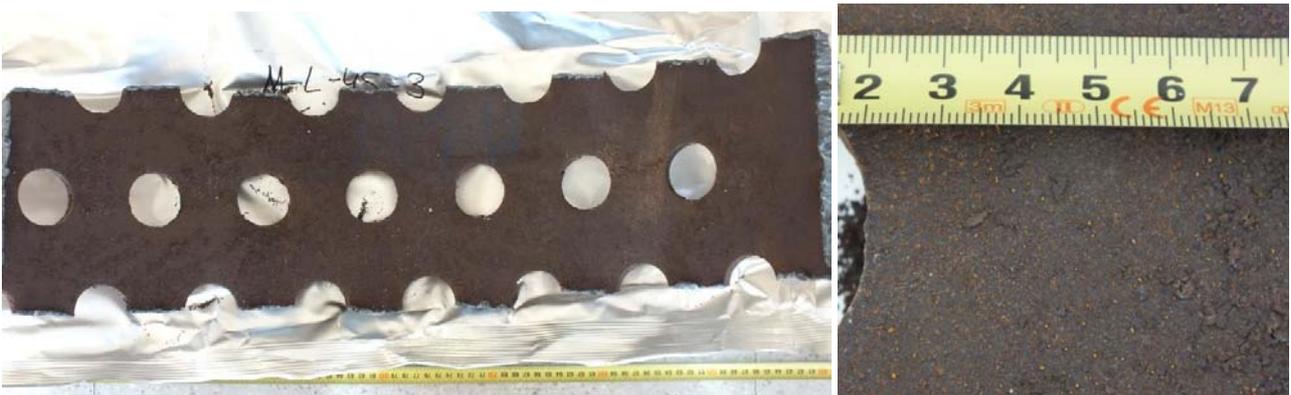
Figure 6.8: Photographs showing general appearance and detail of internal surface of ML45-3 section

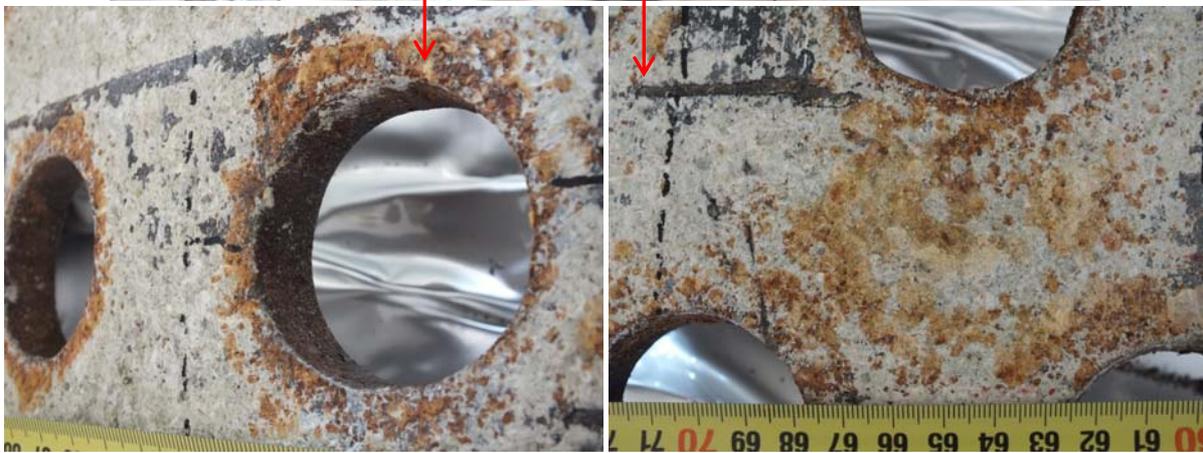
Reddish-brown corrosion products are observed in the external surface, whereas more brownish-black corrosion products are observed in the internal surface, free of bentonite residues. The oxide layer generated in the internal surface seems somewhat more adherent and regular than that observed on the external surface. However the oxide generated in the internal surface of quadrants ML45-3 and ML45-4, is easily spalled.

Figure 6.9: Photographs showing general appearance and detail of external surface of ML45-4 section

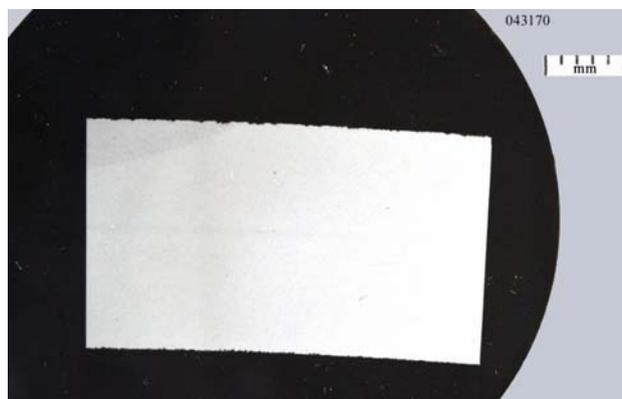
The remaining (un-corroded) wall thickness of section ML-45 is measured on the metallographic probes (Figure 6.15), using a measuring microscope. An average value of 14.7 ± 0.15 mm is obtained. Assuming that the liner was initially 15 mm thick, corrosion penetration values are in line with the maximum values measured on optical micrographs: approximately 200-250 microns on the external surface and up to 180 microns on the internal surface.

Chemical etching of metallographic probes reveal a ferrite-perlite microstructure for the steel constituting the liner, typical of carbon steels.

Figure 6.15: Metallographic probe of transversal section of liner sample ML-45, quadrant 2

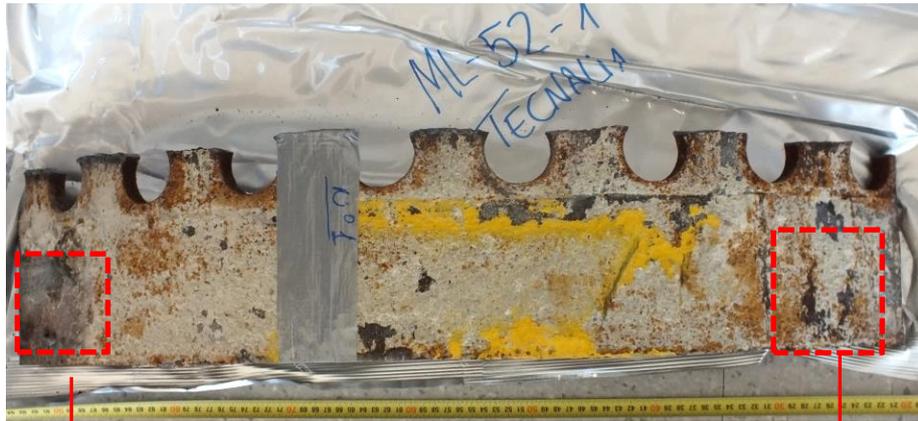
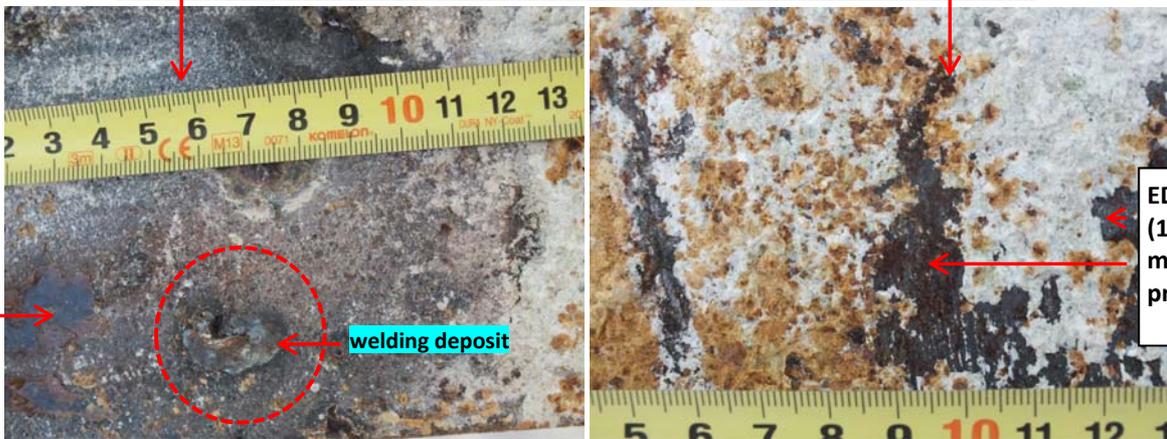
Figures 6.18 to 6.25 show different views of the liner section ML-52. As it was observed for section ML45, the extension of the corrosion is higher in areas bordering the holes, or in areas that could correspond to the separations in the bentonite blocks.

General corrosion is the predominant mechanism observed in both external and internal surface of the samples, with the formation of brownish-red corrosion products in the external surface, whereas more brownish-black corrosion products are observed in the internal surface, free of bentonite residues.

Figure 6.18: Photographs showing general appearance and detail of external surface in ML52-1 section

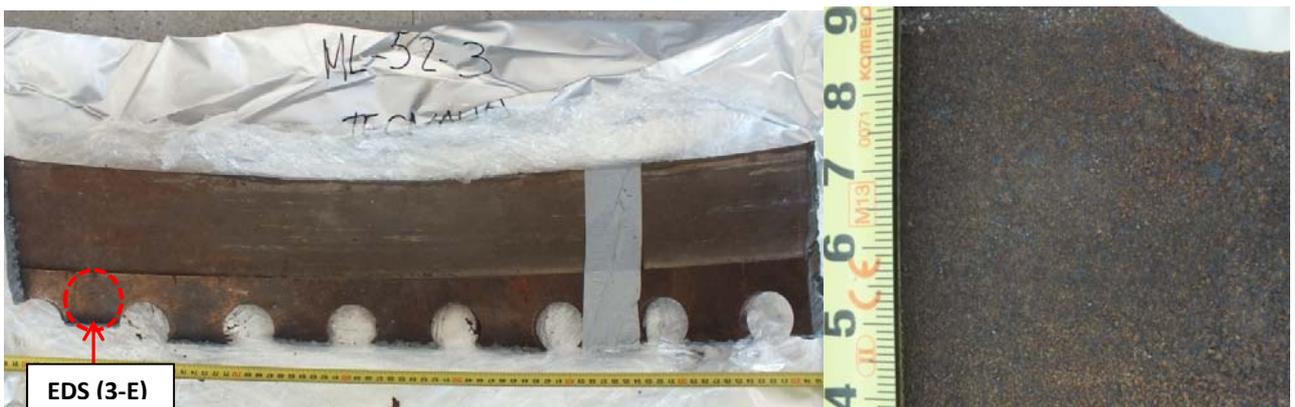
Figure 6.23: Photographs showing general appearance and detail of internal surface of ML52-3 section

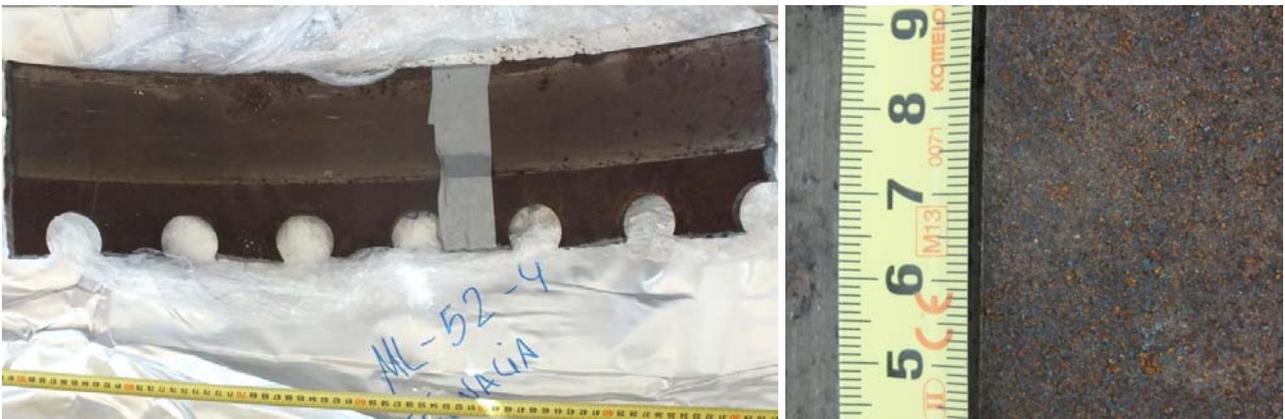
Figure 6.25: Photographs showing general appearance and detail of internal surface of ML52-4 section

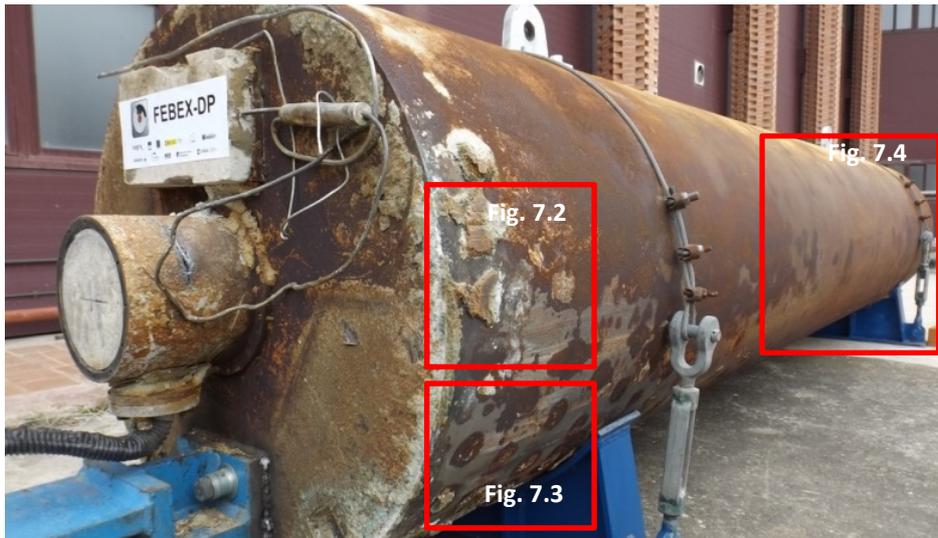
Examination of the heater showed a quite uniform overall generalized corrosion of the surface. No visible pitting or other types of localized corrosion were detected. Reddish-brown corrosion products were observed in the external surface. The oxide layer generated in the surface of the heater was quite adherent and regular.

Figure 7.1: Photograph showing 3 o'clock view of the heater at AITEMIN premises

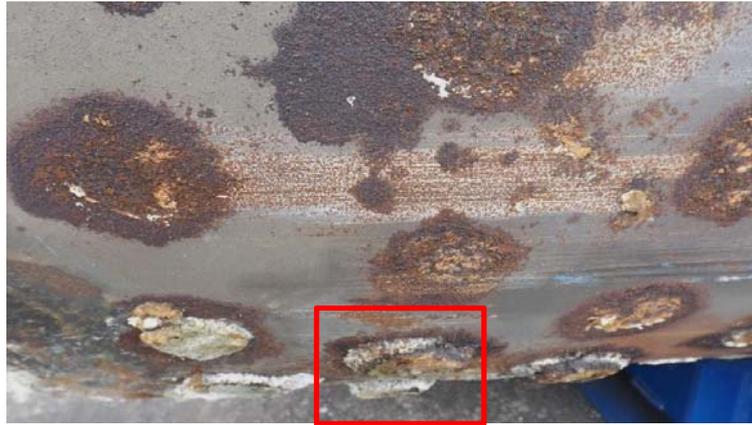
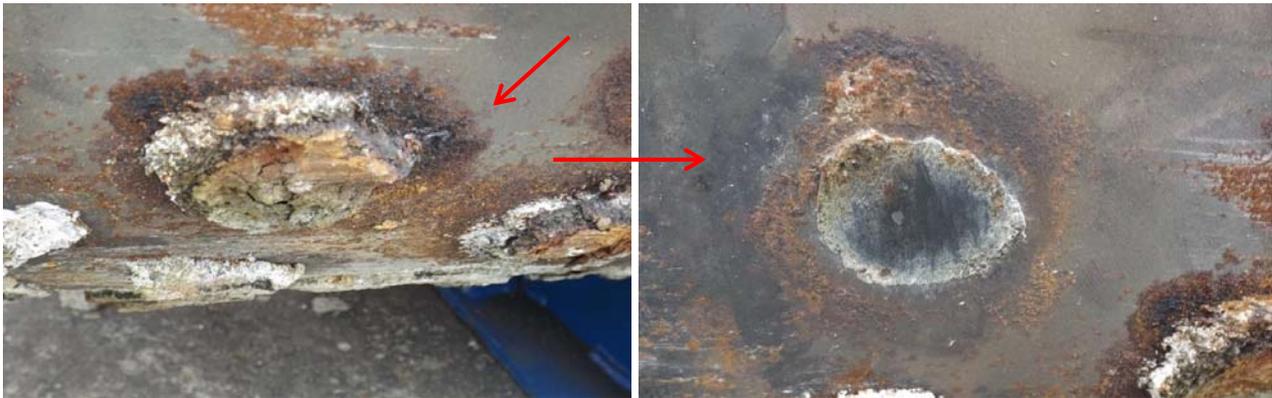
Figure 7.3: Detail of photograph shown in Fig. 7.1. Photograph of the bottom-right, shows this area after removing the adhered bentonite.

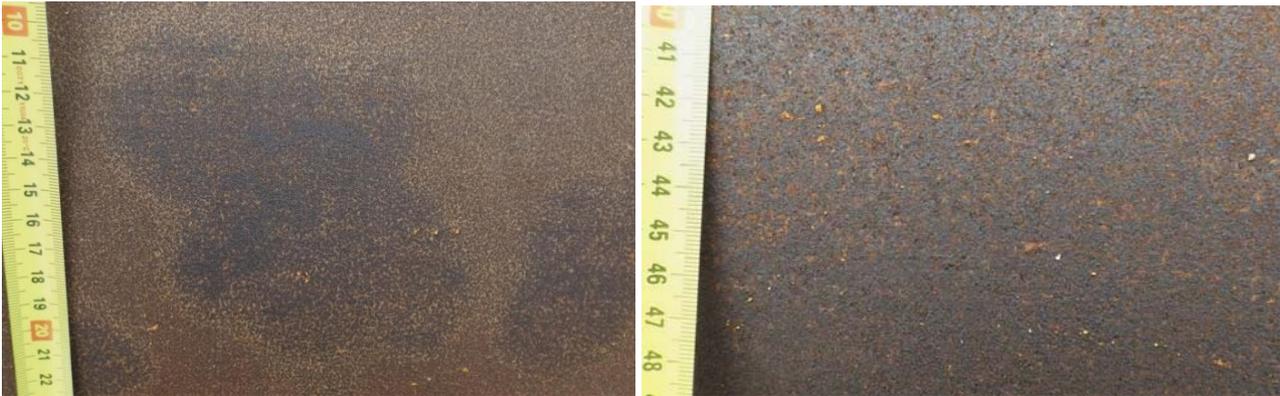
Figure 7.5: Details of photograph shown in Fig. 7.4

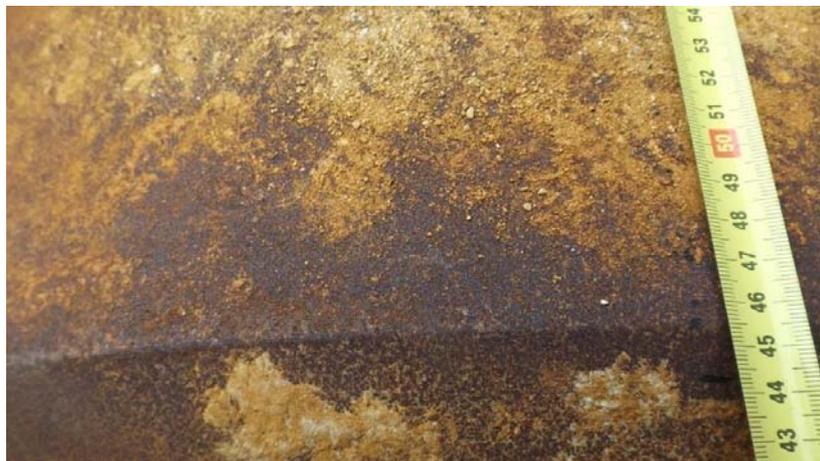
The two lid-cylinder welded joints at the top and back side of the heater showed a good condition.

Figure 7.6: Photograph showing top end of the heater at AITEMIN premises

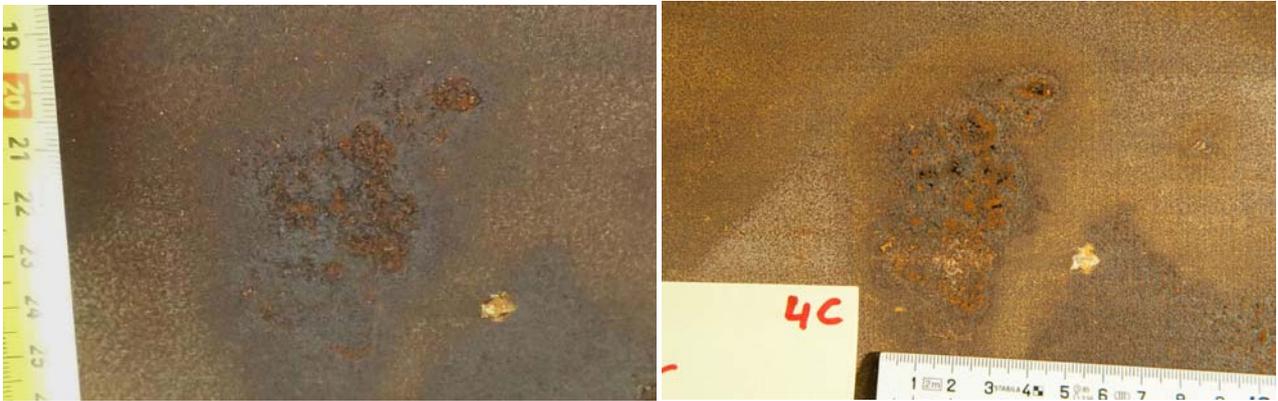
Figure 7.8: Detail of photograph shown in Fig. 7.7 (left). Photograph of the same zone in Grimsel (right)

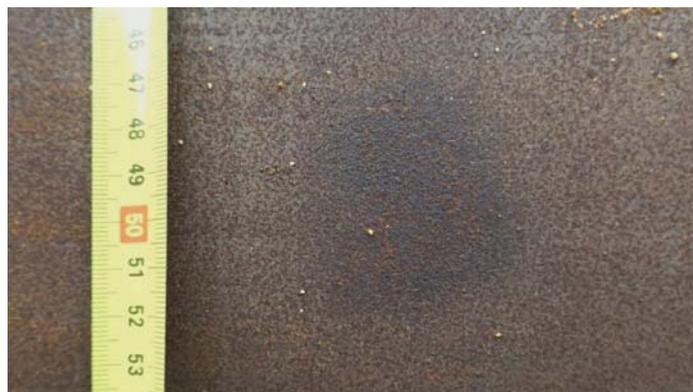
Figure 7.12: Detail of photograph shown in Fig. 7.10

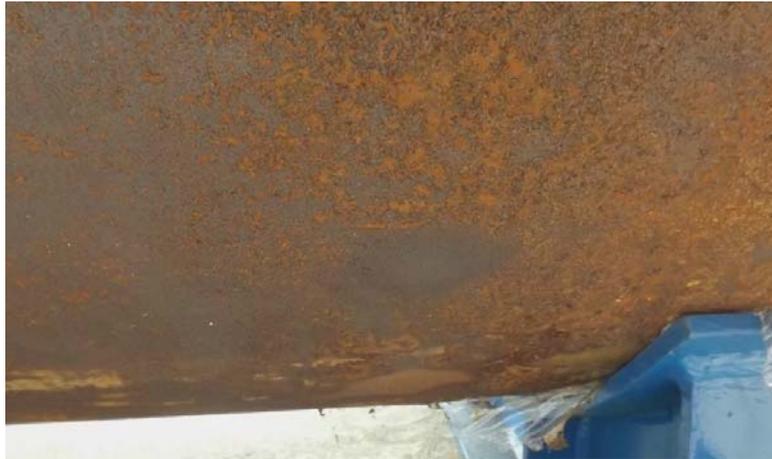
Figure 7.13: Detail of photograph shown in Fig. 7.10

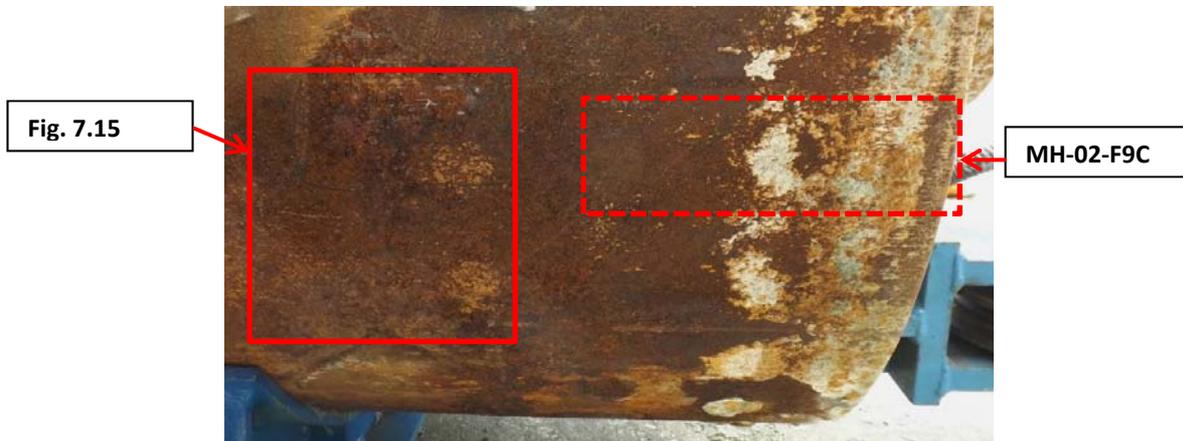
Figure 7.14: Detail of photograph shown in Fig. 7.10. The red dotted line indicates location of heater sample ref. MH-02-F9C

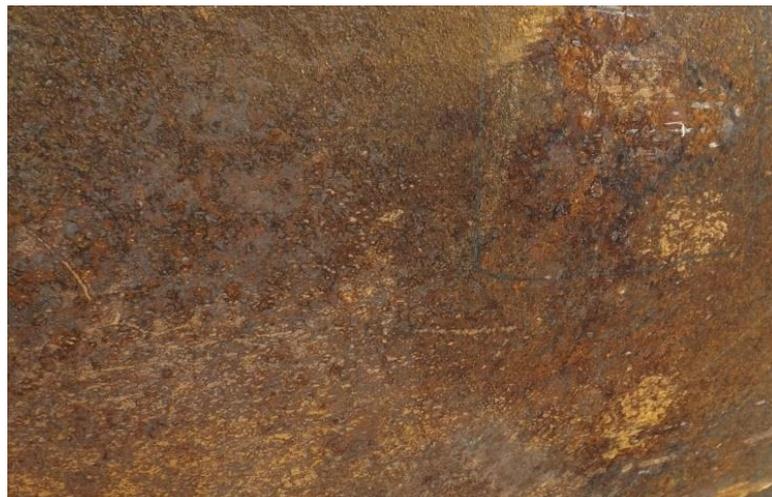
The front part of the heater showed a higher extension of the generalized corrosion damage. Bentonite deposits protruded through the liner holes were still stuck to the surface of the heater. The oxide layer generated in some zones of the front part (9 o'clock position), Figure 7.15, were more easily spalled.

Figure 7.15: Detail of photograph shown in Fig. 7.14
