Arbeitsbericht NAB 16-54

Corrosion Study of FEBEX-DP Components

Virginia Madina

TECNALIA

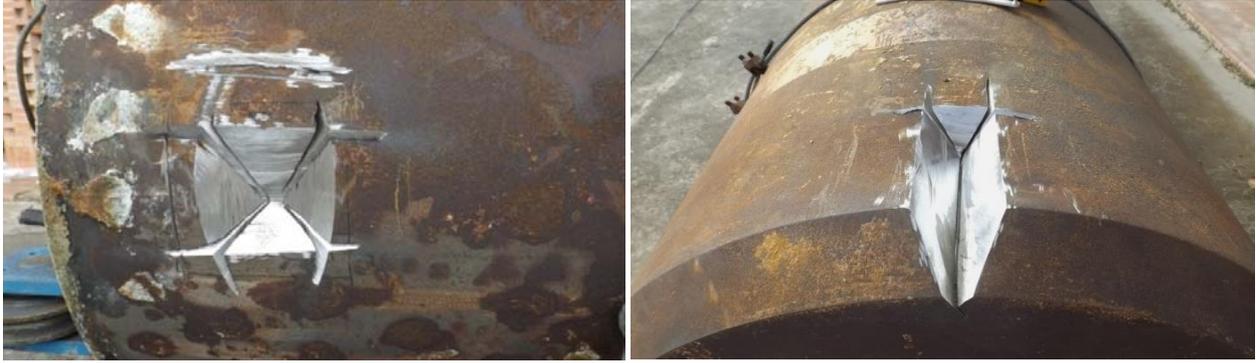
Figure 7.16 shows the location in the heater of sampling sites ref. MH-03-ET and MH-03-ET.

Figure 7.16: Photograph showing the location in the heater of samples ref. MH-03-ET (left) and MH-03-ET (right)

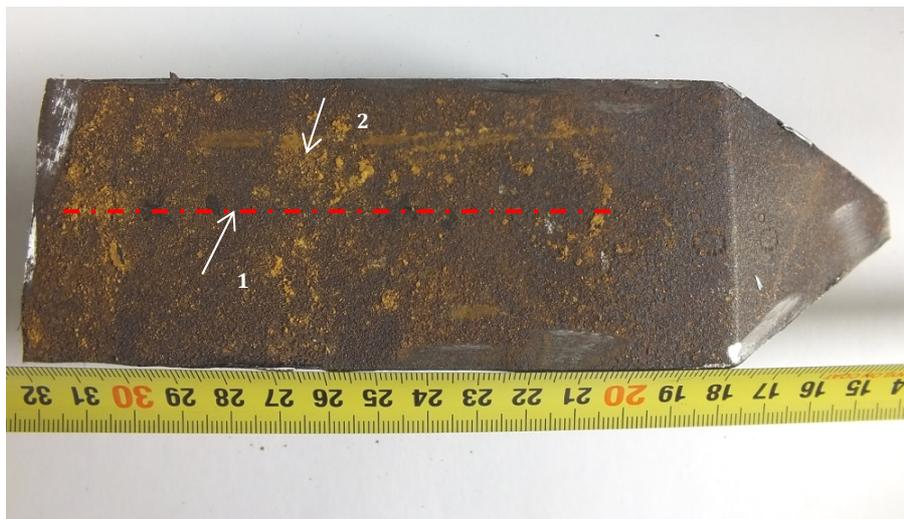
Figure 7.18: Photograph showing sample ref. MH-02-F9C. Arrowheads indicate location of EDS analyses shown in Table 7.1. Red dotted lines indicate the location of the metallographic probes (L=longitudinal, T=transversal)
